SERVICE INSTRUCTIONS

REFERENCE: FSA202304

SUBJECT: ECM Update of Gen1.5 13L F-MAX Vehicles for Urea Dosing Problem in Cold Conditions

FSA TYPE: Customer Notification

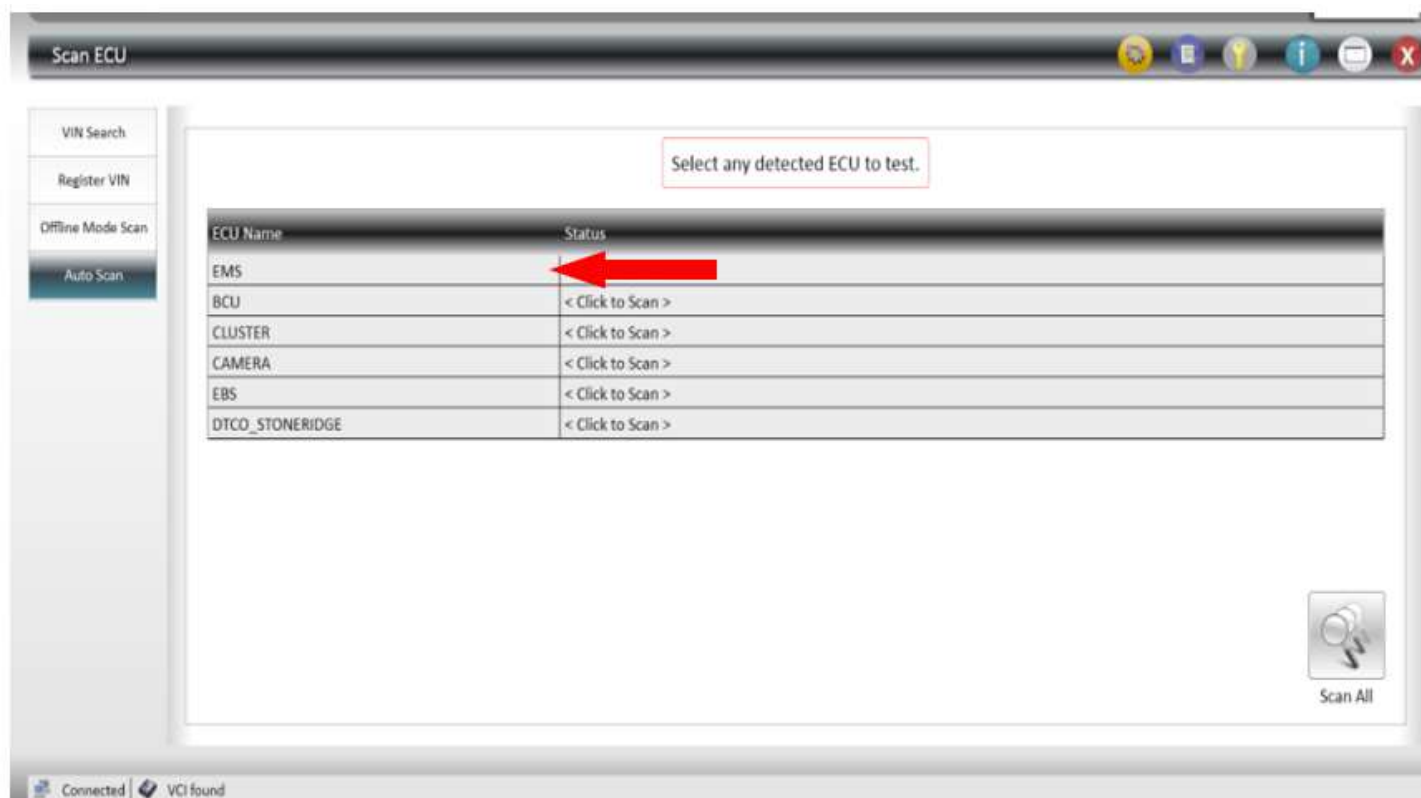
- After running the program click on the “Search Module” button and go to the page which defines vehicle modules “Module Choosing Menu”. On this screen, operation needs to be done on the EMS module.

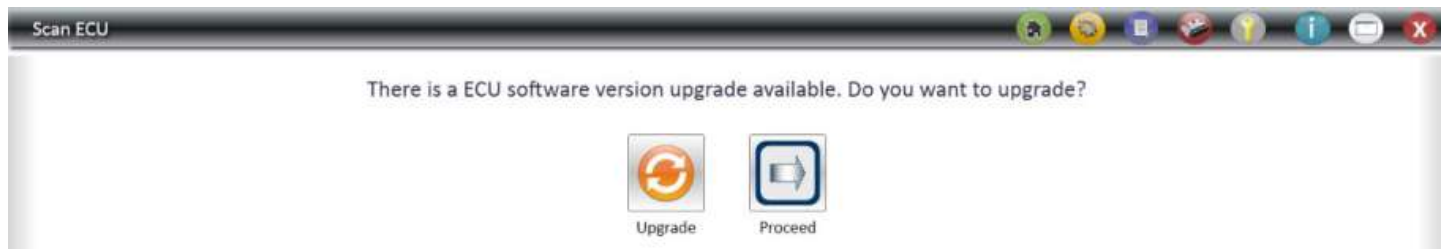
- After completing the required connection please go to the EMS module and if you see below screen, please click "Update" button. If there is an update for the program, this process could be take 1-10 minutes. Please do not touch to the computer during this process and be sure that internet connection and battery is in good condition.
