SERVICE INSTRUCTIONS

REFERENCE: FSA202307

SUBJECT: Injector Nuts Loctite Process

FSA TYPE: Customer Notification

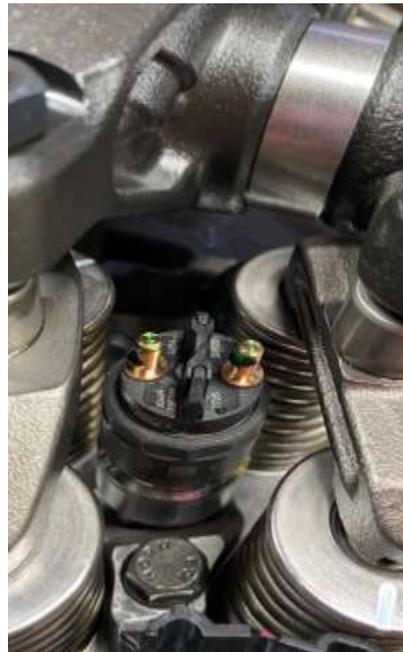
In order to prevent the bolt loosening problem, the following steps should be applied

7-The studs should be dried with a dry shop towel before the loctite application process.

8-Loctite should be applied to all injector studs as in the photo below.
