SERVICE INSTRUCTIONS

REFERENCE: FSA202213

SUBJECT: FSA202213 F-Max Vehicles BCU Update

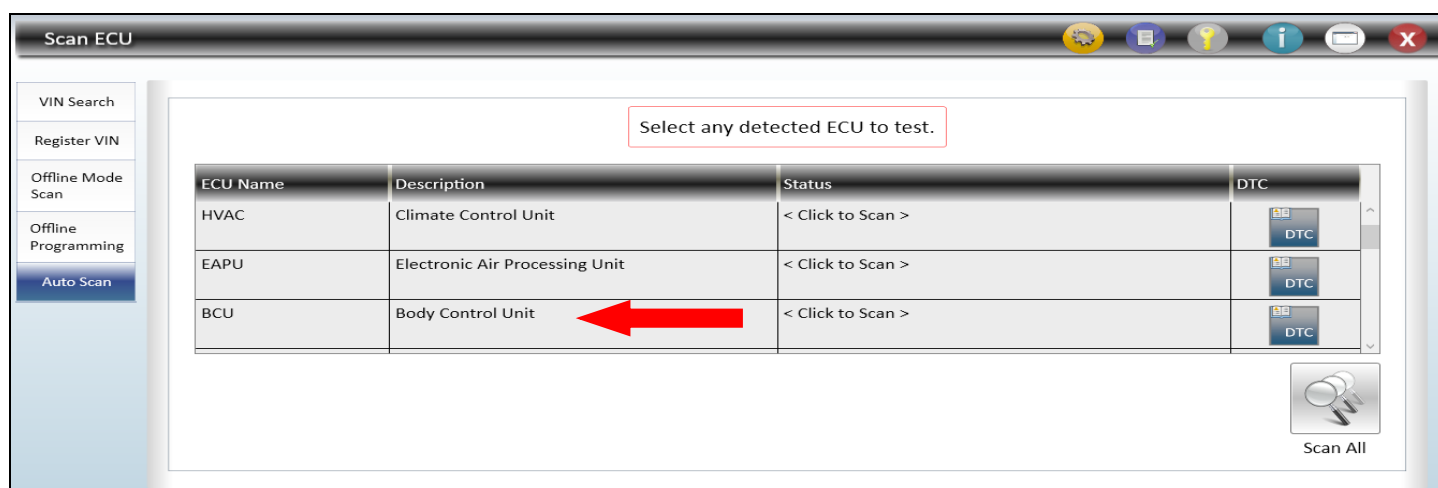
In order to prevent the battery discharge problem occurring in F-MAX vehicles, the BCU module programming is required.

After the update, the software version should be checked on the module information reading screen. The software number should be JC46-14C100-DC_v0_.vbf or higher.
