## SERVICE INSTRUCTIONS

REFERENCE: FSA202122

SUBJECT: Cluster Calibration Update

FSA TYPE: Recall

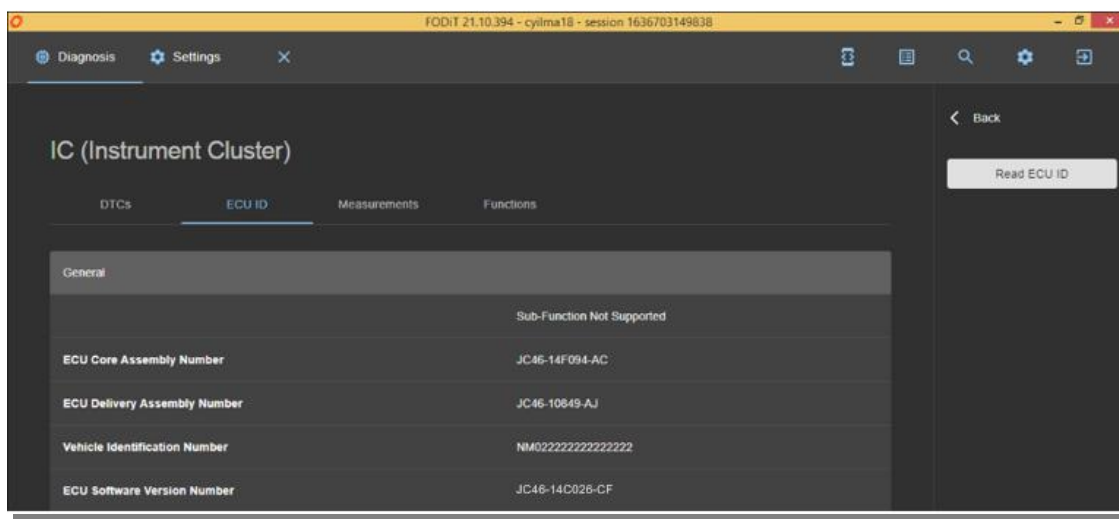
### FODIT ECUID SCREEN

3- After flashing cluster module, software level is JC46-14C026-CF or higher.

After flashing process, screenshot which is including VIN Number and software version (given above) from Read ECUID screen must be added to the claim card.
