## SERVICE INSTRUCTIONS

REFERENCE: R01\_FSA202110

DATE: 13.10.2021

SUBJECT: FSA202110 F-Max Vehicles BCU and ECU Flashing Update

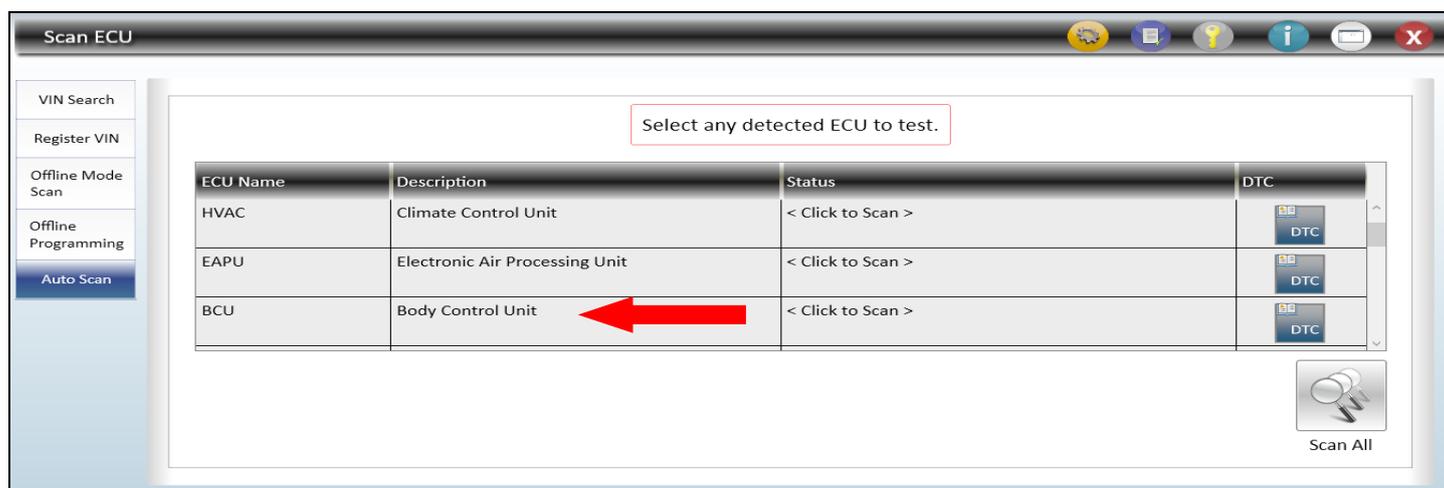
- After you select BCU by clicking 'Click to Scan', click one more time to go into of BCU module.
- After you go into BCU, if below screen is seen, please click 'Upgrade' button. It can take 5-8 minutes if the module has update. During this time, please do not engage with computer for other works and be sure that battery and network speed is ok.

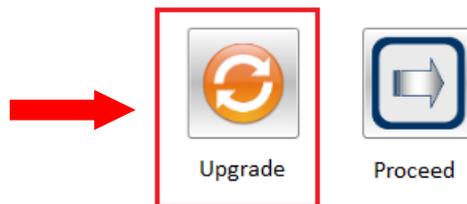
Unit that you are working on has an update. Do you want to upgrade now? (Upgrade is advised)

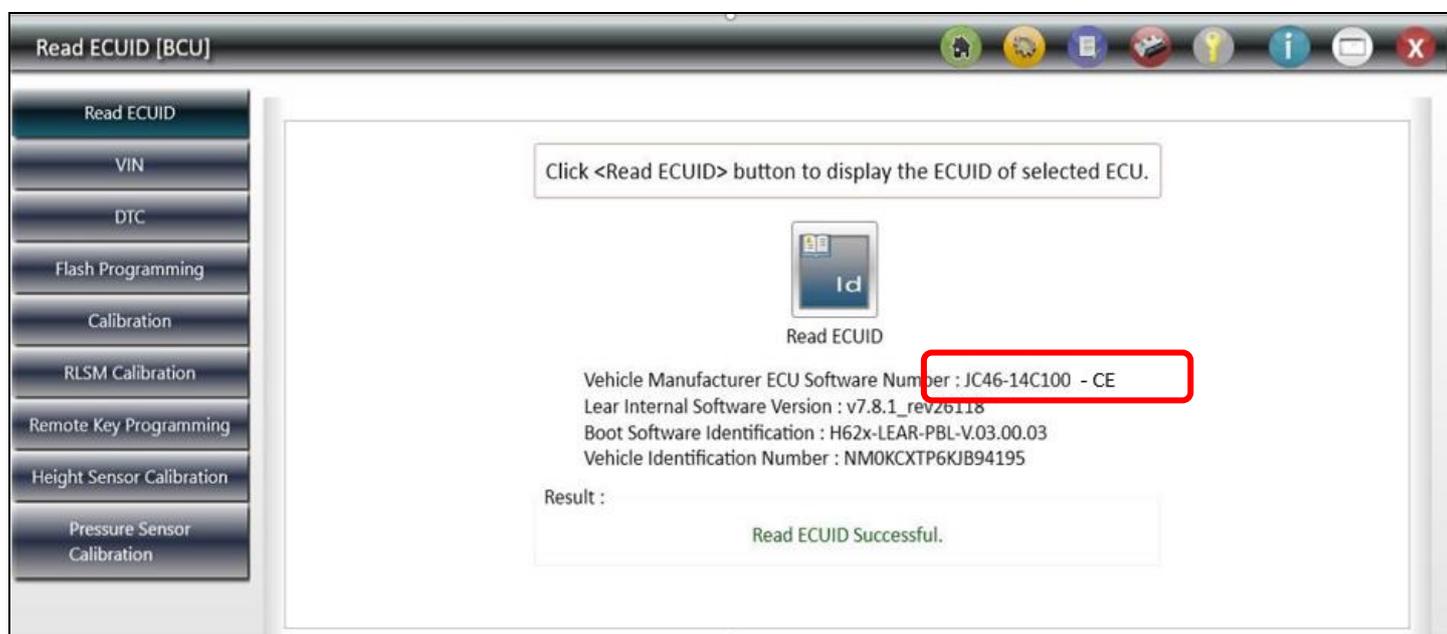
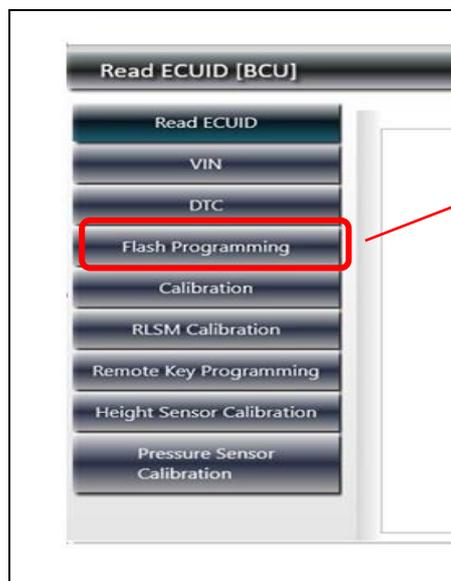
After the update, the software version should be checked on the module information reading screen. The software number should be JC46-14C100-CE or higher.

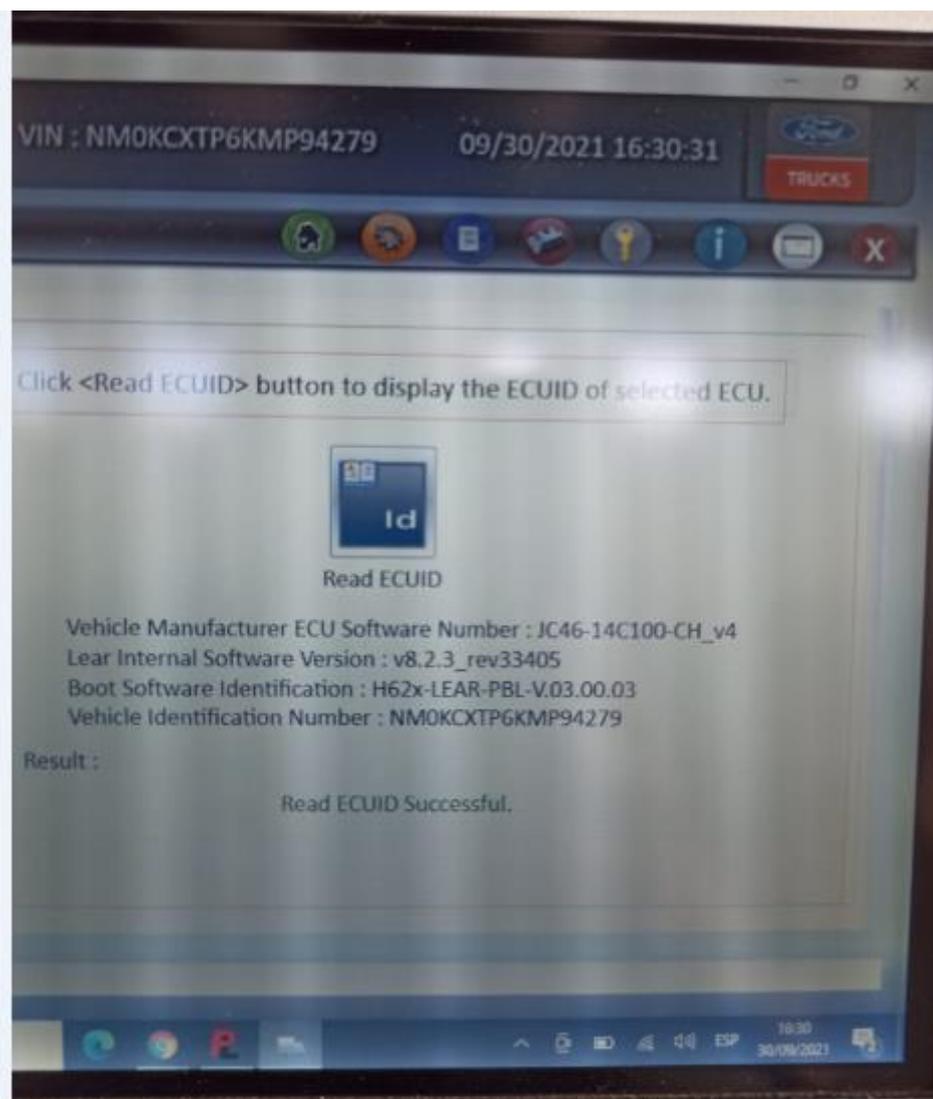
After flashing process, screenshot which is including VIN Number and software version (Software number must be JC46-14C100-CE or higher) from Read ECUID screen must be added to the claim card.

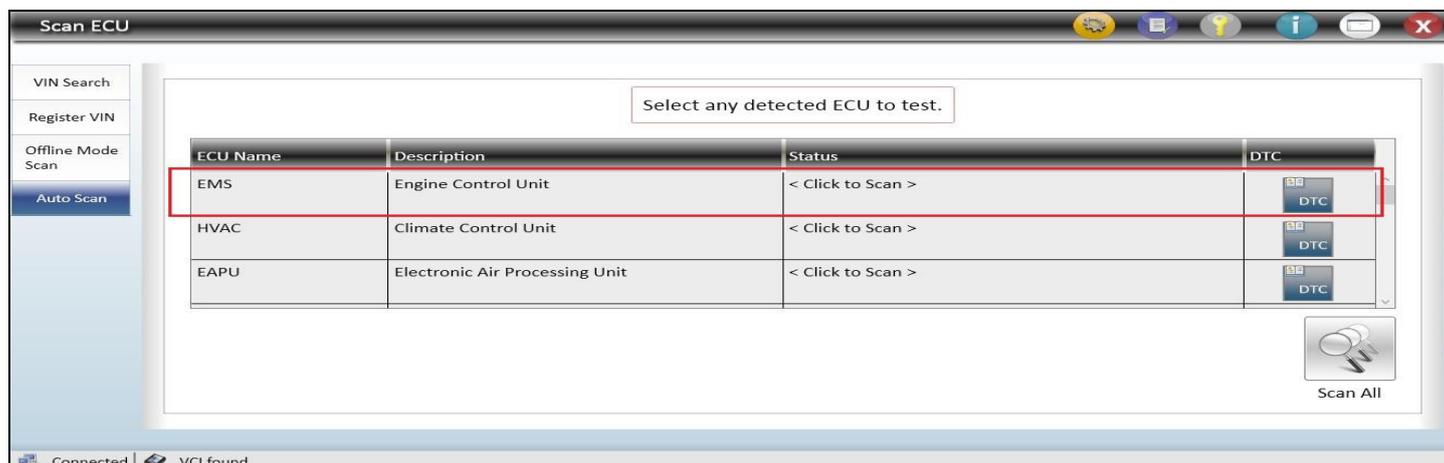
Run the FODP2 program and use "Auto Scan" function to detect the control units. Then select "EMS" module.

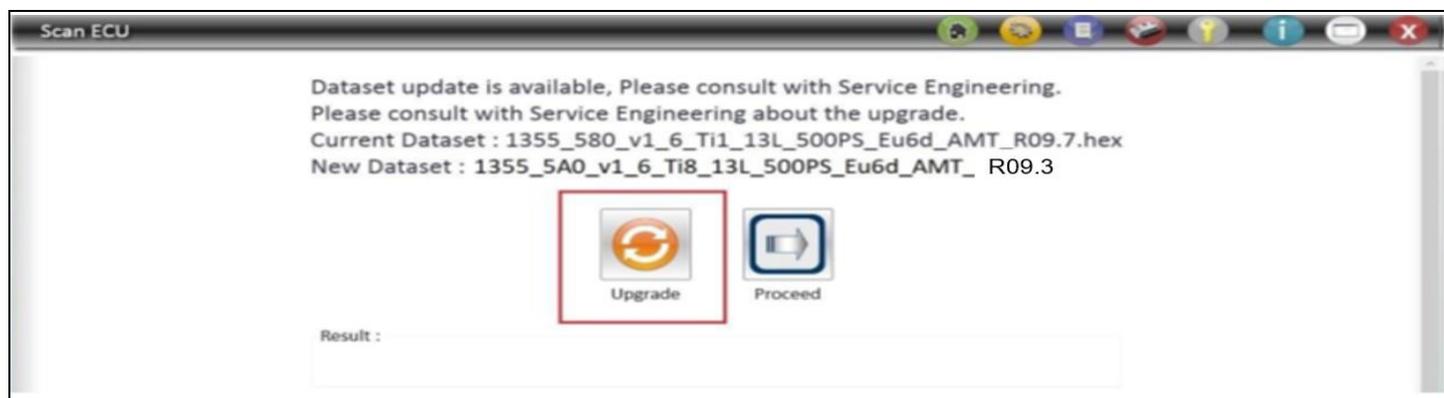
When EMS module is selected, FODP2 will automatically inform you about the software update. Select "upgrade" to start the flashing process. Make sure that computer battery charge level, internet connection are ok and flashing is not interrupted. This process may take up to 10 minutes.

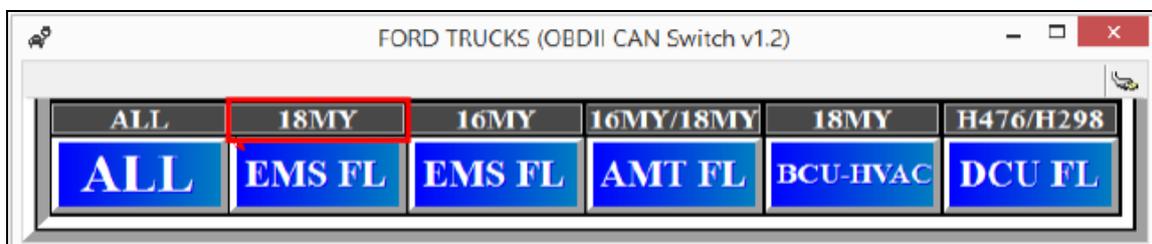
**Note:** Before starting the software update, please select "18 MY EMS FL" from Maxi CAN Switch programme.

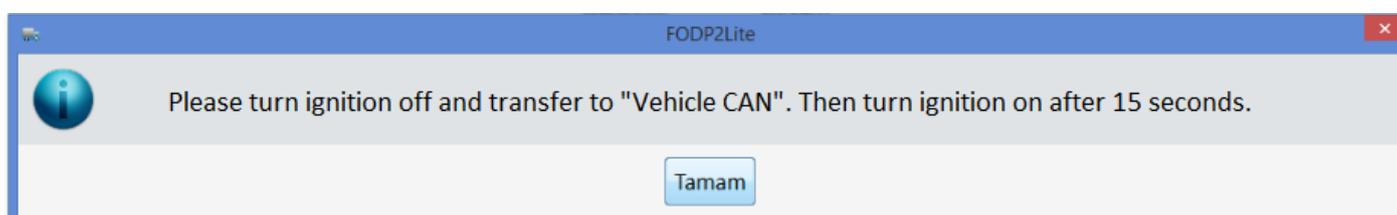
Follow the instructions given by FODP2. At the end of the flashing, system will ask to change to vehicle CAN. Select "ALL" on Maxi wireless CAN switch.

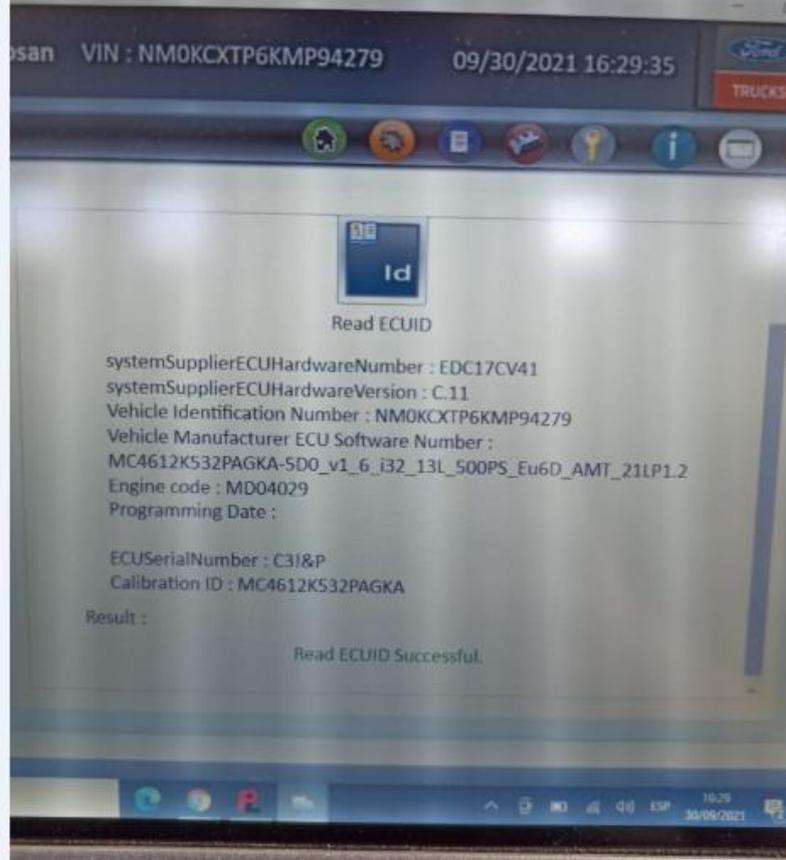
After flashing process, screenshot which is including VIN Number and software version (given above) from Read ECUID screen must be added to the claim card.
