Heavy Commercial Vehicles

Subject	Side spoiler changes on F-MAX vehicles manufactured before 15.12.2022
Model	F-MAX Vehicles
Summary	During the installation of the new level side spoiler on identified F-MAX vehicles, handle and handle connection bolts must be canceled.

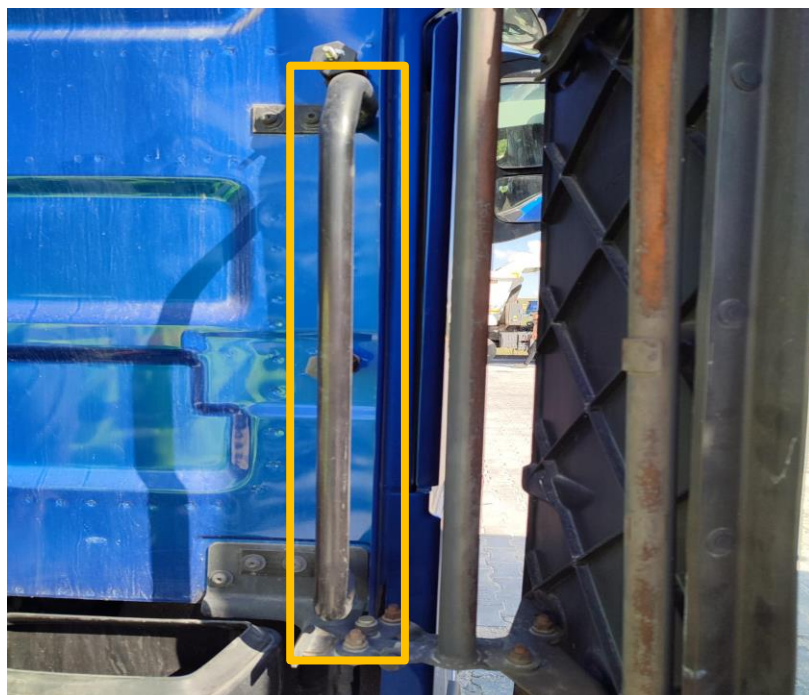
When side spoiler bracket replacement is required in F-MAX vehicles manufactured before 15.12.2022, the handle piece must be removed and the 2 empty bolt holes must be closed with the bolt numbered DC46-V551T14-AA. The handle to be removed is as follows.

Figure 1: Part to be removed

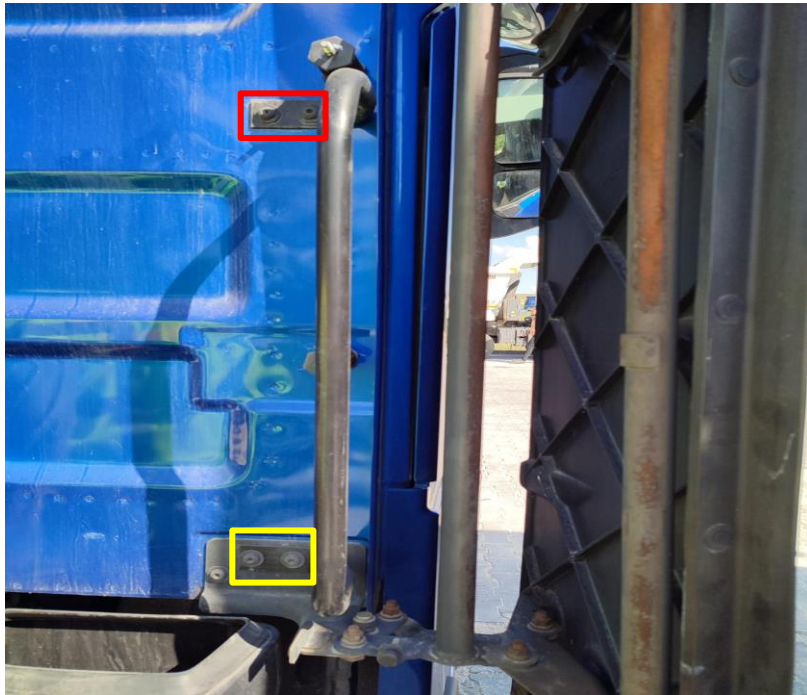
Figure 2: Bolts to be removed.

1. As can be seen in “Figure 2” below, after the air duct is removed, the bolt connections in the red and yellow boxes are removed and the handle is separated from the vehicle body.

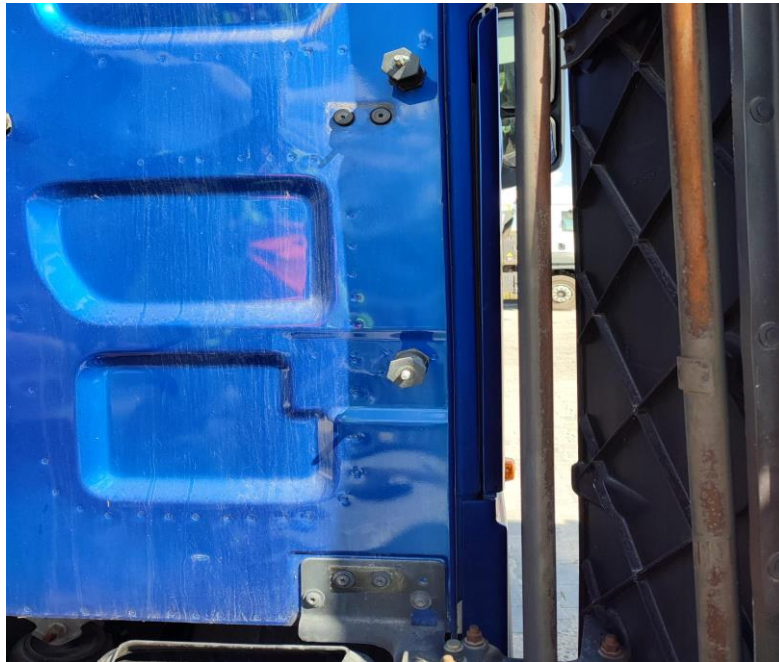
Figure 3: Retightening the bolts

2. The connection bolts in the yellow box are tightened back into place.
3. Bolts numbered DC46-V551T14-AA are tightened to the connections inside the red box. Completed assembly shown in “Figure 3”.

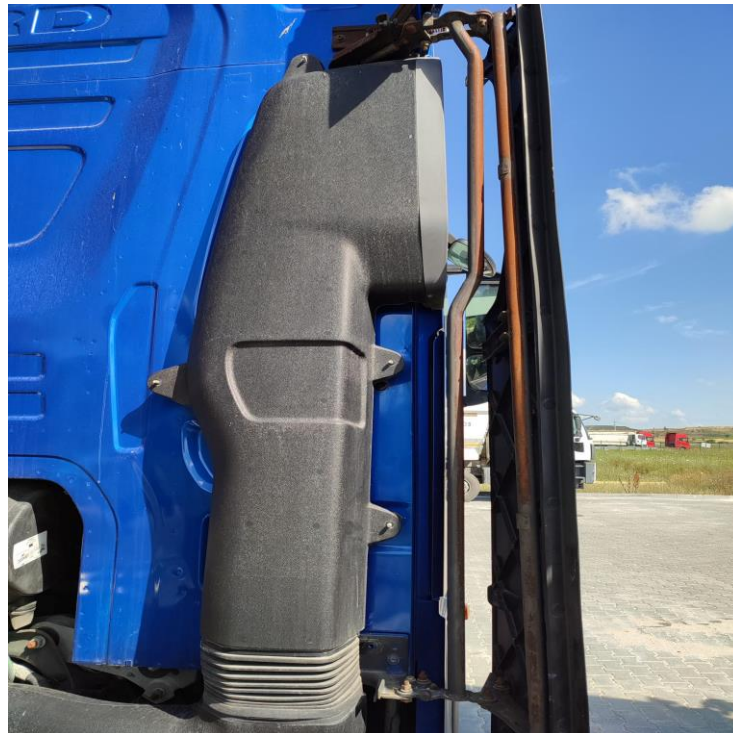
Figure 4: Completed asy.

4. The process is completed by the assembly of air duct.
