Heavy Commercial Vehicles

Subject	Ignition Does Not Work / Not Starting Problems and Repair Methods
Variant	In 2016 Model Year Vehicles (Legacy)
Abstract	Checks and actions to be performed for ignition/not starting problems

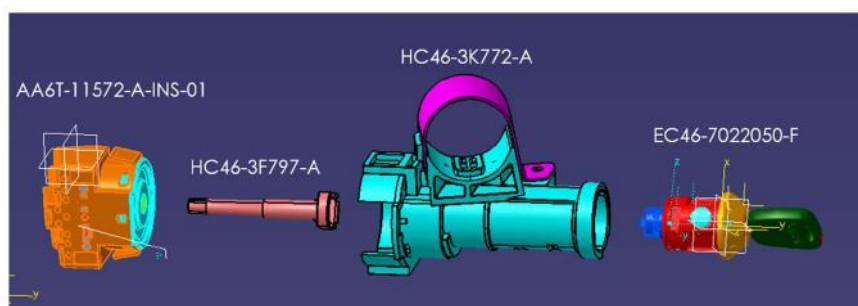
In 2016 Model Year (Legacy) vehicles, the following steps should be checked before any part replacement when the vehicle faces with the ignition problem. If it is possible, a video shows that the vehicle does not start should be added to the claim page. After the parts numbered AA6T-11572-AA, HC46 3F797 AD, HC46 3K772 AC and EC46 7022050 FC are removed, the following steps should be applied for ignition switch control.

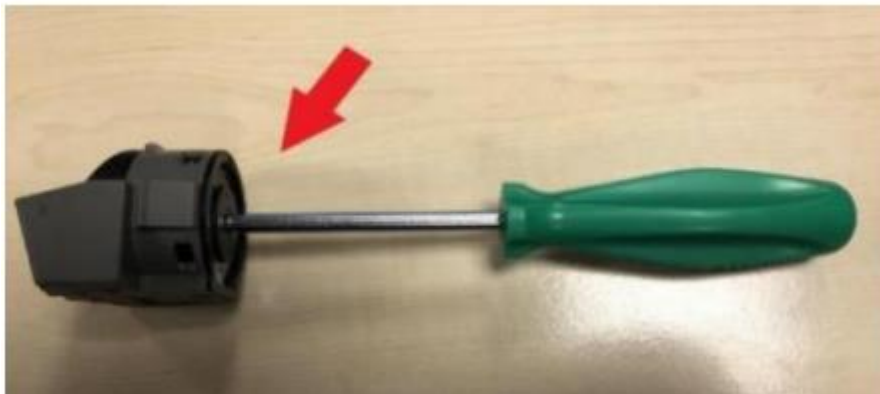
1. Check the ignition switch pins for any signs of burns, over current or physical damage.
2. Pin-to-pin controls should be carried out to Contact 0, Contact 1, Contact 2 and Contact 3 positions, respectively, with the help of a screwdriver, and electrical continuity control should be made with the help of a multimeter on the following pins.

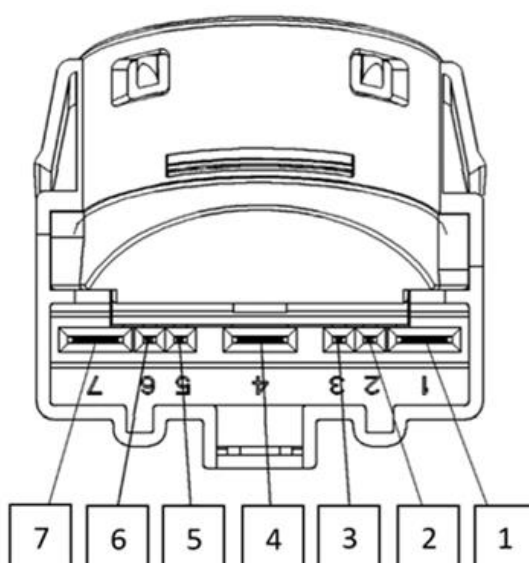
3. An electrical continuity must be observed on the specified pins. In case of electrical continuity on the pins, the contact ignition switch change should not be made.
4. If an electrical discontinuity is observed on the pins, the part AA6T-11572-AA can be replaced. The video of the corresponding pin control must be uploaded to the service system.

Ignition	Pin
Ignition 0	2&4
Ignition 1	4&6
Ignition 2	1&4, 1&6, 4&6
Ignition 3 (In the ignition position 3, the ignition key is turned to the start position and kept pressed.)	1&4, 1&7, 4&7
