**Heavy Commercial Vehicles**

<b>Subject</b>	Sunroof (roof window) Water Leakage Problem in F-Max vehicles
<b>Model</b>	F-Max Vehicles
<b>Summary</b>	In case of water ingress into the cabin in the sunroof area, the bolts of the sunroof area in the bulletin should be tightened to the required torque value.

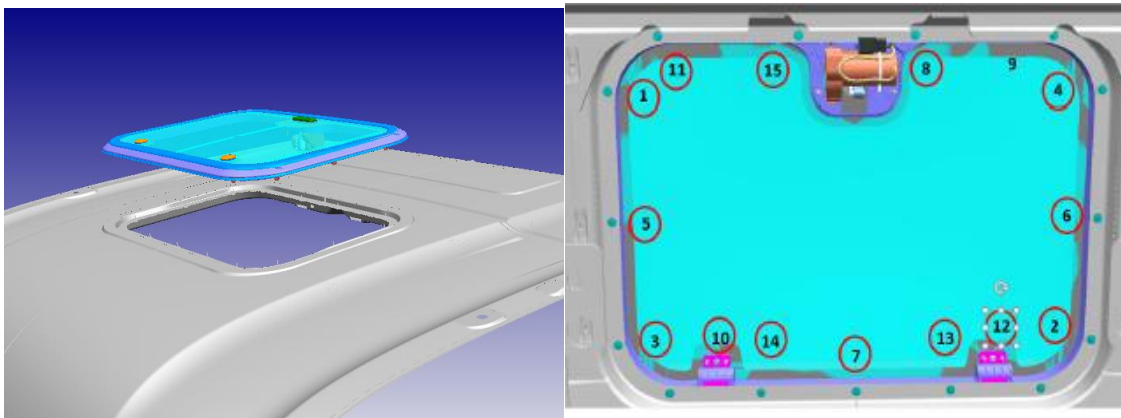
**Figure 3:** The trim panel area under the sunroof wick should be cleaned with a dry cloth.

5- The sunroof (ceiling frame) should be dismantled and the ceiling panel on which the sunroof wick presses should be wiped with a dry cloth. Afterwards, the sunroof must be reassembled (Figure 3). Connection bolts should be tightened with a torque of 8 Nm by applying the tightening sequence given in Figure 3. After the process, the water test should be done again. If no water leakage is detected, the process should be terminated. If the water ingress recurs, the technical service should be contacted.
