Heavy Commercial Vehicles

Subject	F-MAX Passenger Seat Replacement
Model	F-MAX (H625)
Summary	If it is requested to replace the mechanical suspension passenger seat with an air passenger seat on F-MAX (H625) vehicles, the following procedures must be required. When the passenger 's seat is changed, it is necessary to change the socket in the wiring that goes to the passenger 's seat for the compatibility of the wiring connector.

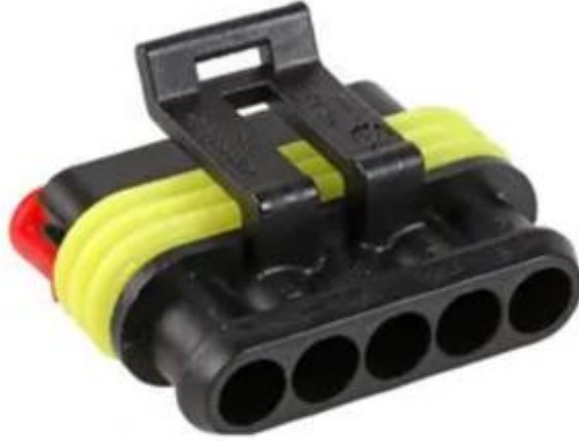
Important Note: There is a 6-pin connector on the air passenger seat. If the wiring connector to the passenger seat is currently 5 pins, the following operations should be performed.

Image-10: Old Connector (5 pins)

- 2.1. The harness connector to the passenger seat is currently 5-pin. A new 6-pin socket will come from the service kit with part number JC46-14B475-HBA. The procedure to be done here is only connector replacement. Shifting to any other pin in cables, getting additional etc. is not going to be done.

- 2.3. The 4 cables in the 5-pin connector will be removed one by one and moved to the 6-pin connector in a way that the pin numbers will remain the same. In other words, the cable in pin 1 of the old connector will be moved to the pin 1 of the new connector. All pins will be moved accordingly.

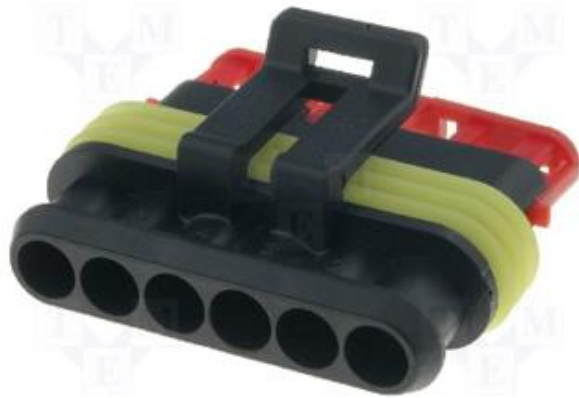
Image-11: New Connector (6 pins) – Available in kit no: JC46-14B475-HBA
