Heavy Commercial Vehicles

Subject	Intarder Cooling System, replacement of metal pipes
Variant	All vehicles that have intarder
Abstract	This technical bulletin describes the transition to installation design with an O-clip in order to prevent bracket problems caused by metal pipes in the Ford Trucks Intarder Cooling System

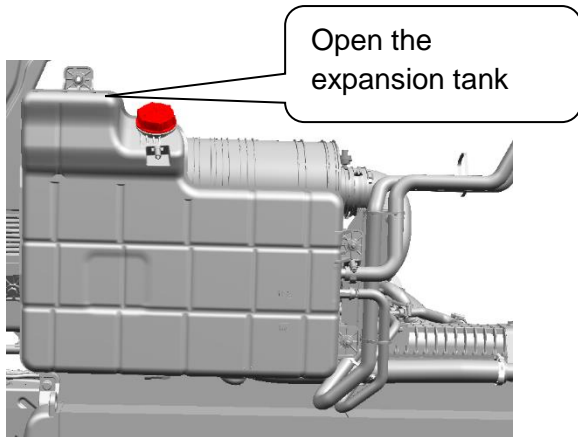
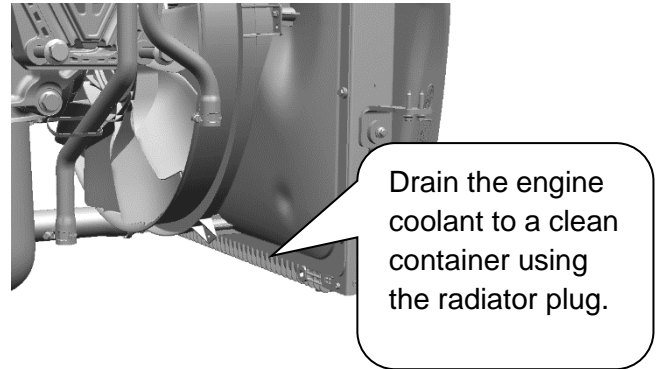
Drive the vehicle to a suitable place and stop it there, raise the bonnet

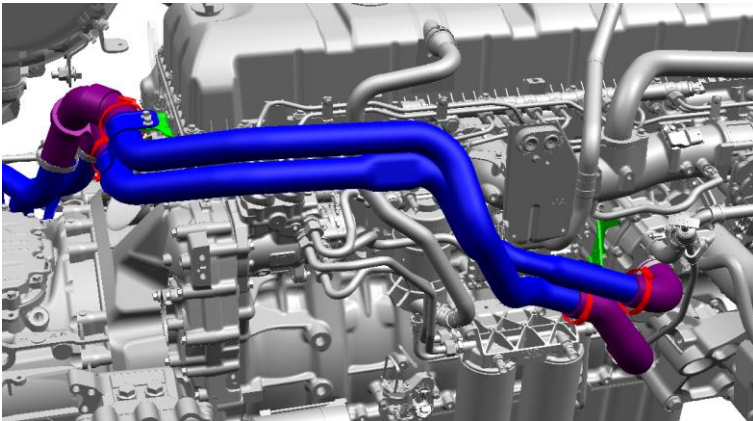
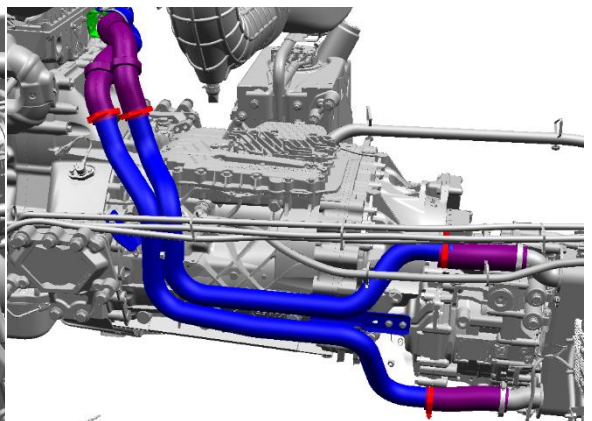
Remove the clamps on the hose-metal pipe connections,
Then, remove the hoses from metal pipes.

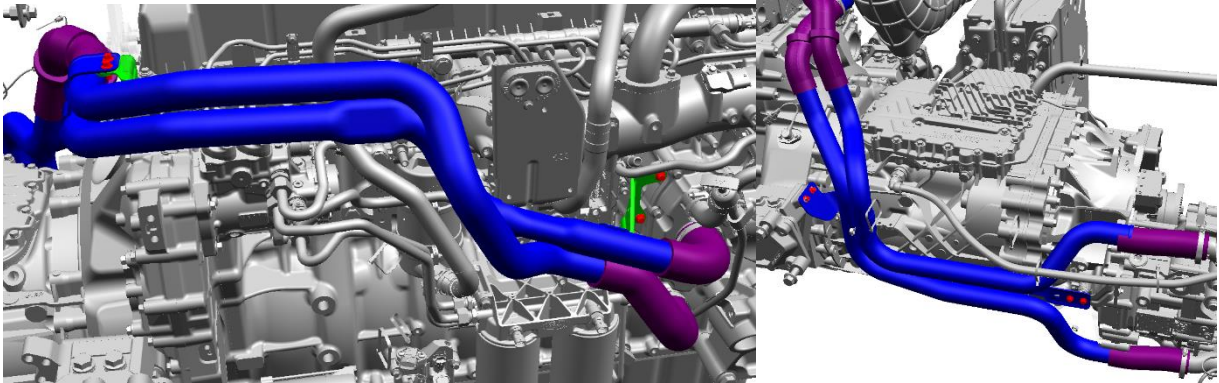
Remove the connection bolts of metal pipe brackets.

Remove the metal pipes and brackets.

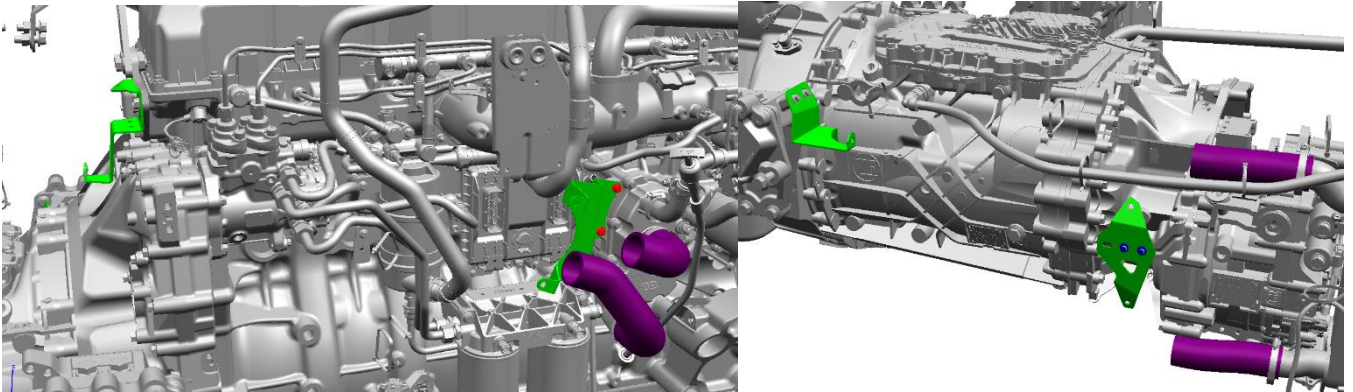
Install new bracket to their positions and complete the tightening of bolts to the specified torque values.

25±3.8 Nm

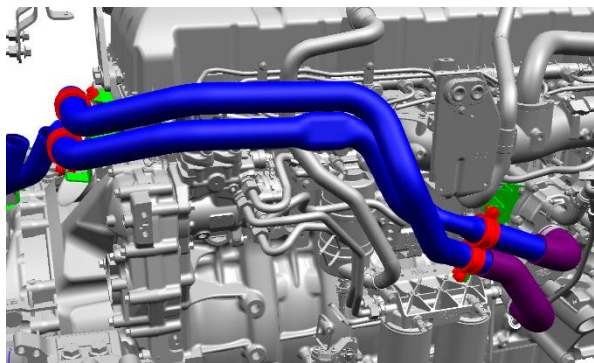
Place new metal pipes to their positions and position the O-clips between the markings. Then, tighten the bolts to the specified torque values.

$25 \pm 3,8$ Nm

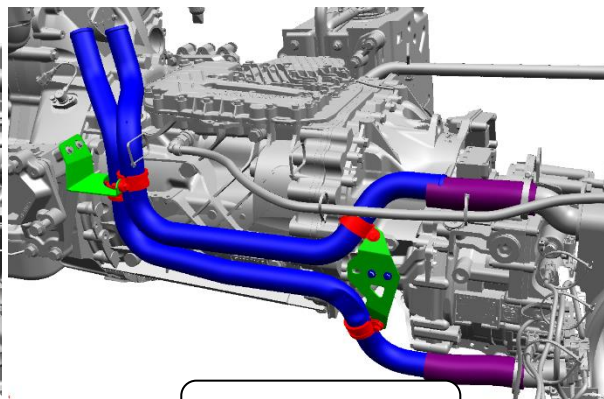
$47,5 \pm 7,2$ Nm

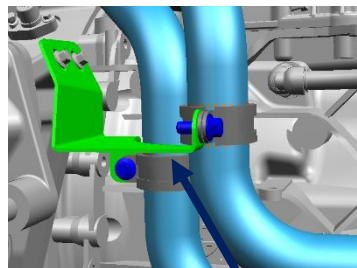
O-Clip: LC46-721488-AA x

O-Clip: DC46-721488-AA x

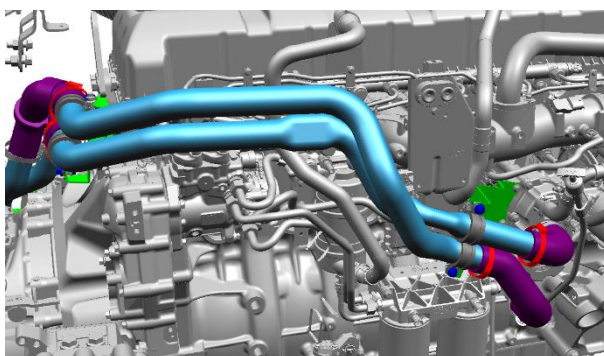
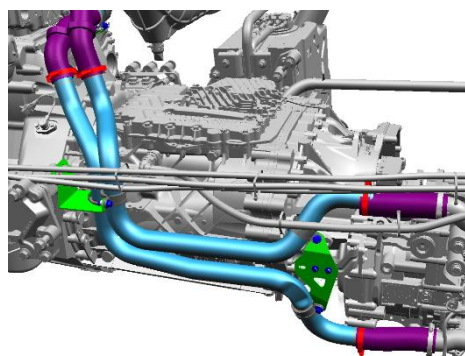
Insert hoses to metal pipes and position as per the aligning lines. Then, tighten the clamps and complete the operation.

5.4 ± 0.5 Nm
