SERVICE PROCEDURE

REFERENCE: FSA 202503

SUBJECT: Side Skirt and EGT Sensor Contact

FSA TYPE: Next Service Visit

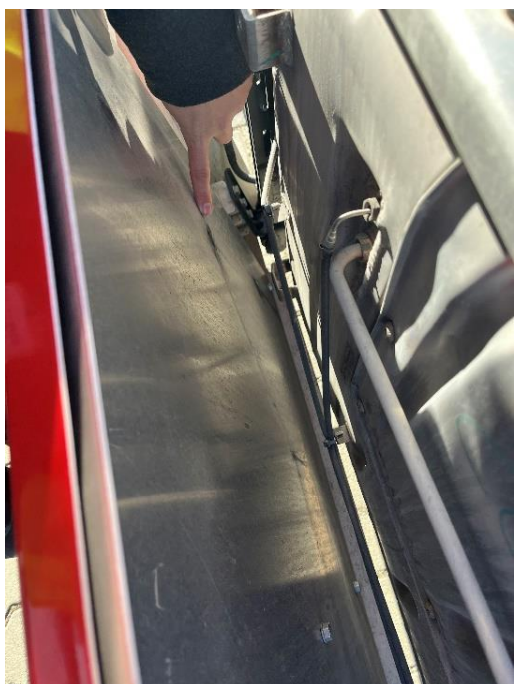
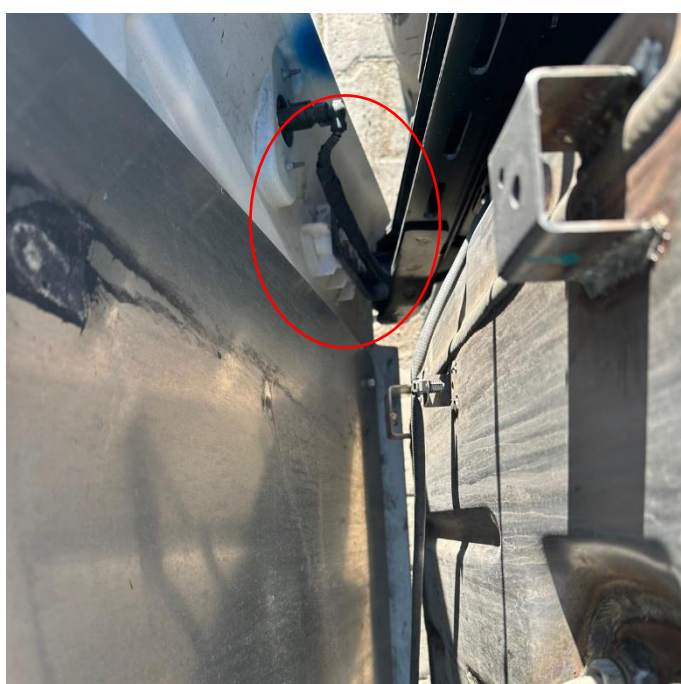
1. The side skirt is carefully unfolded. Then, the rope connections are detached, and the side skirt is fully lowered.

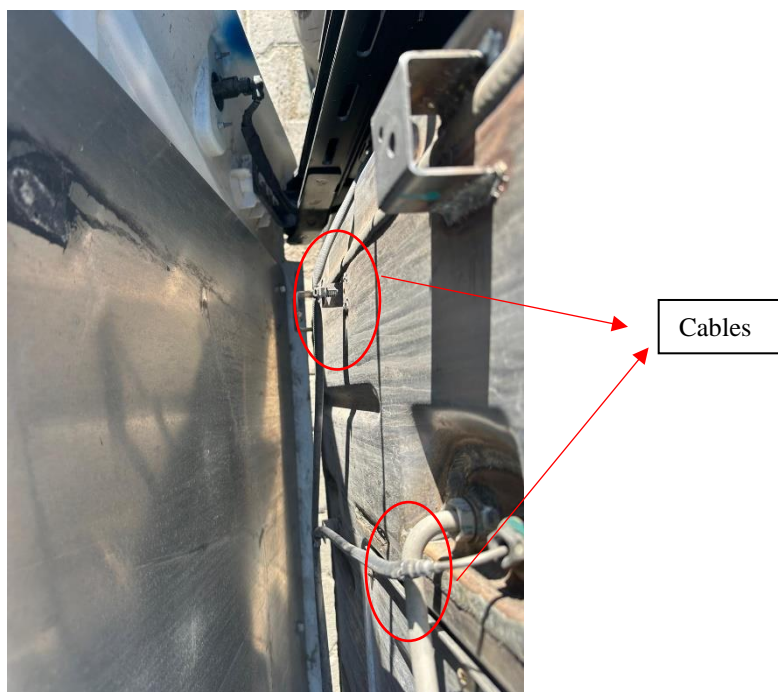
3. Then, the EGT cables on the muffler are visually inspected for any damage. **If damage is suspected, the EGT cables are replaced with new ones. (Cable no GC46-12B591-DB)**

Note* : If there is damage to the EGT cable at the contact point on the bracket, it must be replaced. Please send the required photos as proof for the warranty claims.

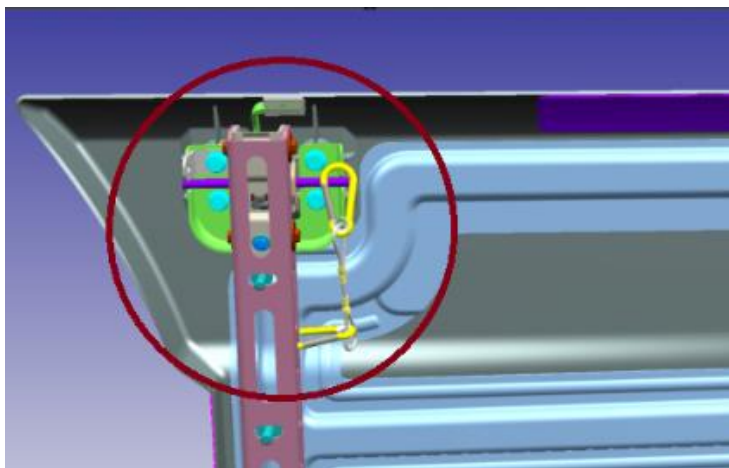
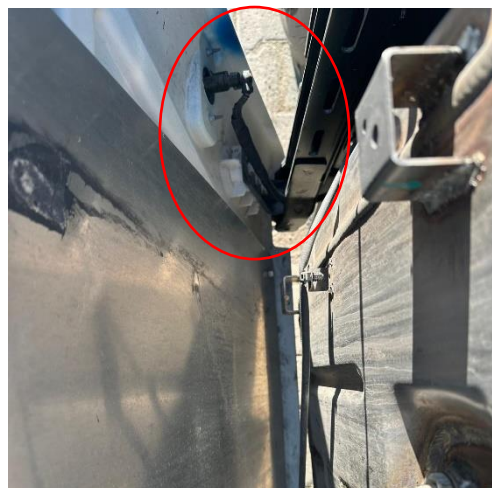
5. The ropes are attached, and it is checked whether the ropes perform their function when the side skirt is released.

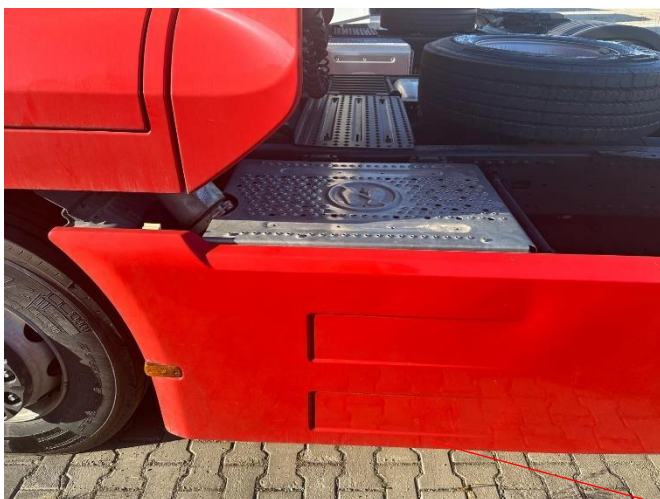
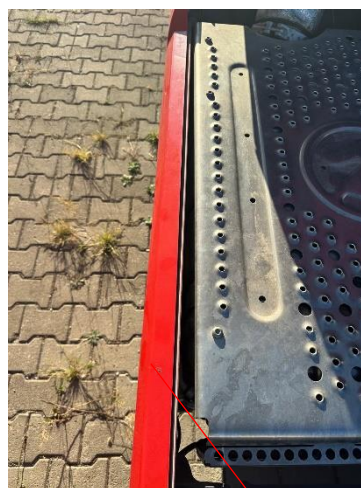
6. After ensuring that the side skirt is properly mounted and does not move, the vehicle is a short regeneration is done for muffler inspection.
