## Field Service Application

REFERANS: FSA 202513

SUBJECT: Gen 2.0 SCR Harness Touch Condition

### Heavy Commercial Vehicles

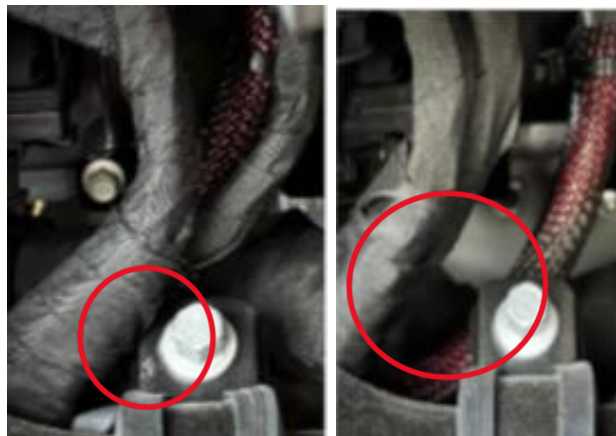
3. In the harness positioning mentioned in Step 2:  
If the relevant harness is in contact with the bracket or appears as shown in the photo below like touching or approaching to bracket, proceed to the next step for the definition of corrective actions.  
(Vehicles with approaching scr lines have potential close contact and should also be included to avoid future risk.)

Touching

Approaching

- Cut the convolute tube with part number **GC46-9A288-AA** to a size sufficient to cover the contact area (cutting must be done using side cutters or scissors).
- Wrap the cut convolute tube around the area where the harness contacts the bracket.
- After applying the convolute tubing, to prevent it from slipping off, cut a section of cloth tape **FC46-1A303-AA** (used on the harness) and tightly tape it over the wrap (cutting must be done using side cutters or scissors).
- After these steps are completed, the area should appear as shown in the photo below.

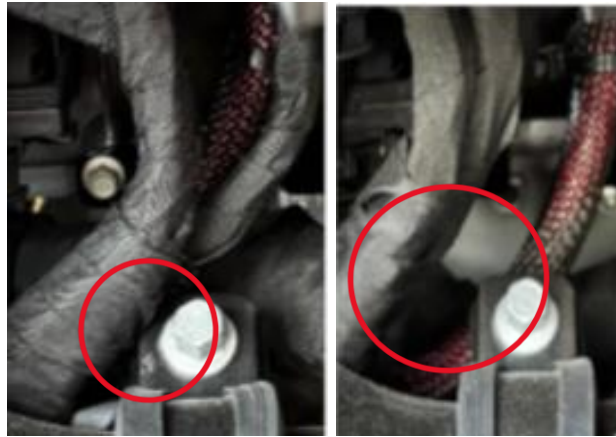
If the relevant harness is in contact with the bracket or appears as shown in the photo below like touching or approaching to bracket, proceed to the next step for the definition of corrective actions. (Vehicles with potential close contact should also be included to avoid future risk.)

Touching

Approaching

- Cut the convolute tupe with part number **GC46-9A288-AA** to a size sufficient to cover the contact area (cutting must be done using side cutters or scissors).
- Wrap the cut convolute tupe around the area where the harness contacts the bracket.
- After applying the convolute tubing, to prevent it from slipping off, cut a section of cloth tape **FC46-1A303-AA** (used on the harness) and tightly tape it over the wrap (cutting must be done using side cutters or scissors).
- After these steps are completed, the area should appear as shown in the photo below.

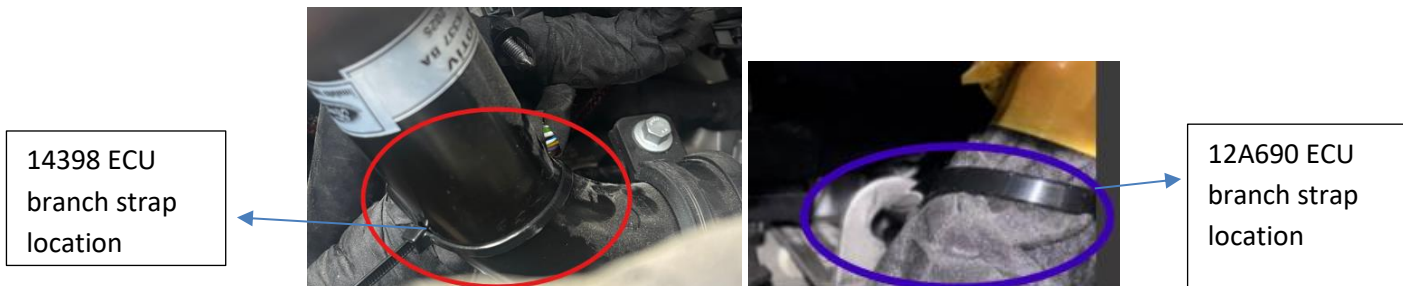
14398 ECU  
branch strap  
location

12A690 ECU  
branch strap  
location

- 6) The 14398 and 12A690 convoluted tubed & taped wiring harness ECU branches should be strapped to move away from the bracket by connecting them to the same parts as FMAX described above by the plastic strap (**8C46-2D218-AA**).
