Field Service Application

REFERANS: FSA 202514

SUBJECT: Gen 2.0 SCR Efficiency ECU Update

FSA Type: Recall

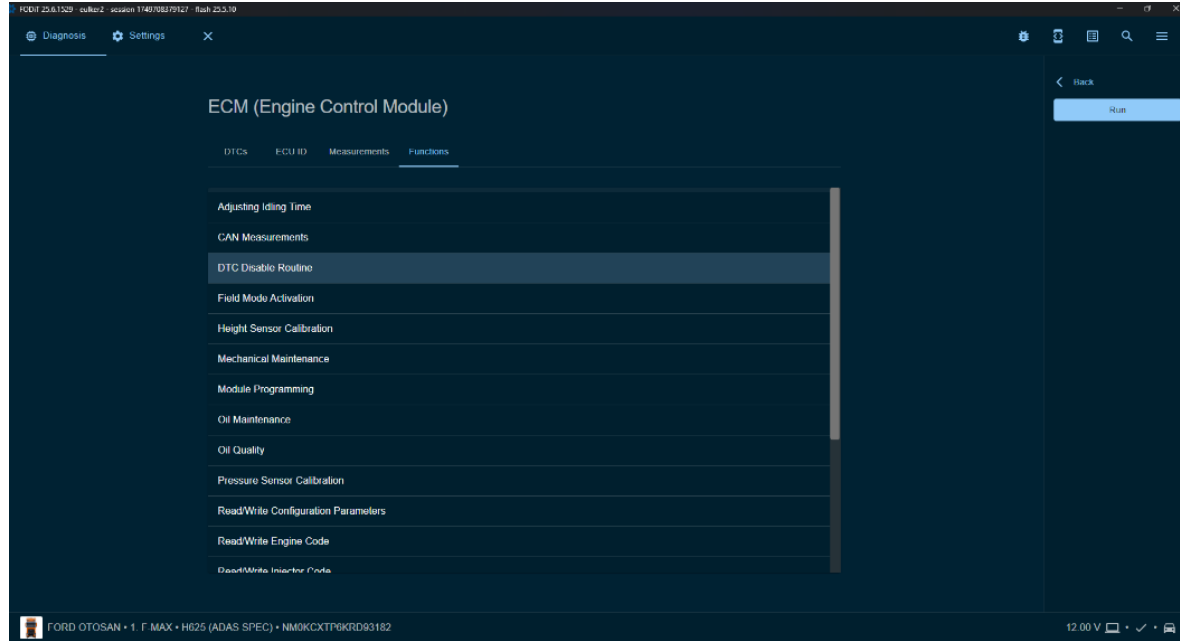
Image 1 – FODiT “ECM (Engine Control Module) / Functions” Screen

1- From the FODiT, the “ECM (Engine Control Module) / Functions” screen should be accessed and the “DTC Disable Routine” selected.

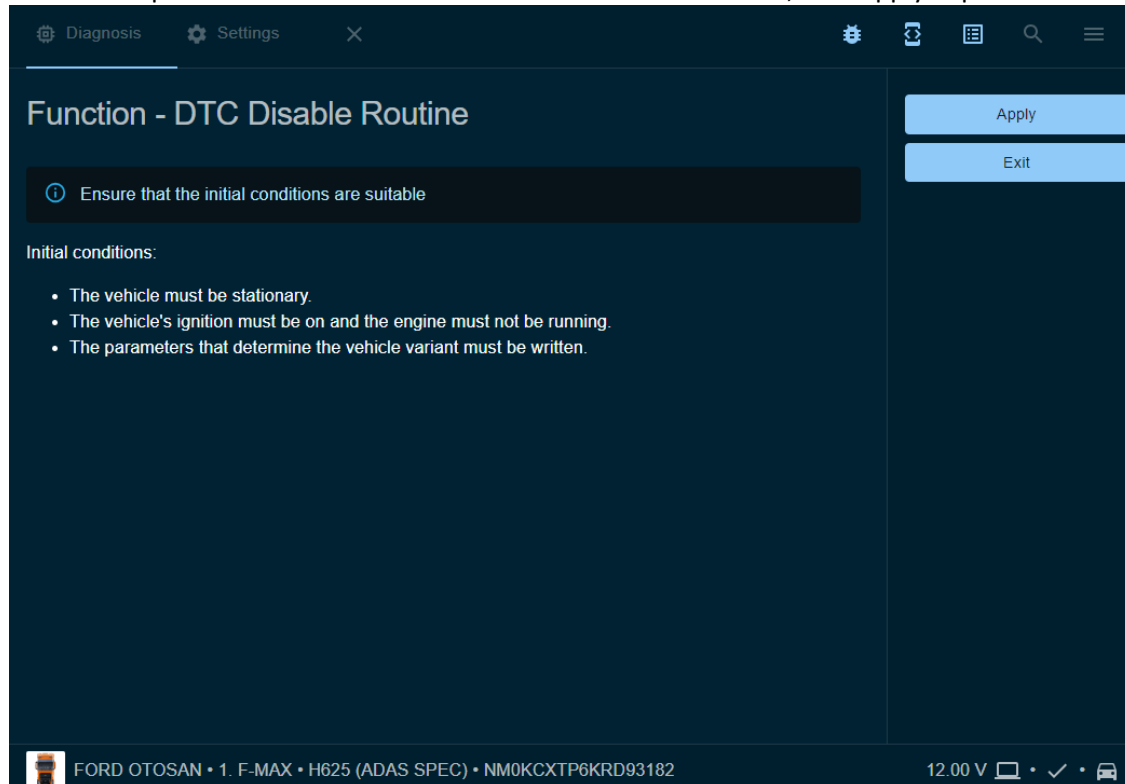
Image 2 – FODiT “Function - DTC Disable Routine” Screen

2- On the opened FODiT “Function - DTC Disable Routine” screen, the “Apply” option should be pressed.

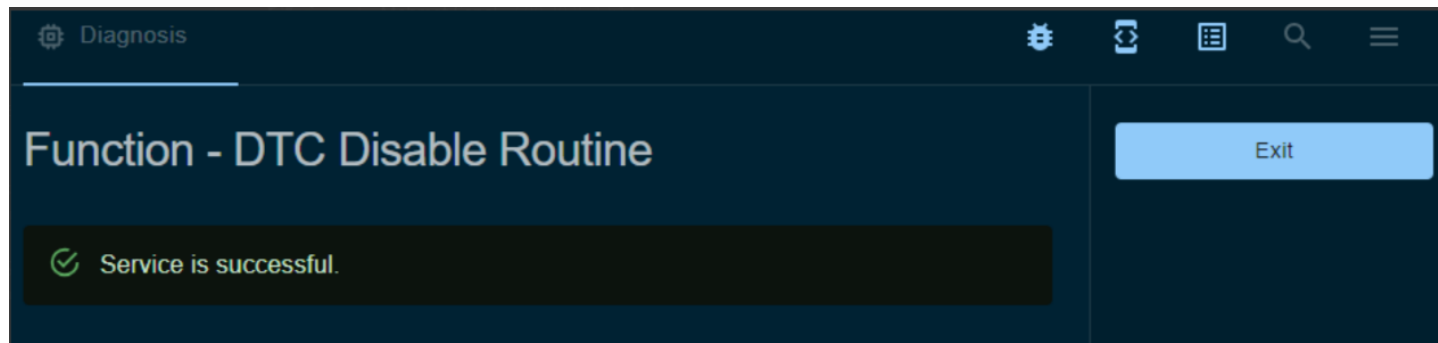
Figure 3 - FODiT “Function - DTC Disable Routine” Screen - Successfully Completed Operation Screen

3- When the “DTC Disable Routine” is completed, the message “Service is successful” indicating the operation was successful will be displayed on the screen.
