SERVICE PROCEDURE

REFERENCE: FSA 202515

SUBJECT: Gen 2.0 Intercooler Pipe (Blue) Hardness Issue

FSA TYPE: Customer Notification

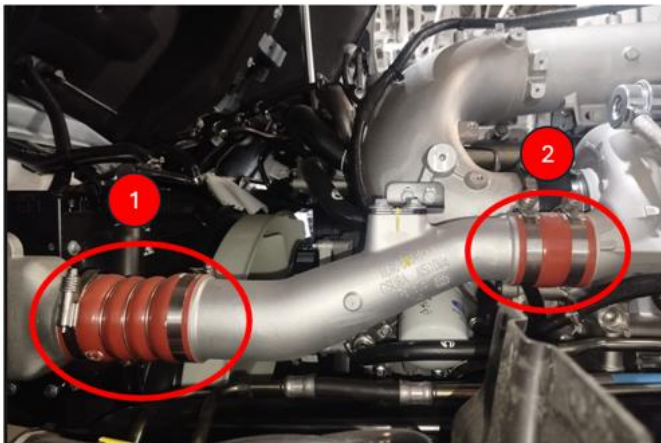
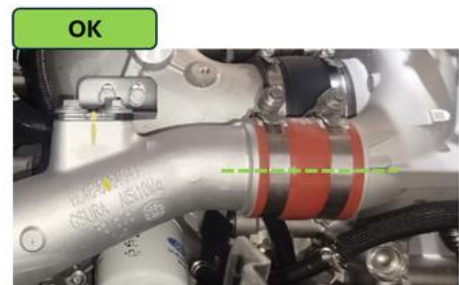
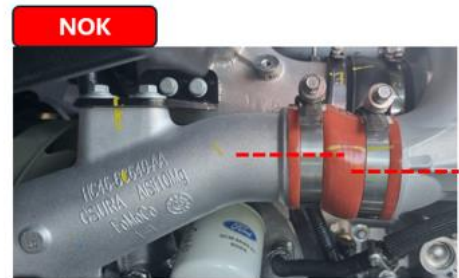
6. The inspection will be carried out on pipes 1 and 2 based on the OK/NOK images. If there is any axial misalignment in these pipes, similar to the NOK image, they will need to be repaired.

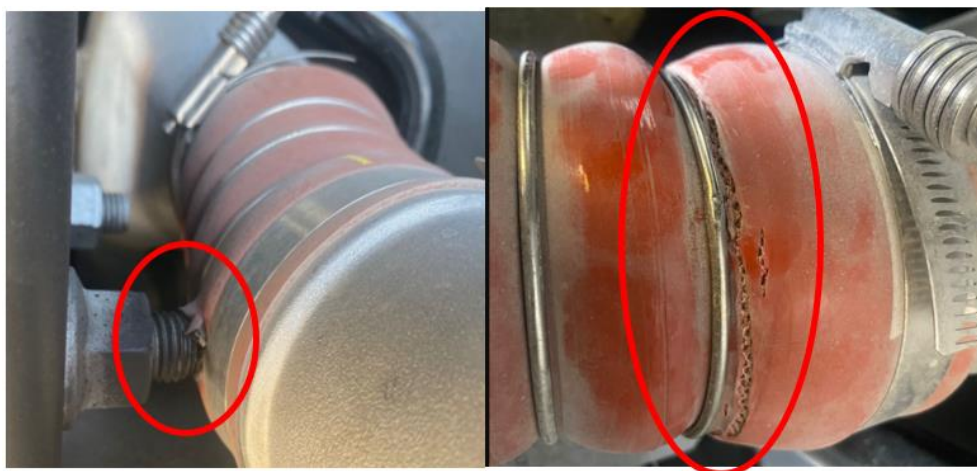
7. If, as illustrated in the images below, there is contact between the bolt and the hose and/or visible damage such as tearing, the concentricity condition outlined in the previous step must be verified, and the SC46 6K770 BB component should be replaced. **So that reason, please open warranty pre-approval ticket and video/photo evidence is required to process warranty claims.**
