TECHNICAL SERVICE BULLETIN No. 22/2025

21/11/2025

Heavy Commercial Vehicles

Subject	Urea Pump Diagnosis and Replacement
Model	All 12,7L & 9L EU6 Vehicles
Summary	Introduction of a guideline document to systematically perform the required checks prior to Urea Pump replacement

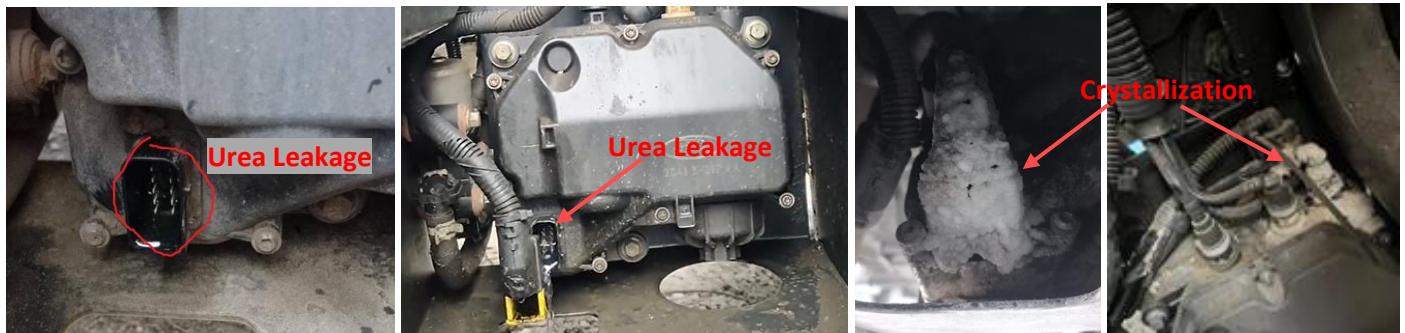
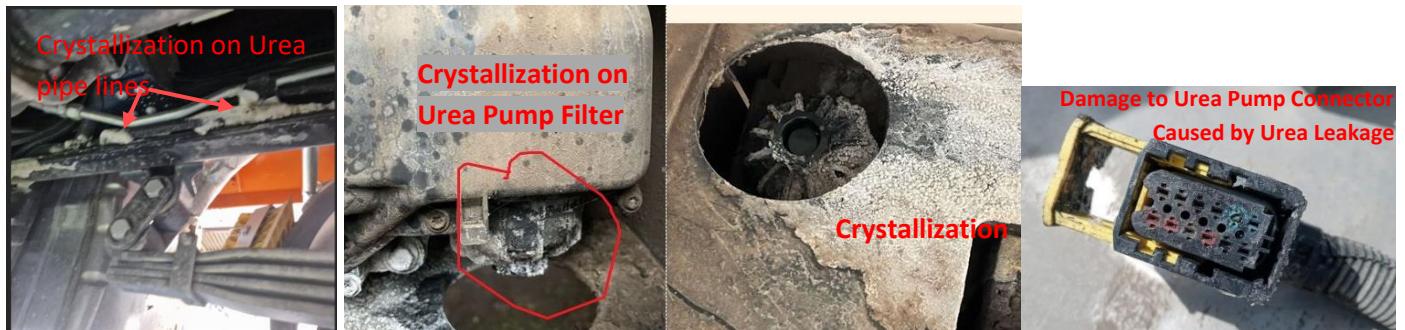
Picture 1 Physical Inspection for Damage and Leaks

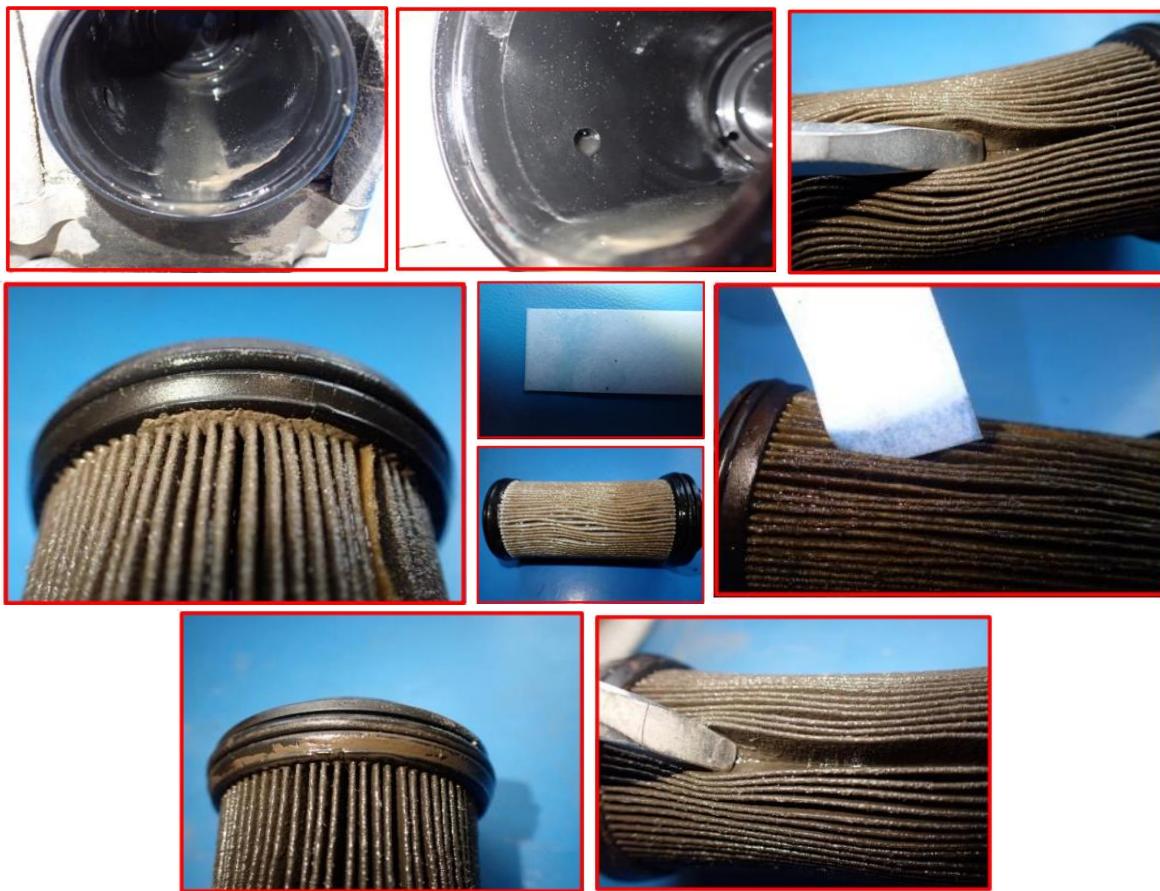
3	Urea Filter Contamination Check	<ul style="list-style-type: none"> * Remove the urea filter (5L264) from the pump module. Inspect it for crystallization, contamination, oil/diesel ingress, or clogging (see "Contamination in Urea Filter" - Image 2). * [LOG 3] Attach a photo of the removed filter to the warranty claim ticket. * If contamination is observed in the filter, proceed to Step 6: DPF Regeneration Test and Functional Checks. * If the filter appears clean, replace the filter and move on to the next step.
4	Pump Module and Harness Electrical Checks	<ul style="list-style-type: none"> * With the ignition off, disconnect the ECM (C1E115-C1) and Urea Pump Module (C1E348) connectors. Using a multimeter, perform wiring harness and component resistance checks. Expected values can be found in Table 1. * [LOG 4] Complete the "Electrical Measurement Table" in Table 2 with all pre-repair and post-repair values and save it as a document. Attach this document to the warranty claim ticket. (See Urea Pump Pin diagram - Image 3). * If a wiring fault is found and repaired, proceed to Step 6: DPF Regeneration Test and Functional Checks. * If no electrical problem is found, move on to the next step.

Picture 2 Contaminated Urea Filter..

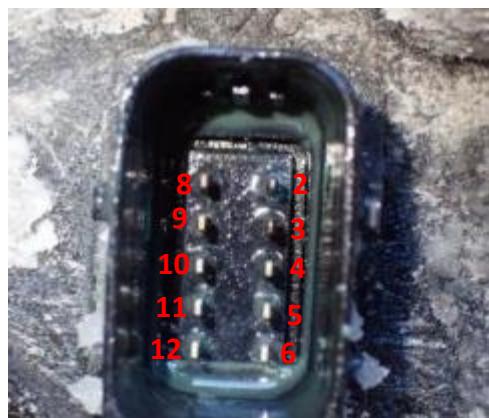
Picture 3 Urea Pump Pin Layout.

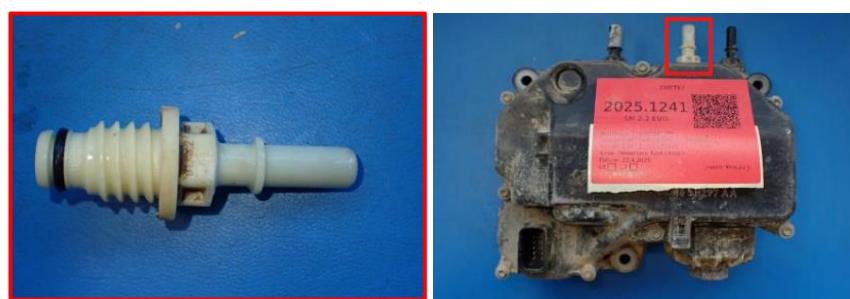
Picture 4 Back Flow Connector

5	BackFlow Connector Replacement	<ul style="list-style-type: none"> * For this step, you need to remove the Urea Tank. Then, replace the backflow valve (5L267) connector located on the urea pump as shown in Image 4. Damage in this connector is usually internal and not visible. Tightening torque: 4.5 Nm ± 0.5. * This step is a critical, low-cost action that often resolves "pressure" faults and prevents unnecessary pump replacement.
6	DPF Regeneration Test and Functional Checks	<ul style="list-style-type: none"> * Reconnect all components. Initiate the DPF regeneration. * During the test, ensure there are no leaks or abnormal noise, and system pressure on the AFFT screen (RAP) approx. 9000 hPa (Image 5). * [LOG 5] Take a screenshot of the AFFT screen and, after regeneration is complete, perform a new full DTC scan and attach it to the warranty claim ticket.
7	Final Decision and Pump Replacement Authorization	<ul style="list-style-type: none"> * After all the above steps are completed and all records ([LOG 1] through [LOG 5]) have been attached to the document, if the issue is still not resolved, the pump replacement can be performed. * After replacing the pump, initiate the DPF regeneration again. Ensure that no fault codes reappear after regeneration.
