## TSB-ENHCV-2225 Urea Pump Replacement Checklist

### Appendix 1

21.11.2025

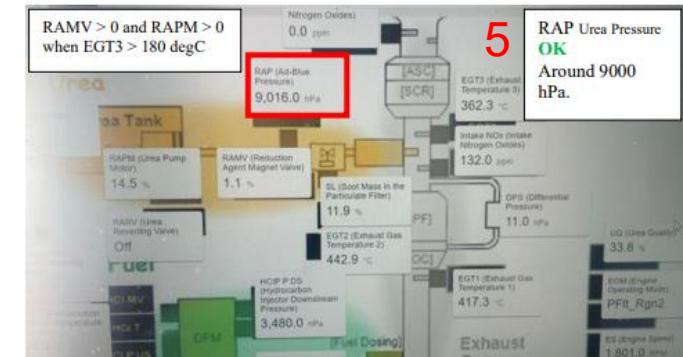
5

RAP Urea Pressure  
OK  
Around 9000  
hPa.
