## Introduction

Cluster colour (screen) distortion concern may be observed on New F-Max vehicles. To resolve this issue, a Cluster Module replacement is required. **Before proceeding with the cluster replacement, please ensure that “FSA 202604 – Cluster Software Update” has already been applied to the vehicle.**

Ford Trucks Service Engineering  
Ford Otosan A.Ş

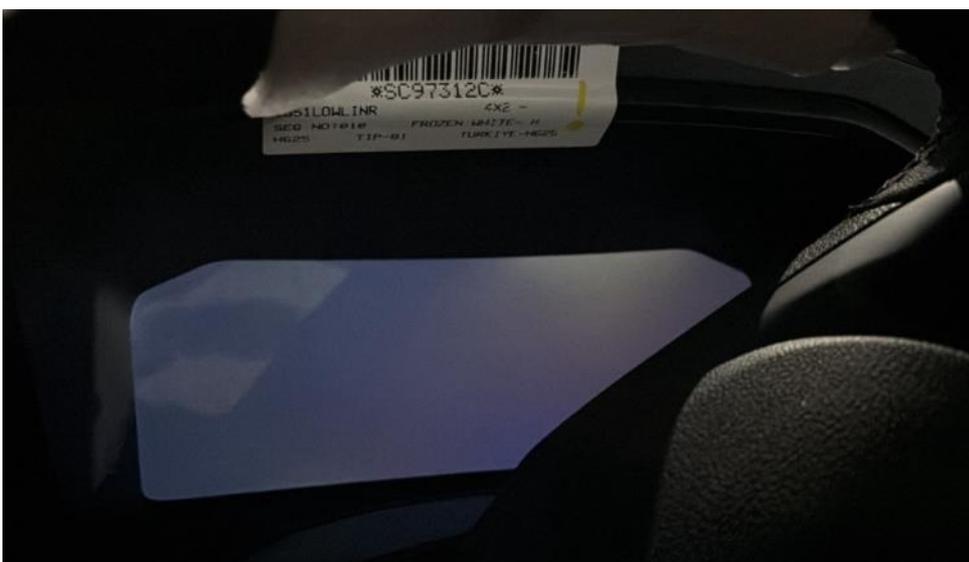
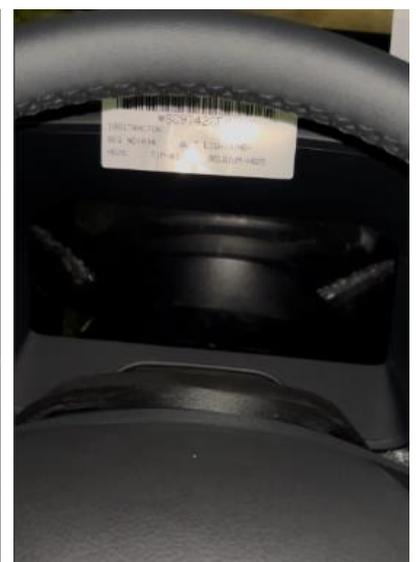
After confirming the FSA status, if a cluster with software version TC46-14C026-AF still exhibits a malfunction (example failure images are shared below), a cluster replacement must be requested under the FSA procedure.

Cluster Colour (Screen) and Distortion (Black Screen) sample images are shown below. The error condition may occur when the ignition is ON and the cluster screen does not turn on.
