*Heavy Commercial Vehicles*

| <b>Subject</b> | Front Area Oil Leak Check on Ecotorq 16S AMT Transmissions |
| <b>Model</b> | GEN 1.5 and GEN 2 Vehicles |
| <b>Summary</b> | Inspection and part replacements to be performed if oil leakage is detected in the front section of the transmission. |

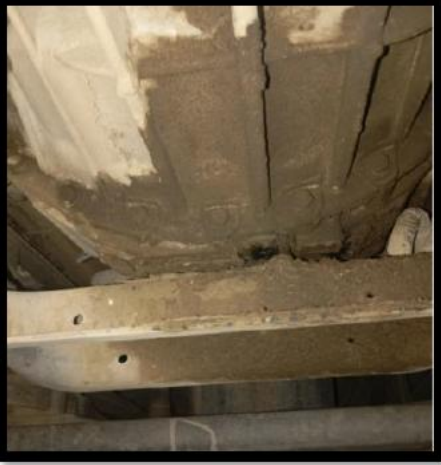
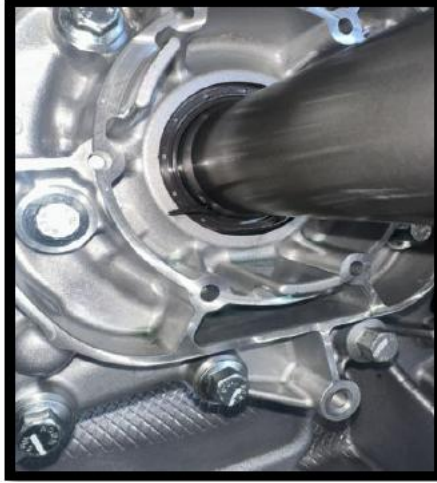
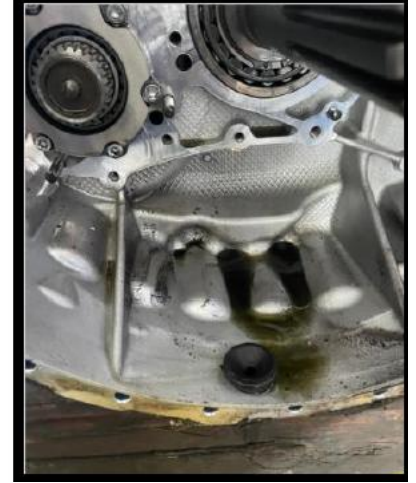
- The transmission must be removed from the vehicle, and the color of the transmission fluid should be checked.
- If the color of the leaking oil is consistent with transmission oil (**turquoise in new vehicles, dark green in vehicles with higher mileage**), the following possible leak locations should be checked.

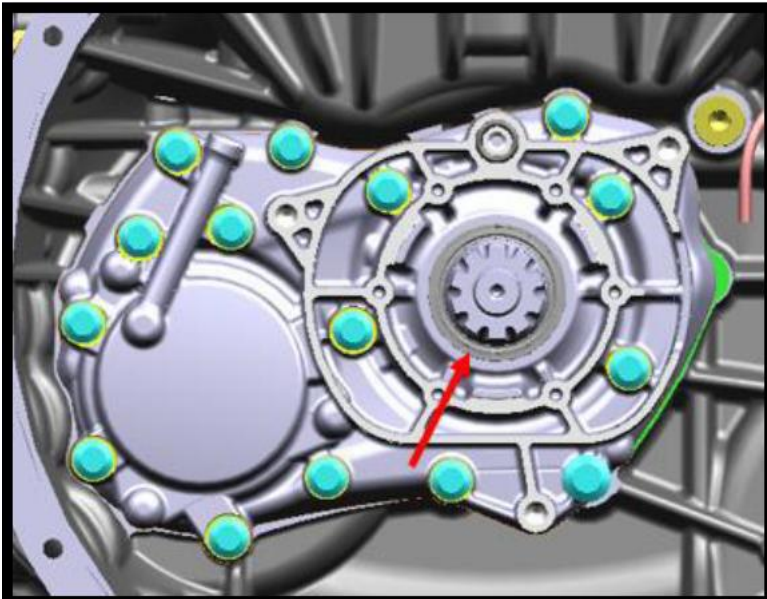
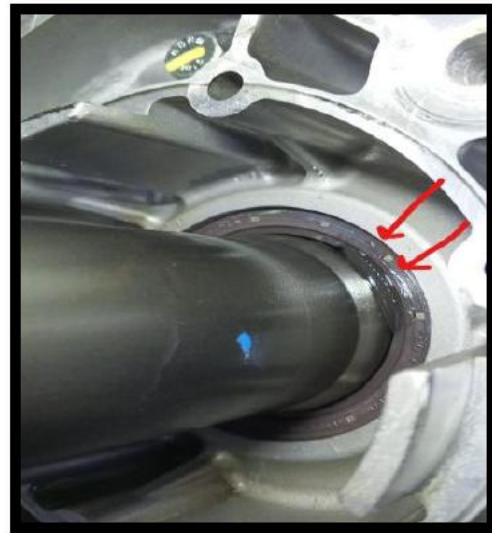
**Potential areas for monitoring leakage activity;****a-) Input Shaft Seal Area**

If there is a leakage between the shaft and the seal lip that is different from the required oil film appearance and continues downwards, only the seal can be replaced. A visual of the area where the oil leakage occurs must be included in the work order to be opened.

| Control Step | Observation/Condition | IF Yes | IF No |
|---|---|---|---|
| <b>2. Input Shaft Felt Area (a)</b> | Is there downward oil leakage between the seal lip and the shaft? | Replace the input shaft seal. Proceed to the next checkpoint.(b) | Proceed to the next checkpoint.(b) |

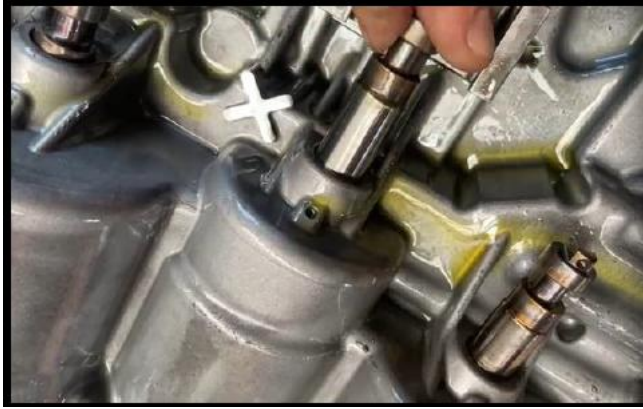
#### **b-) Transmission Control Unit Air Exhaust Duct Area**

If there is some oil leakage from the transmission control unit air exhaust duct, the oil leak may be arising from the transmission control unit. In this case, the transmission control unit should be removed and the oil drained from the unit.

| Control Step | Observation/Condition | IF Yes | IF No |
|---|---|---|---|
| <b>3. Transmission Control Unit Air Exhaust Duct (b)</b> | Is there oil leakage from the Transmission Control Unit's air exhaust duct? | The Transmission Control Unit is removed, the oil is drained, and the oil level is observed. Proceed to the front cover inspection step. (c) | Proceed to the front cover inspection step.(c) |

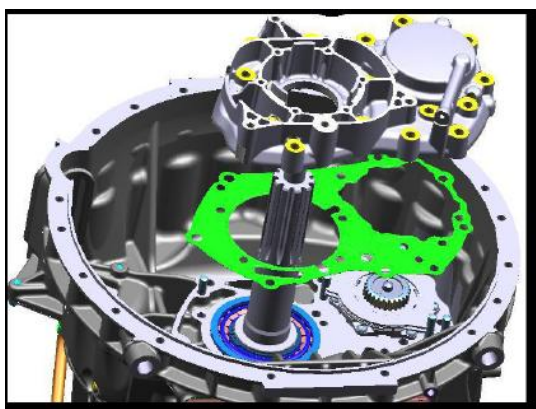
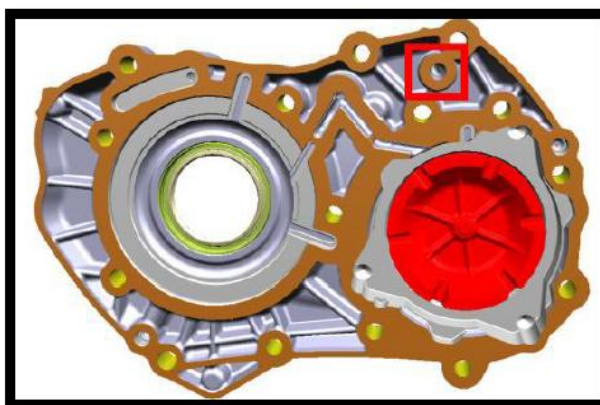
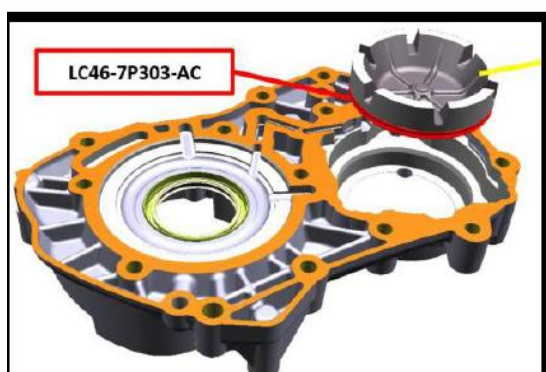
### c-) Front Cover Area;

The front cover of the transmission must be removed from the transmission. The auxiliary shaft brake piston must be removed from the front cover, and the presence of oil in the area under the piston must be checked.

- If there is oil; the amount of oil should be photographed, the health of the piston seal should be checked, and the findings should be added to the work order.

- If there is no oil; the area under the piston, the air channels of the front plate (front cover) and the air channels of the transmission housing should be cleaned and reused.

| Control Step | Observation/Condition | IF Yes | IF No |
|---|---|---|---|
| <b>4. Front Cover(c)</b> | Is the auxiliary shaft brake piston and its rear end heavily lubricated with oil? | Felt replacement is recommended. Felt deformation must be documented visually. (LC46-7P303-A) | The piston and seal are checked. The air ducts are thoroughly cleaned before reuse. |

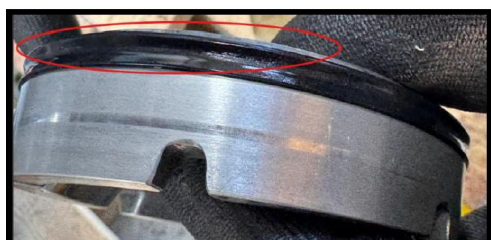
*\*According to observations, if the layshaft (auxiliary shaft) brake piston and seal are heavily lubricated, it is recommended to replace the following parts.*

- LC46-7P303-A – Replace the auxiliary shaft brake piston seal if it is lubricated and deformed as described above.
- PC46-7D289-A or SC46-7D289-A – Replace the entire front cover kit if there is wear.

| Control Step | Observation/Condition | IF Yes | IF No |
|---|---|---|---|
| <b>5. Front Cover Kit</b> | Is there any wear on the front cover kit? | The PC46-7D289-A or SC46-7D289-A complete kit must be replaced. | No replacement is needed; it can be cleaned and reused. |
