**Heavy Commercial Vehicles**

| <b>Subject</b> | Electrical Connection and Torque Inspection Procedure for F-Line Vehicles After Cab Painting Operations |
| <b>Variant</b> | F-Line Vehicles |
| <b>Abstract</b> | This Technical Service Bulletin has been prepared to describe the electrical connection inspections and torque checks required following cab painting operations on F-Line vehicles. The purpose is to verify critical connection points and prevent potential failures after service operations. |

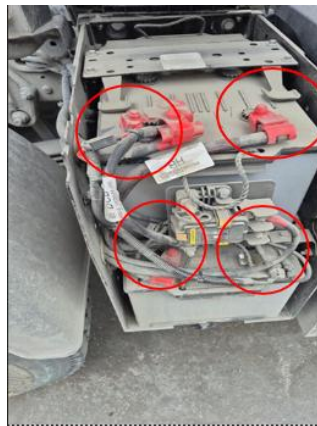
1. Turn off the battery master cut-off switch.
2. Tighten the battery positive (+) and negative (–) terminals to 13 Nm. After tightening, apply a torque mark

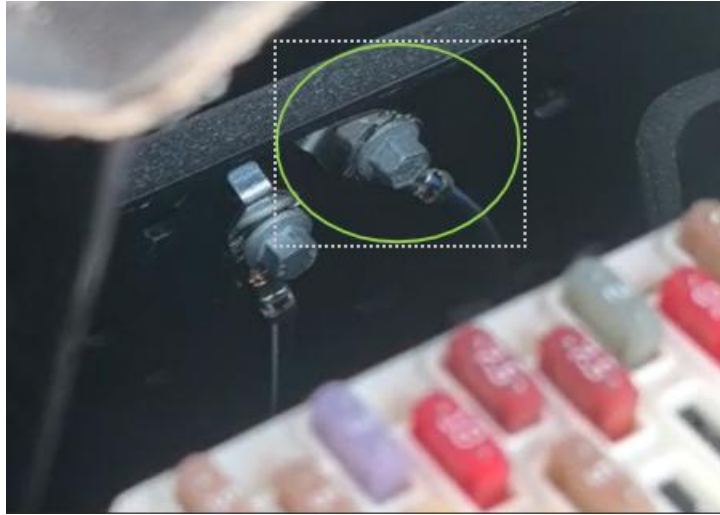
3. Tighten the grounding connections located on the left side of the main fuse box to 9 Nm. After tightening, apply a torque mark. The location of these grounding connections is shown in the image referenced in Step 4.

4. Verify that the IP grounding bolts are the same type as the M6 reference bolt highlighted by the green circle in the image.

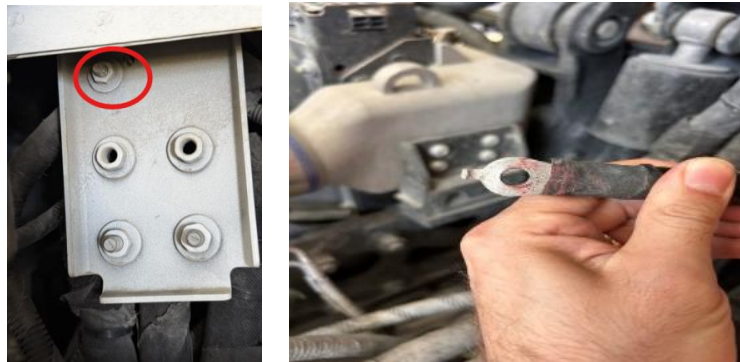
5. Check the chassis-to-cab ground eyelet for paint residue. If paint residue is present, clean the surface by sanding. The chassis-to-cab ground eyelet is located under the hood, and the inspection area is highlighted by a red circle in the image.

6. Check the mounting surface of the chassis-to-cab grounding bolt for paint residue and clean the surface by sanding if necessary. The bolt used is an M6 bolt. The inspection area is shown in the image referenced in Step 5.

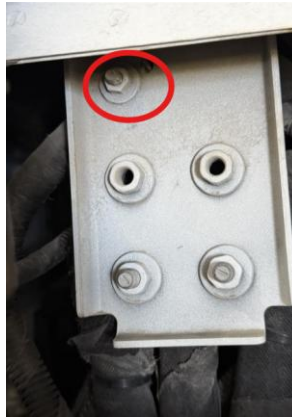
7. Tighten the chassis-to-cab grounding bolt to 12 Nm. After tightening, apply a torque mark. The bolt is located directly beneath the hood when opened. The inspection area is shown within the circle in the image.

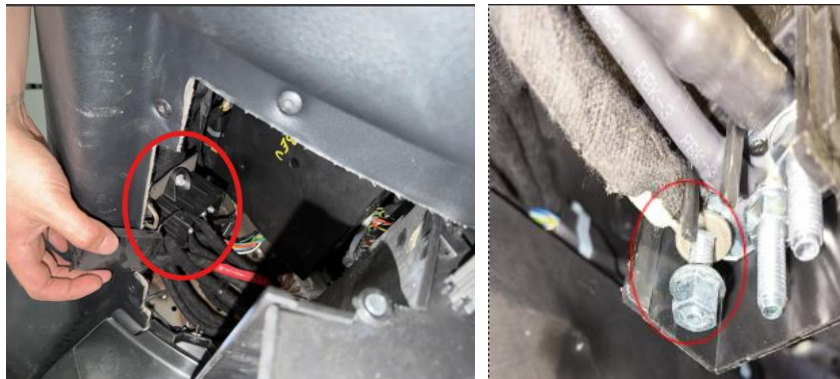
8. Tighten the chassis-to-cab power supply bolt to 13 Nm. After tightening, apply a torque mark. The bolt is located behind the glove compartment. The bolt to be inspected is identified in the image below. The bolt used is an M10 bolt.

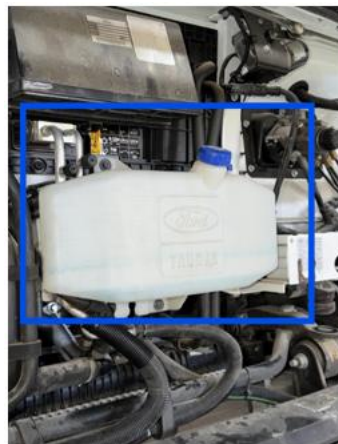
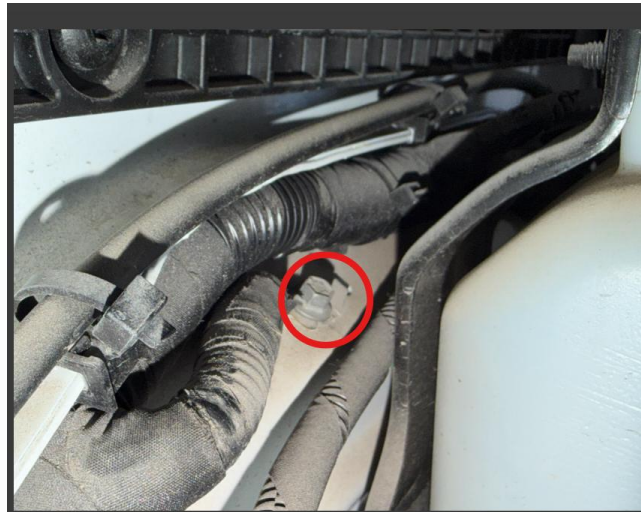
Windshield  
Washer Reservoir

9. Tighten the two grounding bolts located behind the windshield washer reservoir to 9 Nm. After tightening, apply a torque mark. The bolts used are M6 bolts. These bolts are located behind the windshield washer reservoir and are highlighted with a red circle in the image.

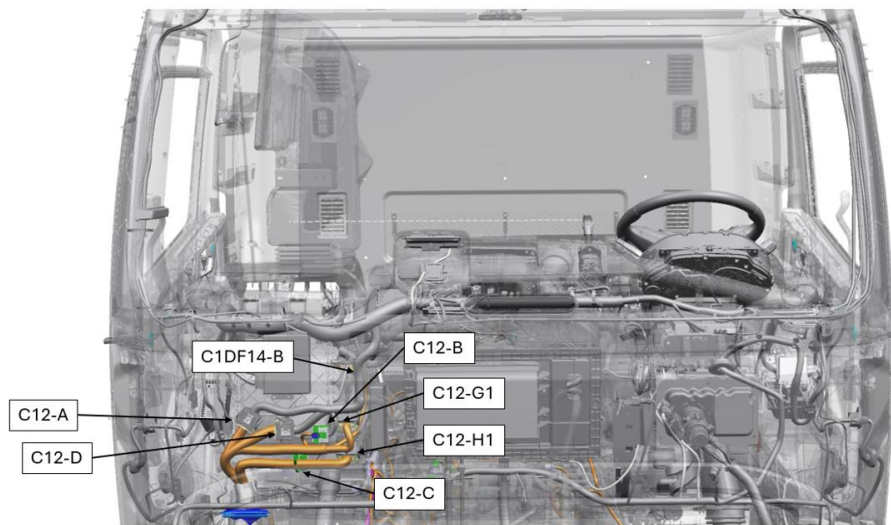
10. Inspect the C12-A, C12-B, C12-C, and C12-D connectors of the 14398 wiring harness. Verify that there is no locking tab damage, pin damage, corrosion, or pin push-back.

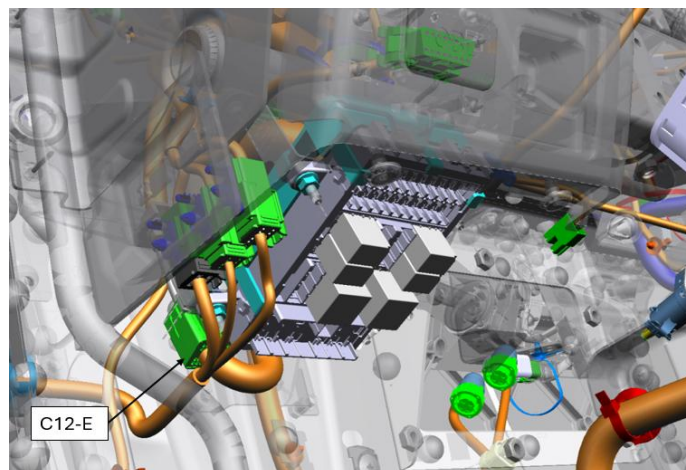
11. Inspect the C12-E connector of the 14B242 wiring harness. Verify that there is no locking tab damage, pin damage, corrosion, or pin push-back.

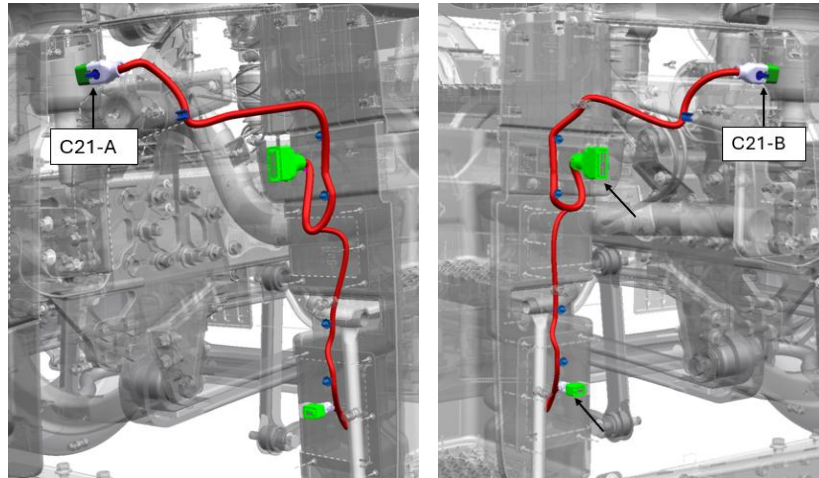
12. Inspect the C21-A and C21-B connectors of the 13N052 wiring harness. Verify that there is locking tab damage, pin damage, corrosion, or pin push-back.
