## SERVICE INSTRUCTIONS

REFERENCE: FSA202212

SUBJECT: Retrofit of Megafuse

FSA TYPE: Recall

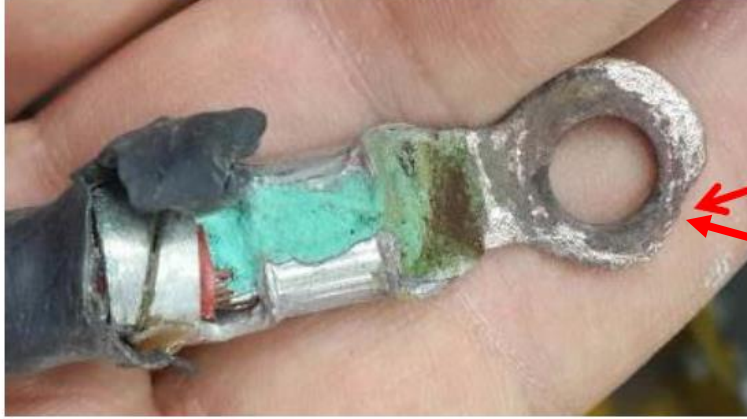
2. After the cleaning process is completed, the condition of the harness should be checked. As shown in the pictures below, if abrasion /thinning/ corrosion of 2mm or more has occurred, the harness should be replaced.

Harness eyelet that needs to be replaced

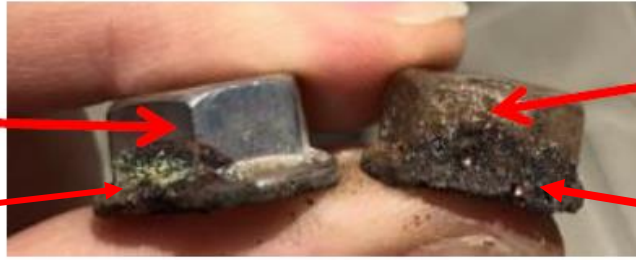
3. If corrosion and abrasion have occurred on the nut below, as shown in the picture below, the nut should be replaced.

the nut that can be used after cleaning

the nut that needs to be replaced

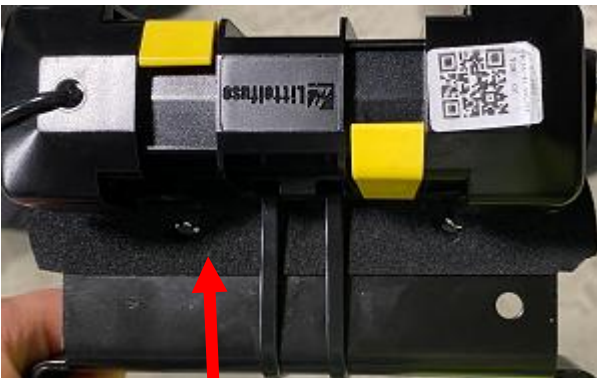
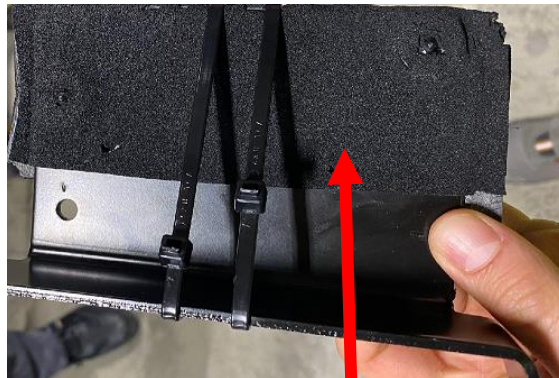
If there is no following tape on the bracket, the tape should be stickied on the bracket as in the photos below. The tape with excess from the sides should be cut from the side.

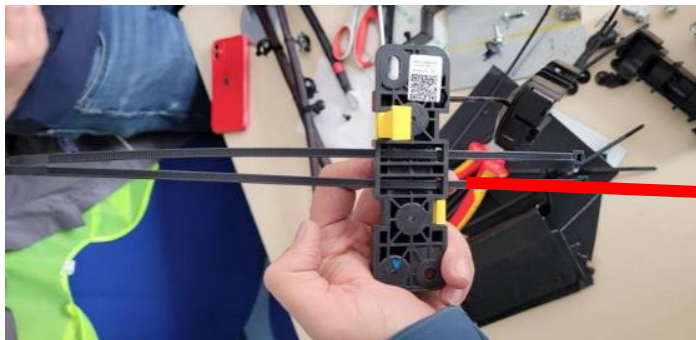
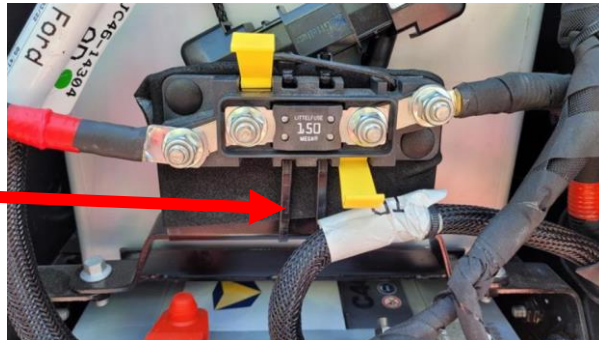
The strap should be passed through the megafuse strap area and the strap should be stickied together on the bracket as shown in the photo below.

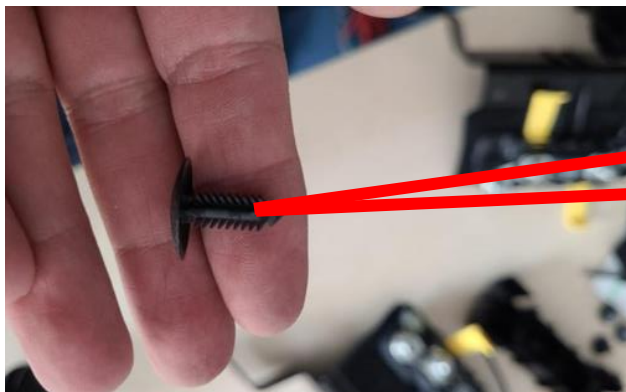
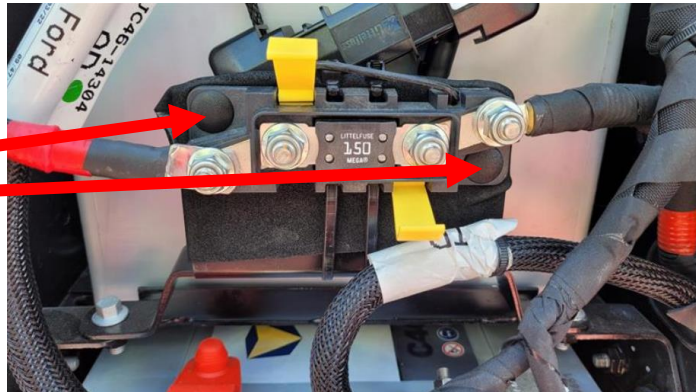
The plastic push-pin should be mounted to the bolt via the sponge.

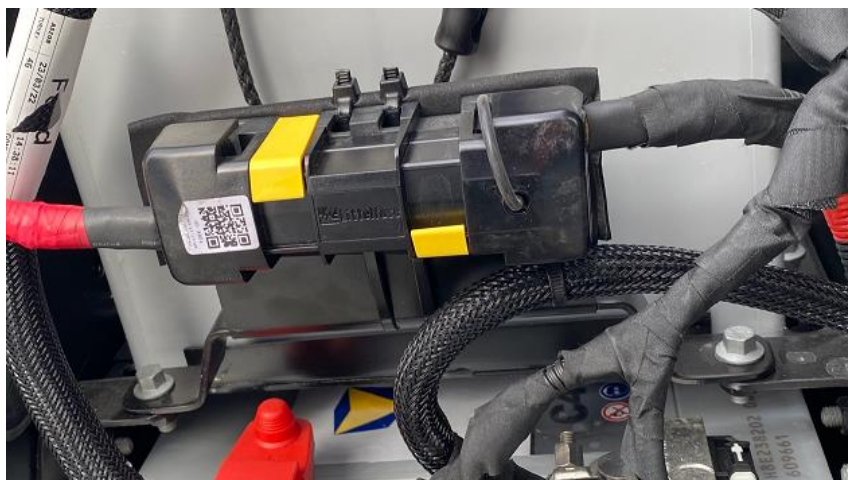
After the Mega Fuse Rework, it will be as in the photo below.

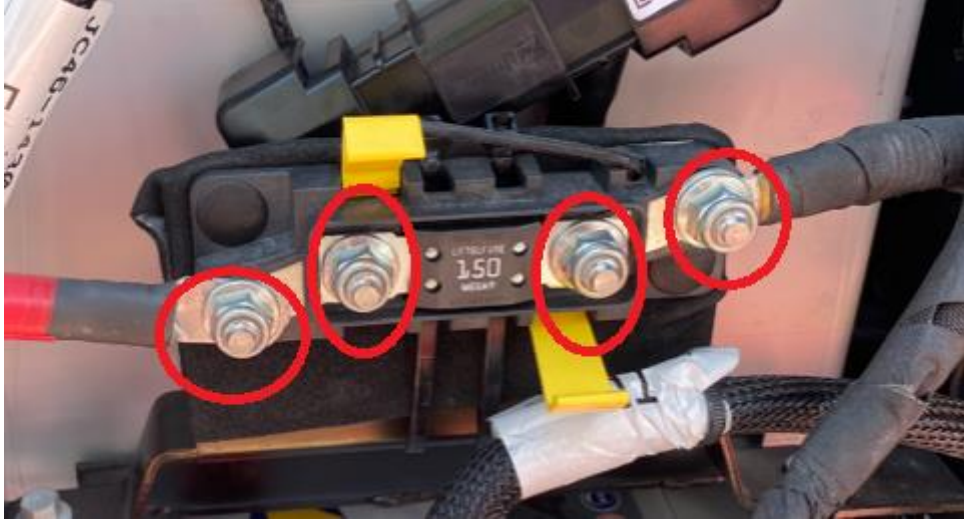
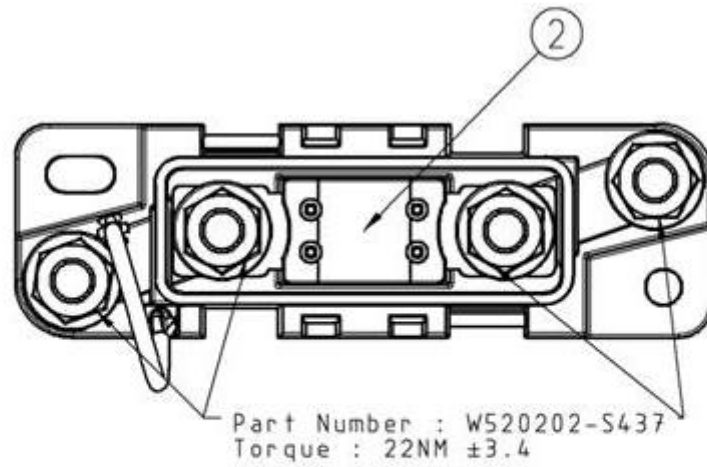
Finally, after the rework process is completed, the bolts marked below should be tightened again to **22NM**.

It should be noted that the harness isolation part should not be stuck between the eyelet and the bolt.
