SERVICE INSTRUCTIONS

REFERENCE: FSA202119

SUBJECT: Routing Change of Electrical Heated Urea Hoses

FSA TYPE: Next Service Visit

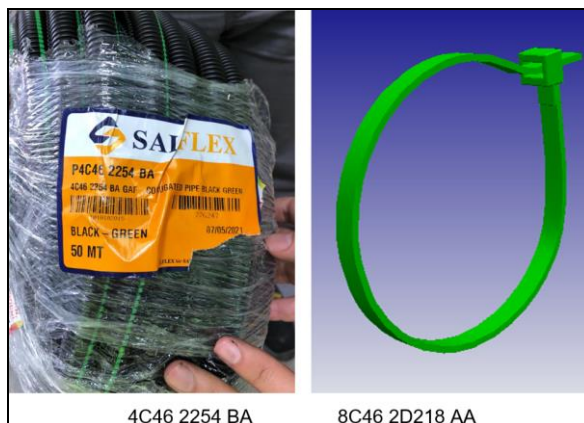
Part Number	Part Description	Usage
4C46 2254 BA	Protection Sleeve	0,5 (Per/vehicle 40cm)
8C46 2D218 AA	Clamps	4

Note: 40 cm **4C46 2254 BA** is used for each vehicle.

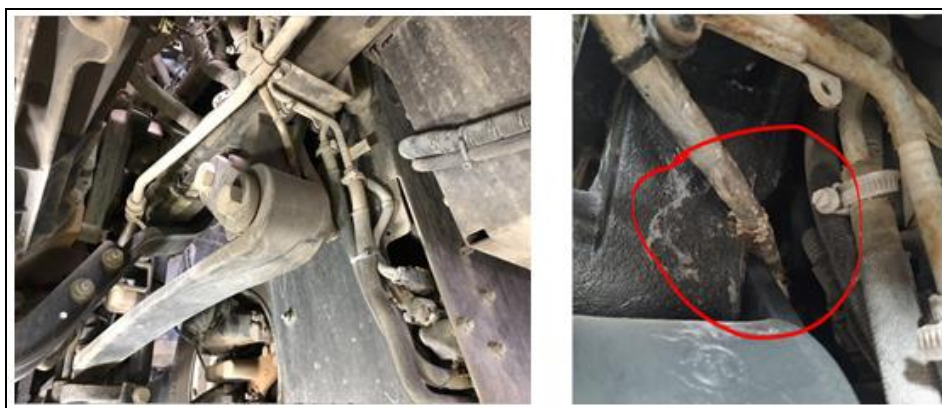
This implementation will be applied to prevent the urea hoses damaged which is close spring due to tension and vibrations as in the image below. First of all, the existing clamps will be cut and the urea hose will be release to apply protection sleeve. After implementation of protection sleeve, urea hose is installed and fixed.

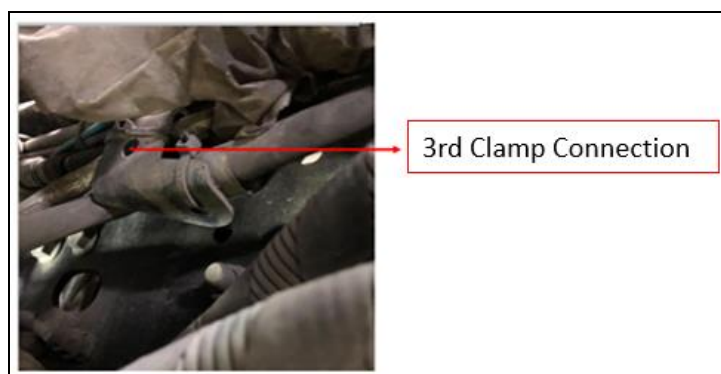
- 3- The clamp connection (3) that is used to fix urea hose to hose bundle, must be cut carefully.

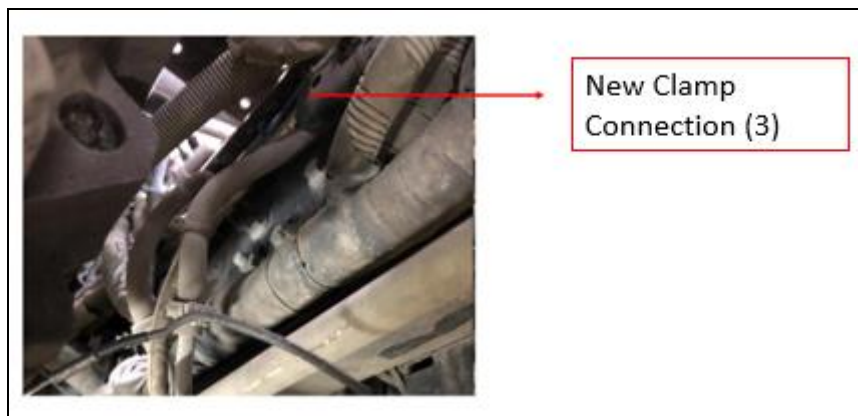
10- Instead of the "clamp connection (3)" which was cut from the junction area of the urea hose with the lines inside the frame, "new clamp connection (3)" should be applied.

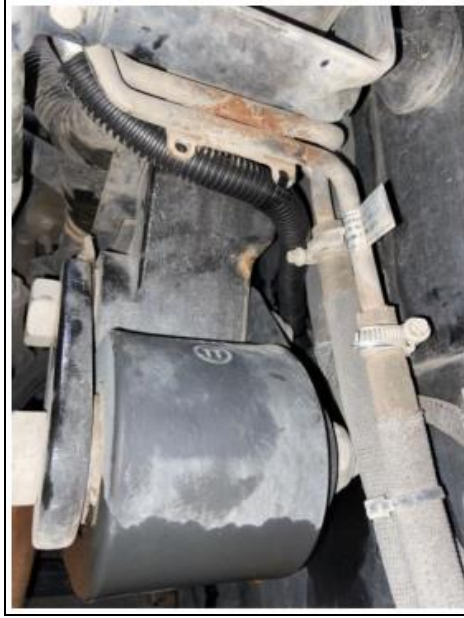
View After Job Completion

11- When the service application is completed, the vehicle should be started and the leakage status of the relevant hoses should be observed to confirm that the hoses are not damaged.
