SERVICE INSTRUCTIONS

REFERENCE: FSA202121

SUBJECT: Replacement of Retarder Exchanger Cooling Hoses

FSA TYPE: Next Service Visit

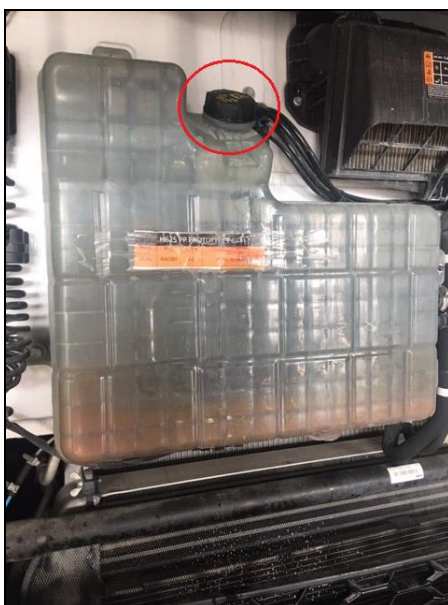
1- Open the front hood. Remove the cap of the expansion tank to allow ease of flow of the coolant.

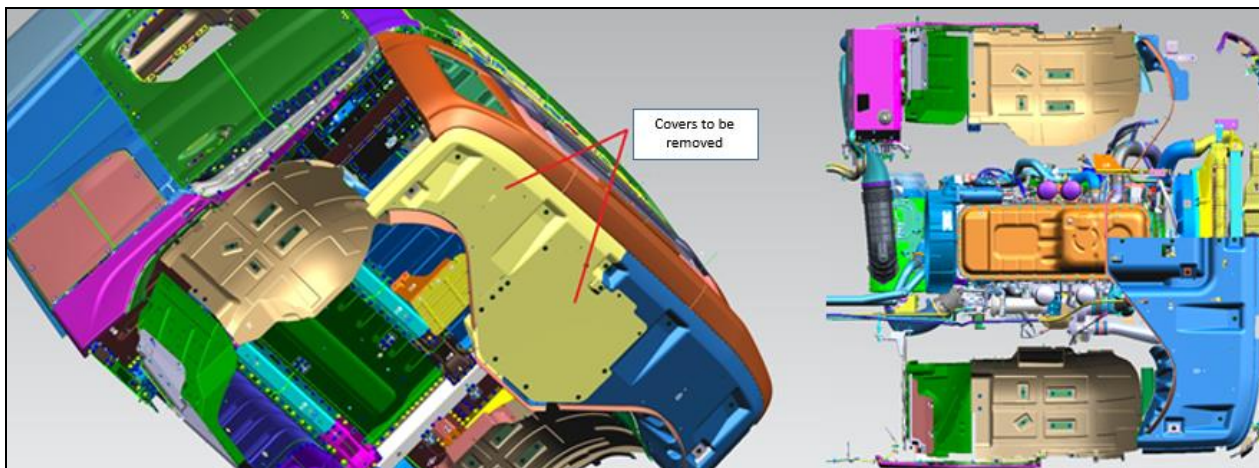
2- The Coolant shall be drained from the lower plug of the radiator. Remove the plastic covers on the right on the lower part of the vehicle in order to access the plug. 17 bolts specified in the figure below shall be removed for this purpose.

9- Place the lower plastic covers to their locations and tighten 17 pieces of M8 bolts to **25 \pm 4Nm**.

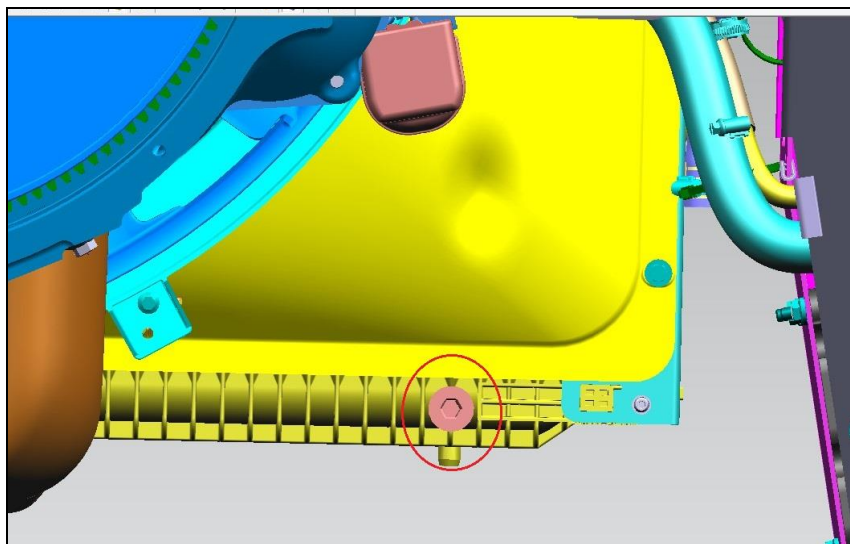
3- Remove the draining plug on the lower right side of the radiator with an M8 allen wrench. Drain the engine coolant to a clean container. The coolant removed from the vehicle shall be refilled at the end of the procedure.

8- Radiator Plug should be placed and torque to **4 \pm 1Nm**

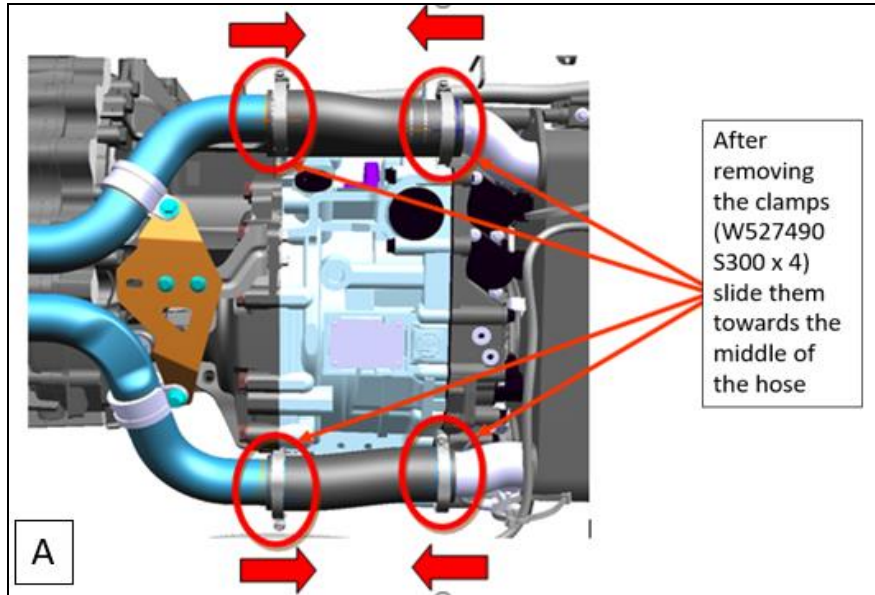
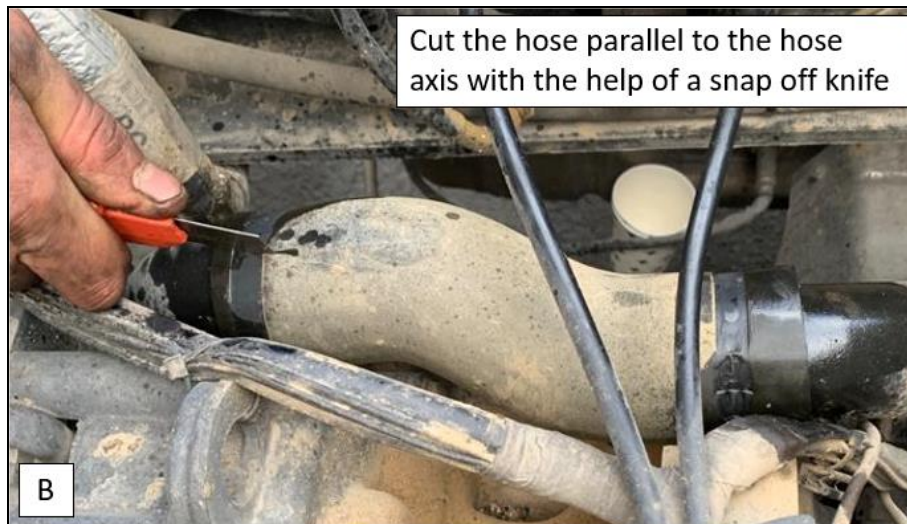
4- Please remove hose clamps (4 units x W527490-S300) which is located retarder exchanger hose's outlet and inlet side as mention **Figure A**. After removing the clamps, please cut the hose as given below **Figure B**.

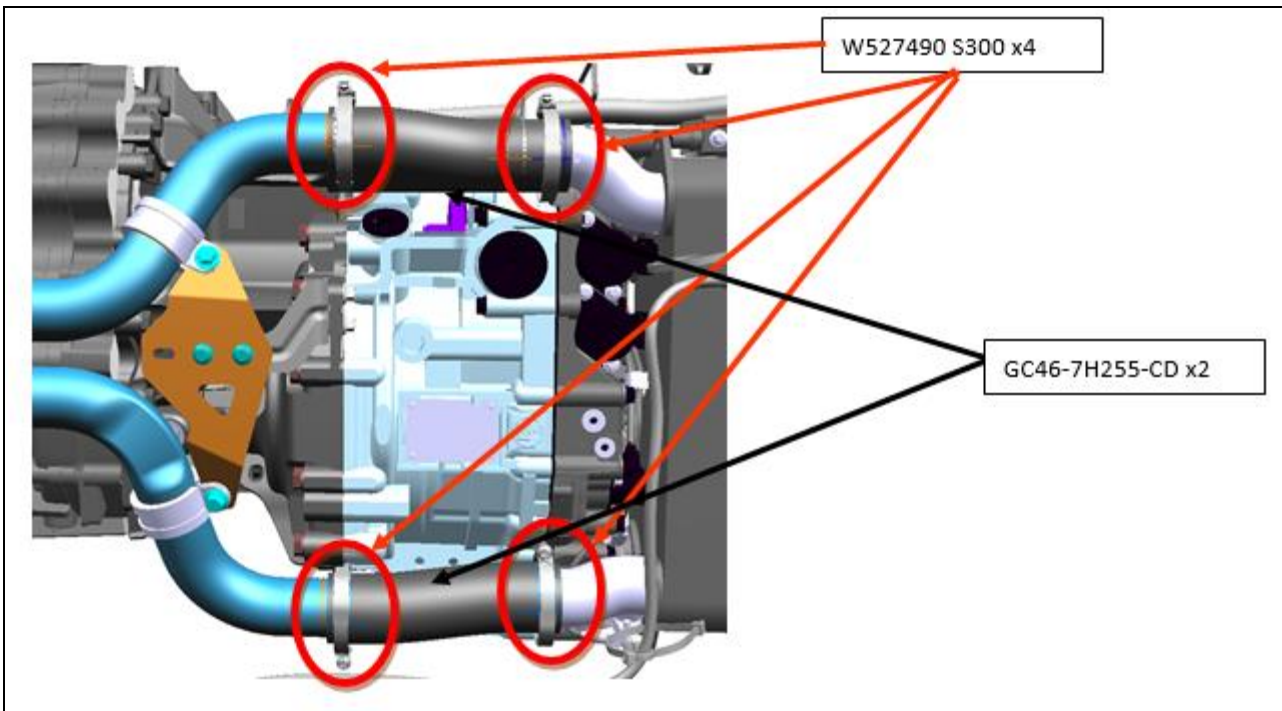
7- New level hoses (**GC46-7H255-CD**) should be placed at the inlet and outlet of the retarder exchanger. Clamps should be torqued to **5.4Nm \pm 0.9** by positioning between the alignment marks on the hose and using a torquemeter.

5- It is recommended to clean the rust-like staffs on the metal pipes and on the heat exchanger spigots with mineral oil or non-fuel base solvents.

6- While installing the rubber part, please **do not remove the brackets and do not move metal pipe** if it's not necessary.

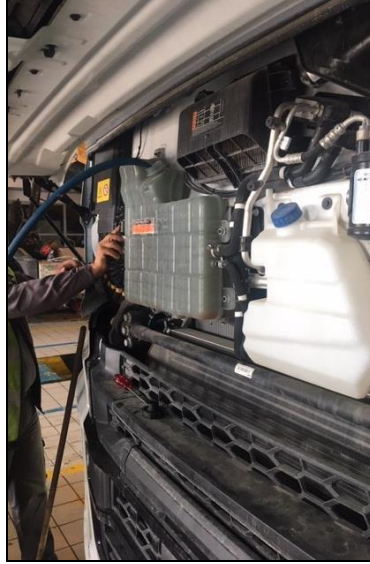
10-Refill the coolant collected in a clean container to the vehicle through the expansion tank. Then, close the cap of the expansion tank.
