SERVICE INSTRUCTIONS

SUBJECT: FORD TRUCKS,9.L VALVE COVER OIL LEAK

INTRODUCTION

Below are the processes to be followed regarding valve cover oil leaks coming to our services.

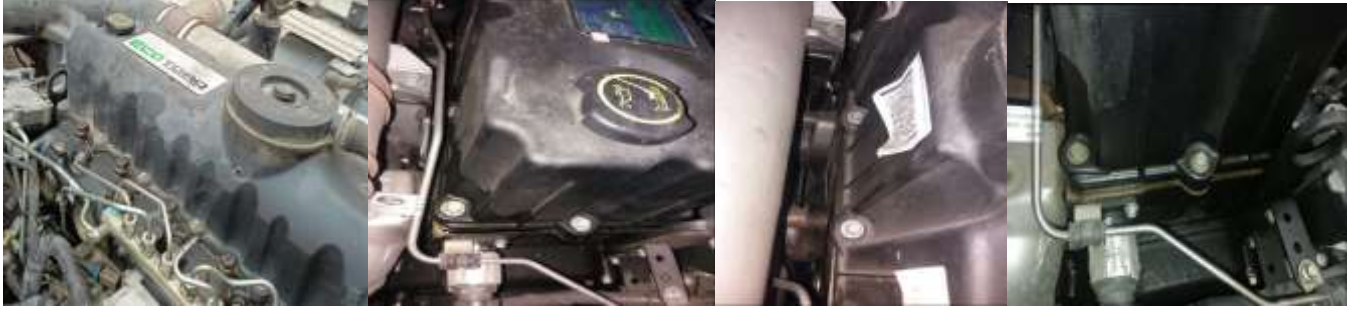
In case of encountering valve cover oil leaks 9 L in the vehicles brought to our service, the following steps have been listed

- 1) Remove the cover and inspect the valve cover and its surroundings.
- 2) If oil leakage is detected during the inspections, disassemble the valve cover bolts.
- 3) After the disassembly process, shorten the pilot parts of the bolts.
