Heavy Commercial Vehicles

Subject	Dry Type Heater Cleaning Process
Model	In All Ford Trucks Vehicles
Summary	The following cleaning method should be applied to all Ford Trucks vehicles that come with a soot-induced backup heater not working problem.

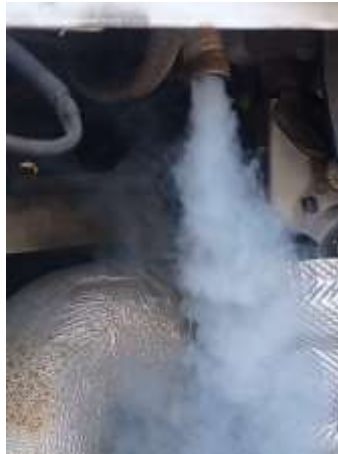
Image 1 - White smoke coming out of the heater exhaust.

The Heater not working or the problem of white smoke coming out of the exhaust from the heater while it is running (**Image 1**) , the following control method should be applied, and the combustion chamber should be cleaned if necessary. Before the repair, the maintenance menu → error codes → should be read from the cluster in Fmax vehicles (**Image 2**). In Legacy Vehicles, the error code will be read on its own control screen(timer) (**Image 3**). On the start screen, move over the setting symbol with the arrow keys and press the lower right button. After going to the setting menu, press the lower left button for 5 seconds. The error code is displayed on the screen numbered

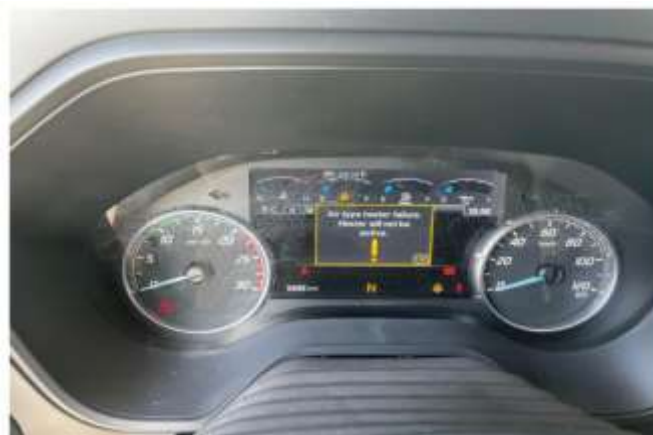
Image 2 - Fmax error code reading

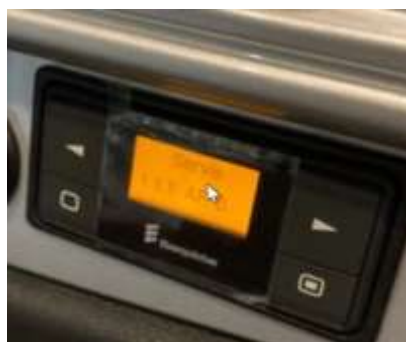
Image 3 - Legacy error code reading

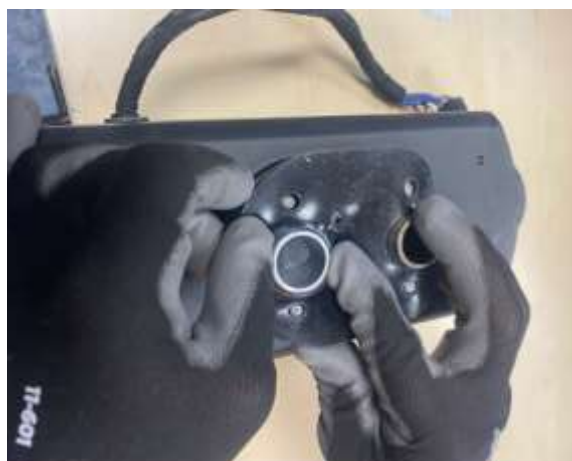
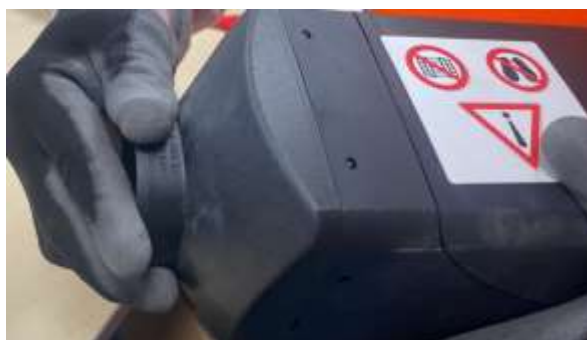
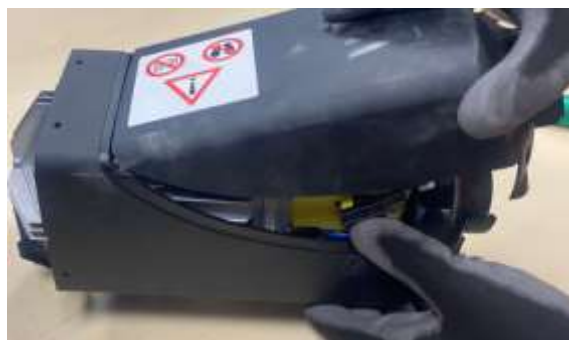
- 1) Remove the plastic gasket and protective caps.

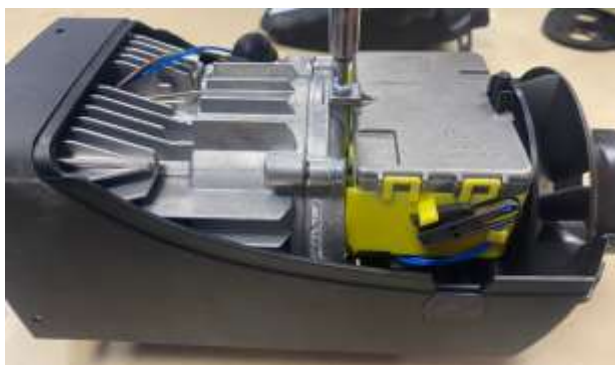
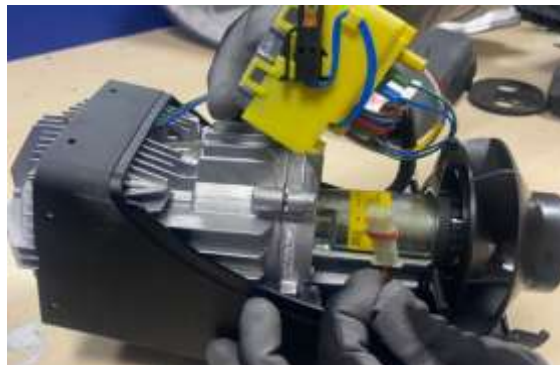
- 2) Remove the control box. If the combustion chamber is sooty, it may be caused by glow plug (error code 20, 21, 22) or fan (error code 31,32,33,34). Do the checks corresponding to the error codes, replace the spark plug or fan if necessary.

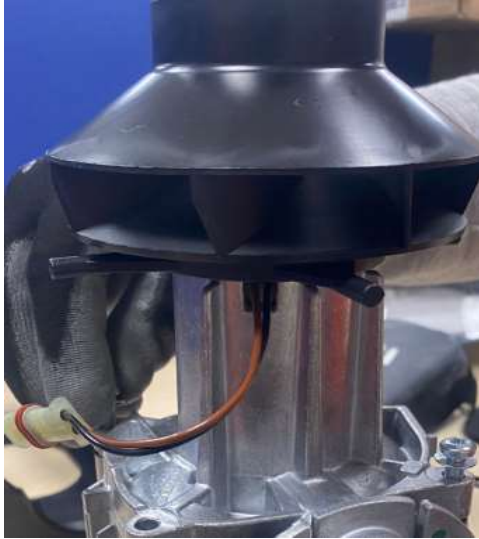
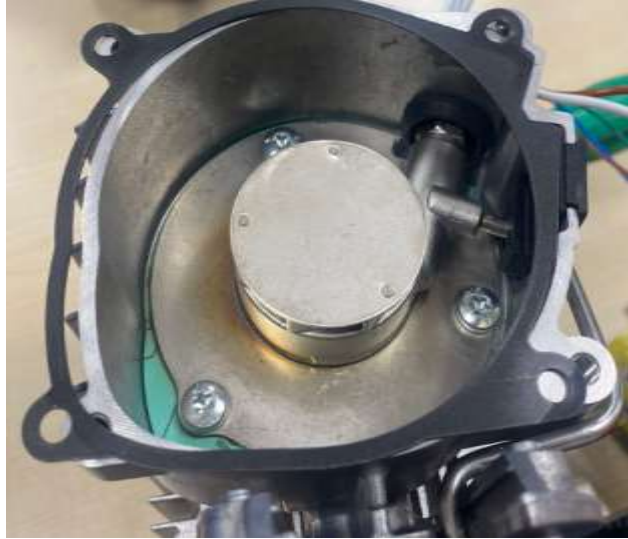
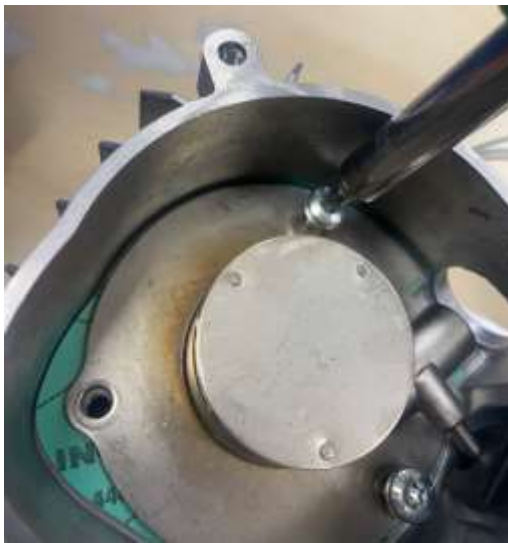
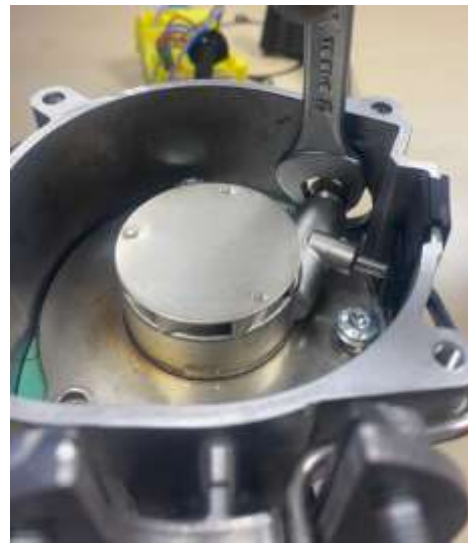
3) Remove the Combustion Chamber.

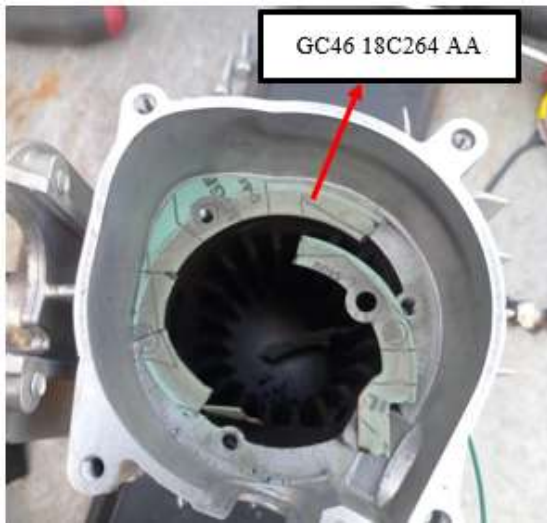
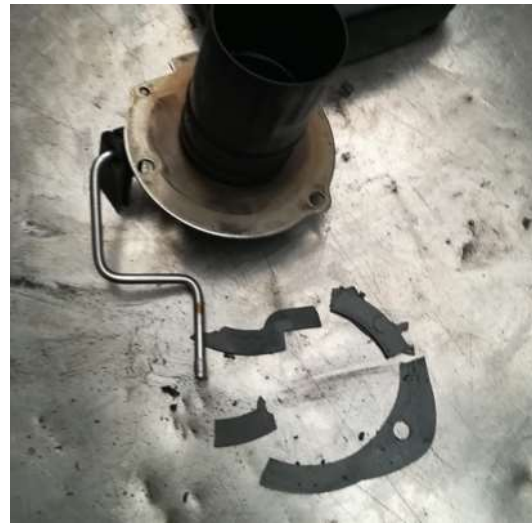
- 4) If the gasket which number is GC 46 18C264 AA in the image is damaged while removing the combustion chamber, replace it with a new one.

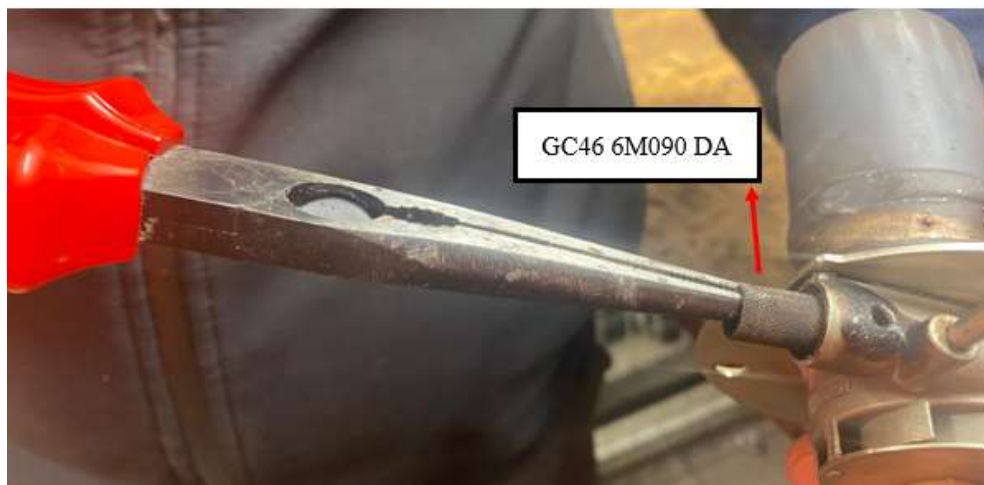
- 5) Remove the dirty filter in the combustion chamber with the pliers.

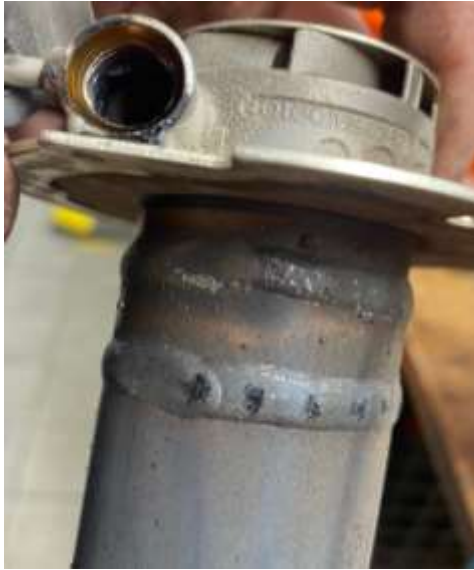
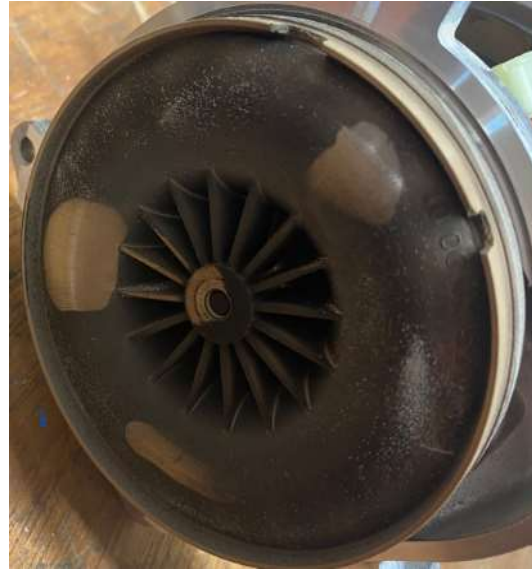
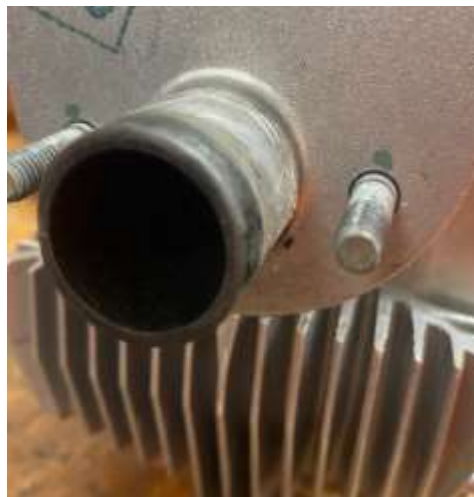
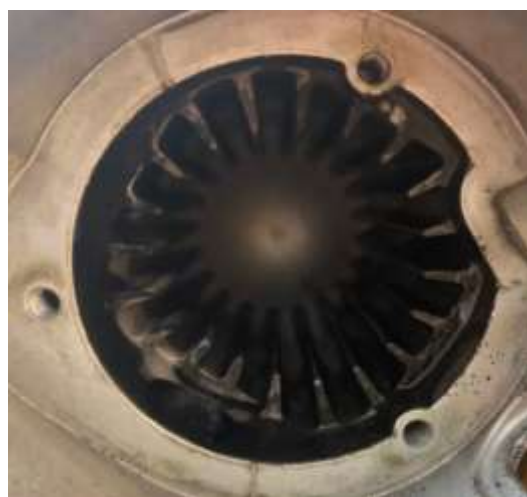
- 6) Clean the parts with soot by spraying brake lining spray/soot cleaner. Before using the brake lining spray, shake it and wait for it to penetrate after spraying on dirty parts. Clean the parts with a dry cloth.

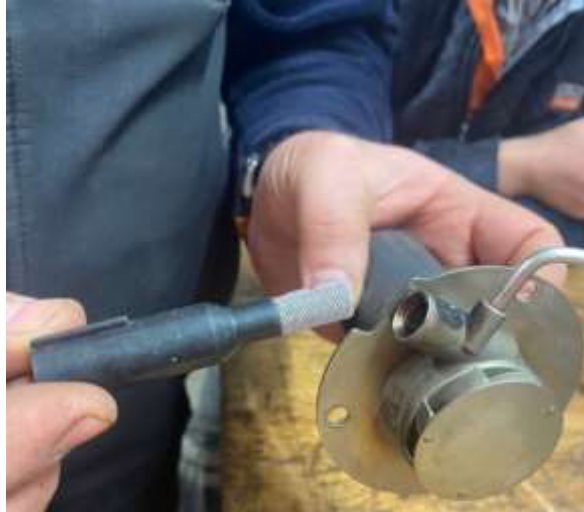
- 7) Since the removed filter will be damaged, attach the new GC46 6M090 DA filter with its apparatus as in the image.

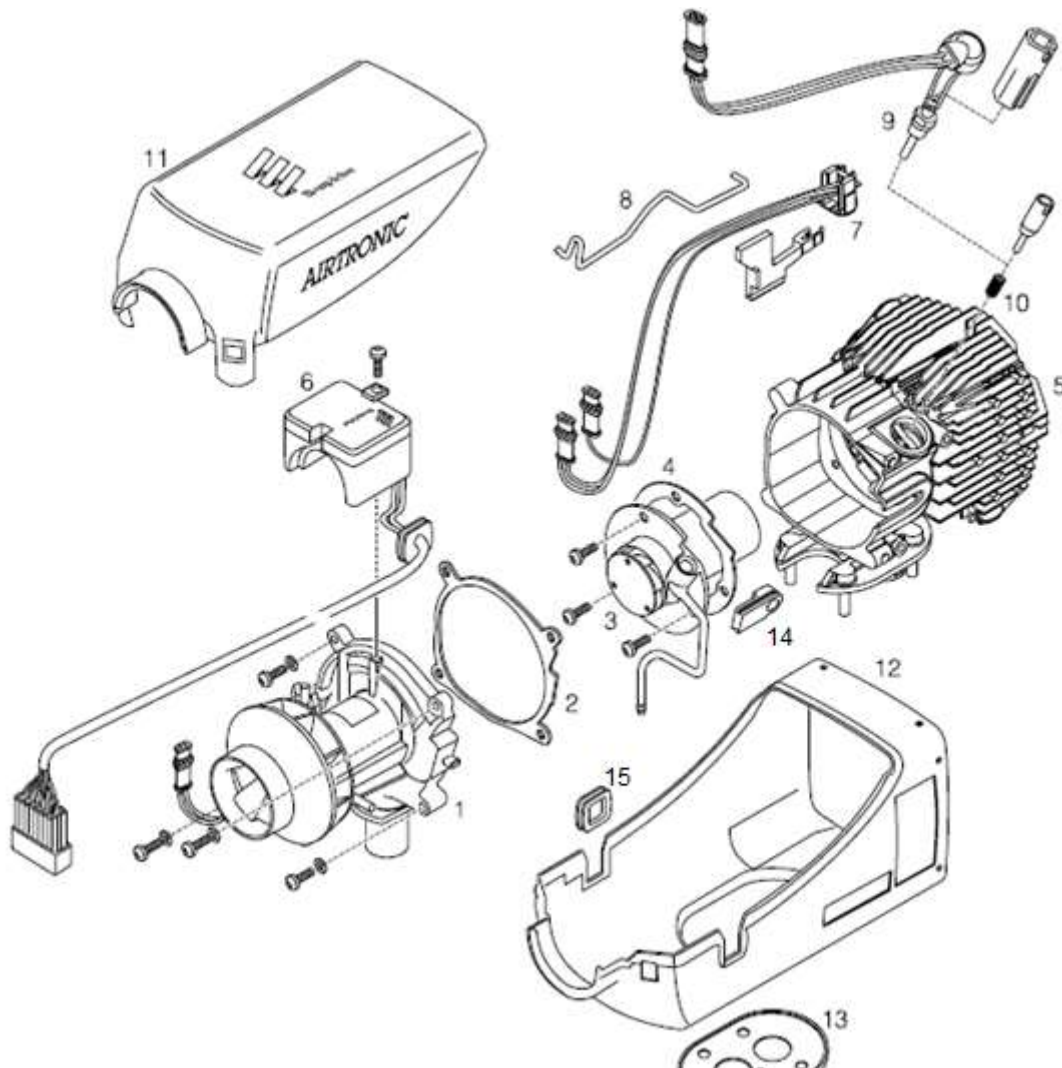
If there is any part damaged during the cleaning process or detected as already damaged, **only the damaged part or parts** can be replaced according to the numbers in the list below.
