TECHNICAL SERVICE BULLETIN No. TSB-ENHCV-1524

HEAVY COMMERCIAL VEHICLES

Subject	Inspection of Ecotorq Transmission Output Coupling Cover Bolts
Model	All Ford Trucks Vehicles with Ecotorq Transmission
Sum	Inspection steps to prevent the output coupling cover bolt from shearing

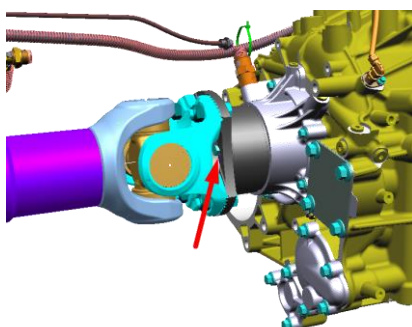
Image 1- Inspection Area

IMPORTANT : For our Ford Trucks vehicles equipped with the domestic Ecotorq transmission, **it is essential to always check the bolts securing the output coupling cover** during each maintenance or when the vehicle enters the service

The inspections to be performed will involve visually checking for bolt loosening and manually checking for torque loosening in the bolts. **No labor should be added to the claim process** for the inspections performed by eye or hand

In case of bolt loosening, missing bolts, or rotation of the bolts during manual inspection, the service procedure outlined below must be fully completed

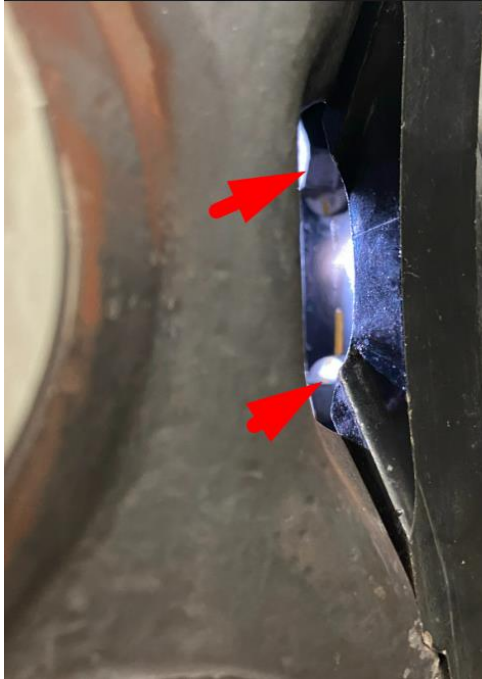
Image 2- Visual inspection with the help of a flashlight

The output coupling window should be illuminated using a flashlight from the opposite direction of your line of sight. Each of the two bolts should be inspected. If one of the bolts is loose or not in the correct mounting position, proceed with the replacement steps as outlined in the document.

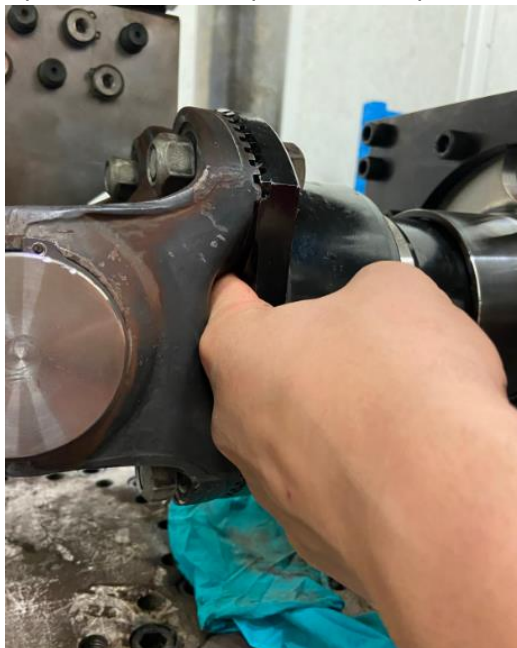
Image 3- Manual Inspection

1. Using your index finger through the output coupling window, check both the presence of the bolts and their tightness. Inspect the coupling cover piece by moving it forward and backward to check for any gaps. Under normal conditions, the coupling cover should be fixed, and the bolts should be tightly mounted. If any abnormalities are present, proceed with the replacement steps as outlined in the document

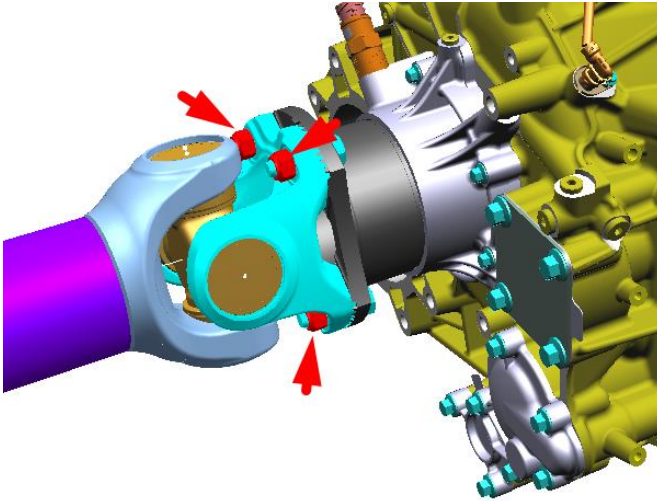
Image 4- Removal of Nuts

To gain access to the coupling cover fasteners, four W520014-S type nuts and four W718766-S type bolts should be carefully removed. (They are numbered as 1, 2, 3, and 4 on the image)

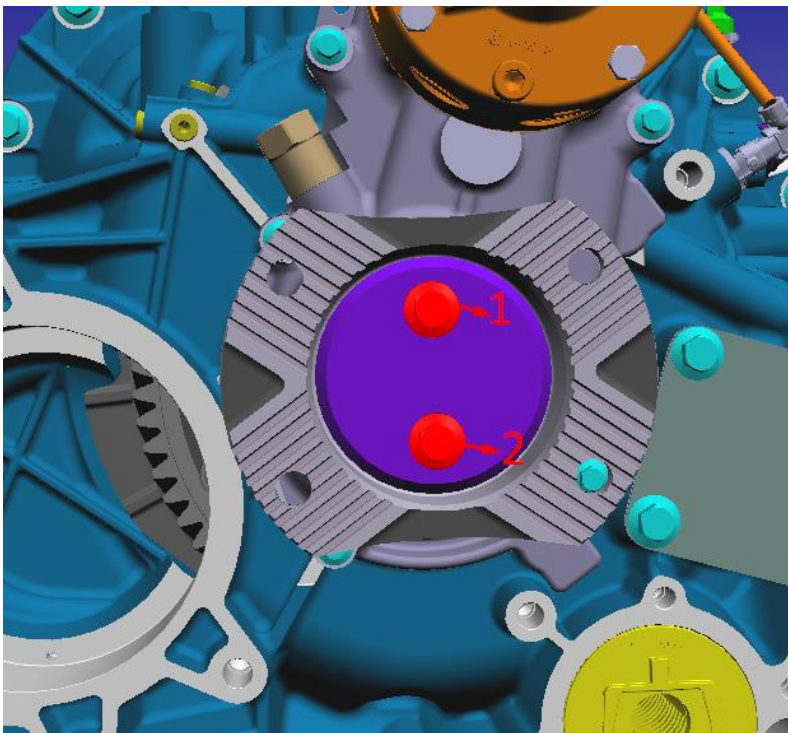
Image 6- Coupling Cover Bolts

Both bolts are removed. (They are numbered as 1 and 2 on the image.)

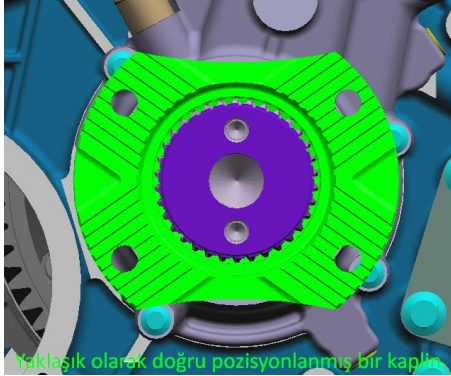
Image 8- Coupling in the Correct Position

Ensure that the coupling, coupling cover, and bolts are positioned as shown in the image below. Since perfect alignment as shown in the image may not be achievable, a slight deviation is acceptable

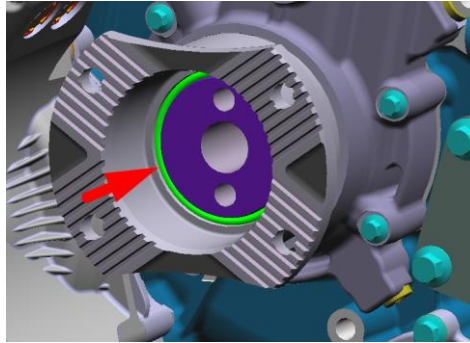
Image 10- O-ring position

- Make sure that the O-ring sits properly in its groove. Ensure that there is absolutely no overflow in the coupling assembly pressure area.. (LC46-7J030-AA)

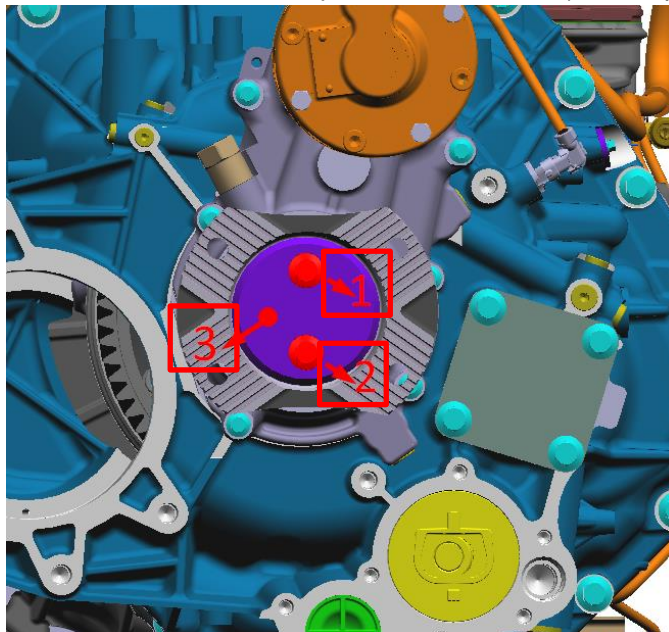
Image 11- Bolt and Cover Position

The gap must be taken up until both bolts sit flush with the cover surface.

- Ensure that the coupling cover (number 3) is centered in the assembly area.
- The gap-free bolts numbered 1 and 2 are tightened to 45 ± 5 Nm. (W500543)
- Bolts numbered 1 and 2 are then tightened to 80 ± 5 Nm. (LC46-7A771-CA)
- The tightening process for bolts numbered 1 and 2 is repeated at 80 ± 5 Nm. (This step is critical.)

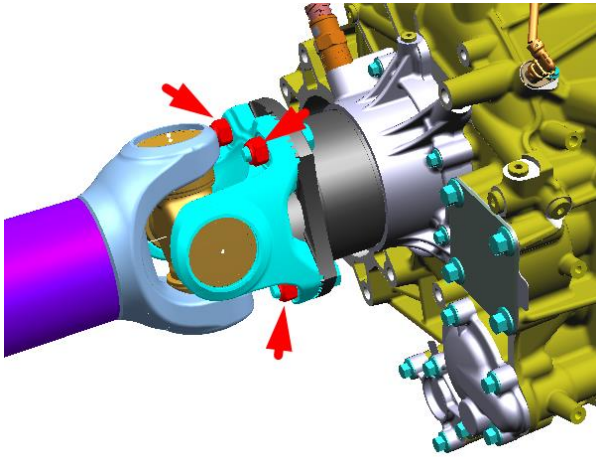
Image 12- Nut Assembly

Install the shaft in place. To complete the shaft assembly, tighten 4 pieces of W520014-S (nuts) and 4 pieces of W718766-S to 175 ± 26.3 Nm.
