*Heavy Commercial Vehicles*

| <b>Subject</b> | Replacement of the spacer parts together with the engine cooling fan replacement on vehicles produced before quality improvement implementation. |
| <b>Model</b> | 12,7 L F-Trucks Produced Before 18.02.2025<br>9 L F-Trucks Produced Before 27.07.2025 |
| <b>Summary</b> | With the aim of improving quality in the fan system, the parts were upgraded to a new revision level in February 2025 for the 12.7L engine and in July 2025 for the 9L engine. In vehicles equipped with the previous revision parts, if a part replacement is required, the entire system must be replaced together. |

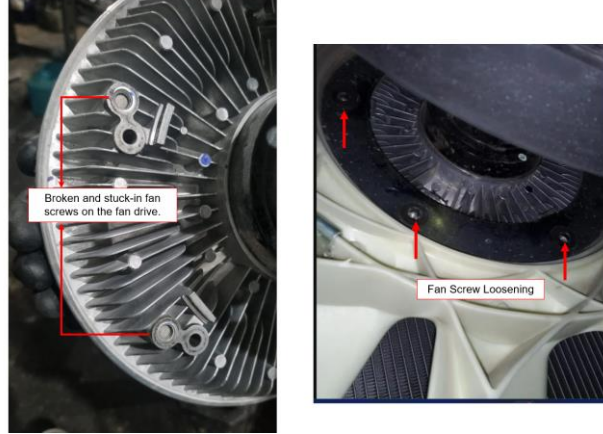
- There is a noise coming from the vehicle, as a result of an inspection, the fan screws were broken or loosen.
- Damaged to the fan propeller of the vehicle due to screw loosening or broken failure, imbalanced rotational motion.

**Figure 1 :** Engine cooling fan failure modes. The photos were taken from previous claims.

On the dates provided above, quality improvement actions for the fan and spacer parts were implemented. When the engine cooling fan parts are replaced due to a fan screw loosening problem, fan screw broken problem or fan clutch electrical failure, GC46-8C617-B\*, GC46-8C617-C\* ; fan spacer parts GC46-8A645-A\* and GC46-8A645-B\* will also need to be replaced.

**Since they are parts that work together, a vehicle in which a new level radiator fan is to be installed must definitely use a new level spacer. Only in this way, quality improvement is possible by changing the two parts together.**

### **Case I: Fan damaged, spacer Ok – Both the fan and the spacer should be replaced**

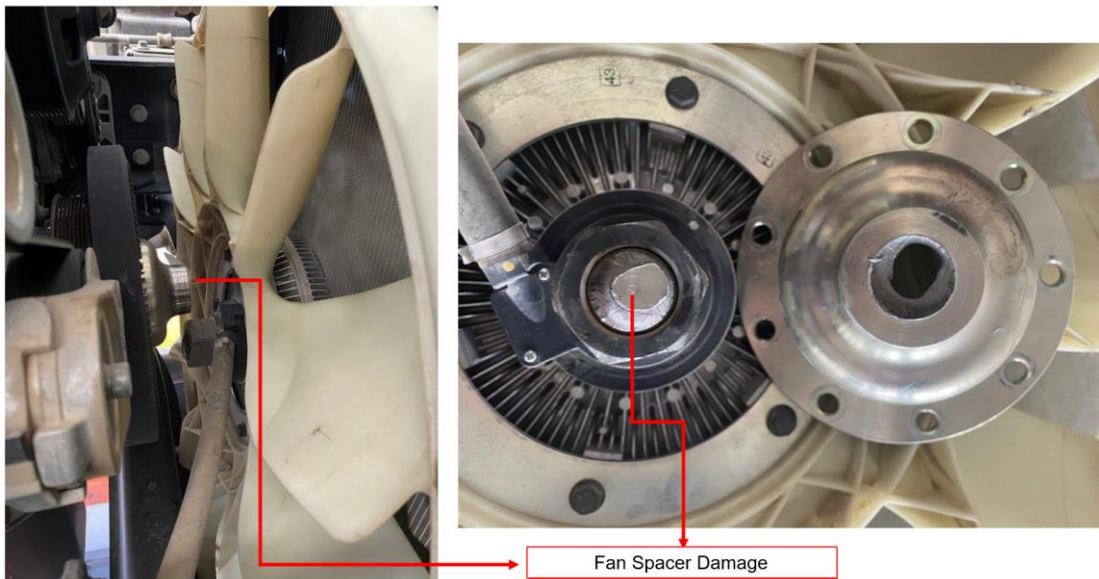
- Fan spacer is broken. Engine cooling fan assembly and broken spacer part fallen.
- Engine cooling fan assembly does not work.

**Figure 2:** Only the spacer part is damaged.

### **Case II. Fan is Ok, Spacer damaged**

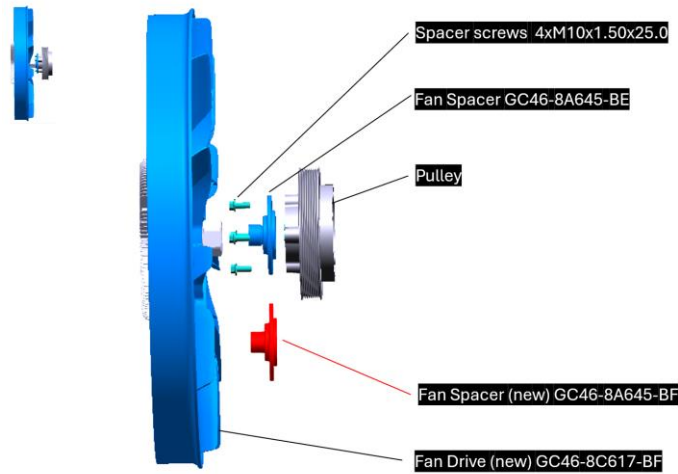
Figure 3 ve Figure 4, describe the radiator fan and assembly parts of the cooling system on vehicles with 12.7L and 9L engines. Additionally, the parts marked as red in the figures are new level fan spacer parts.

**Figure 3:** 12.7L Ecotorq Engine; Engine Cooling Fan, Fan Spacer and Pulley Parts

8C617 → Radiator Fan Assembly - Indicates final parts. It includes the fan hub, fan propeller, bolts connecting the fan hub to the propeller and the electrical wiring that provides of the fan. (Picture 3 and Picture 4)

8A616 → Fan Drive - Indicates component parts only released as spare part in case of the fan drive (fan clutch) is needed to be changed. (Picture 3 and Picture 4)

8A645 → Fan Spacer – Indicates the spacer part that connects the fan to the pulley. (Picture 3 and Picture 4)

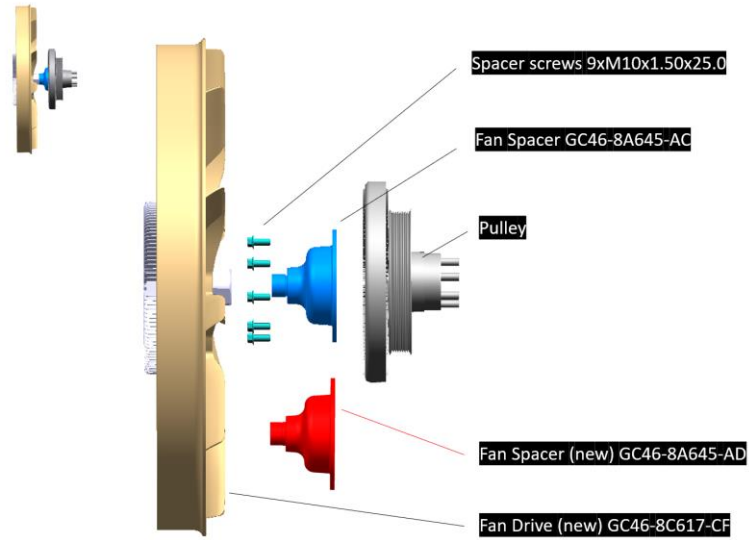
**Figure 4:** 9L Ecotorq Engine; Engine Cooling Fan, Fan Spacer and Pulley Parts

- 1) When the cabin lifted on the vehicle, engine cooling fan assembly must be inspected. Damages on the fan propeller or six fan screws must be checked on the assembly. (Figure4)

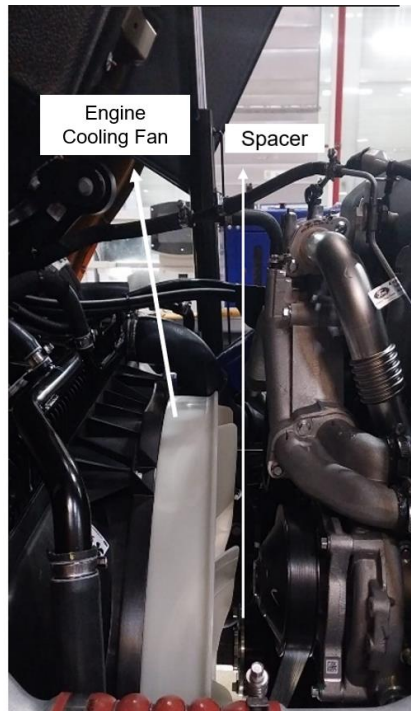
**Figure 5 :** Engine cooling fan and spacer parts after the cabin lift.

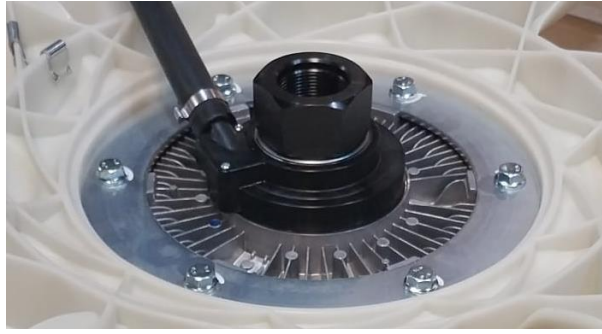
- 2) Depending on failure mode fan screws could be loose or broken. Fan screw locations are pictured in Figure 6.

**Figure 6** : Engine cooling fans have 6xM8x1.25 screws.

- 3) If the vehicle has the problem and it is inspected as described in first and second steps. Both the fan drive (8C617/8A616) and the spacer (8A645) must be changed on vehicle.(Table 1)
- 4) For parts replacement, the fan assembly would be changed between the engine pulley and the radiator shroud. For fan removal and installation process please refer to “USM-ENHCV-1026 Instructions for Cooling Fan R&I”.
- 5) **Since they are parts that work together, a vehicle in which a new level radiator fan (Table1) is to be installed must definitely use a new level spacer (Table1). Only in this way can we assure the system operates properly in coordination.**
- 6) Fan spacer must be mounted on the engine pulley part. The fan spacer position is indicated on the engine (Figure 7).

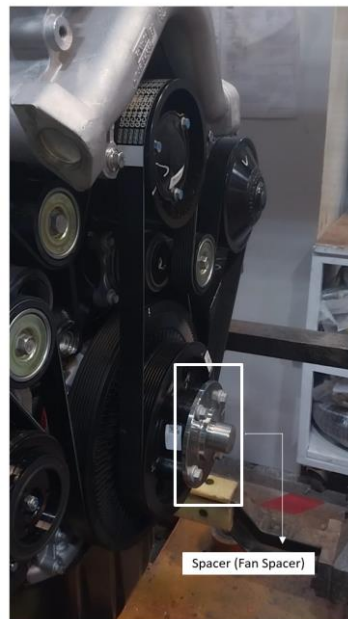
**Figure 7:** Spacer Part FEAD Assembly

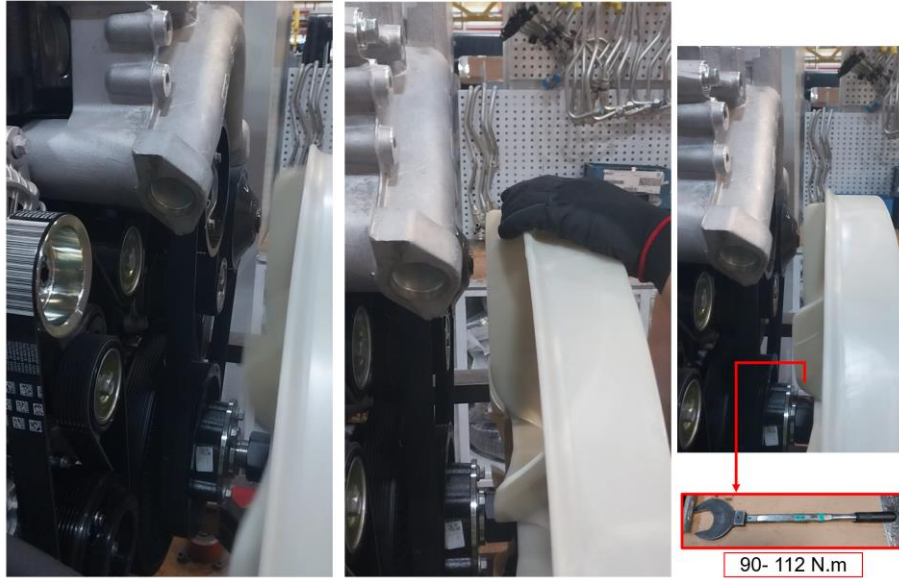
- 7) Part replacements must be completed by using a new level fan and the new level spacer parts. The mounting process of the fan with inner threads of fan shaft and threads on fan spacer. Tightening operation will be proceed.

The cooling fan must be turned by hand until the thread zone, after the fan hexagonal shaft are fully screwed, the fan must be tightened with the torque value between 90N.m -112 N.m

**Figure 8:** Engine cooling fan assembly process.

- 8) Please complete the part replacement process.
- 9) After the engine cooling fan system is assembled, and the part replacement process is completed in the service. Finish the repair with a test drive.
