**Heavy Commercial Vehicle**

| <b>Issue</b> | Air leakage from the retarder air hose on F-Max vehicles equipped with inhouse transmission (IHT) and retarder. |
| <b>Model</b> | H625 IHT transmission vehicles |

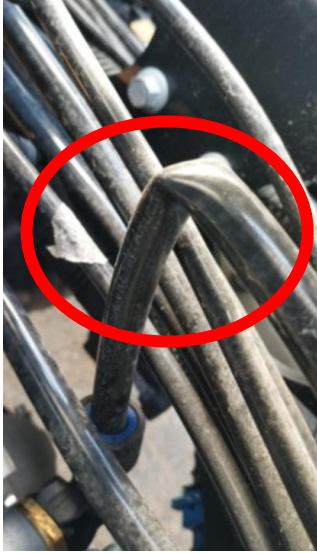
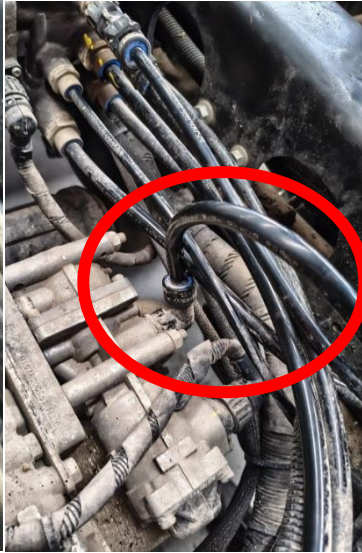
**Incorrect Routing**

| <b>Summary</b> | This bulletin covers the required repair and inspection actions due to the retarder hose being worn and punctured as a result of contact caused by incorrect routing of the retarder air hose, leading to air leakage. |

The air hose entering the retarder must be routed underneath the brake lines, as shown in the image below. During the operation, ensure that the air lines are not kinked and that there are no sharp bends at the connector inlets.

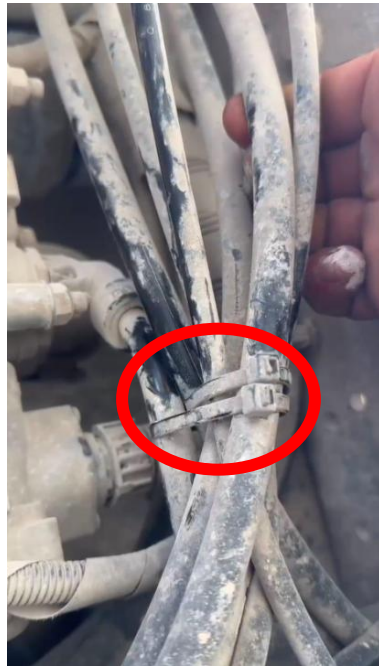
**Important Note-1:** **Do not attach the retarder air hose to the brake air hoses with a strap.** An example of incorrect installation is shown below.

**Important Note-2:** During the inspections, detailed images of worn and damaged retarder air lines, images of the incorrect installation before repair, and images of the installation after repair must be added to the claim. **Connector replacement is not required for the related repair process.**
