TECHNICAL SERVICE BULLETIN No. 22/2025

21/11/2025

Heavy Commercial Vehicles

Subject	Urea Pump Diagnosis and Replacement
Model	All 12,7L & 9L EU6 Vehicles
Summary	Introduction of a guideline document to systematically perform the required checks prior to Urea Pump replacement

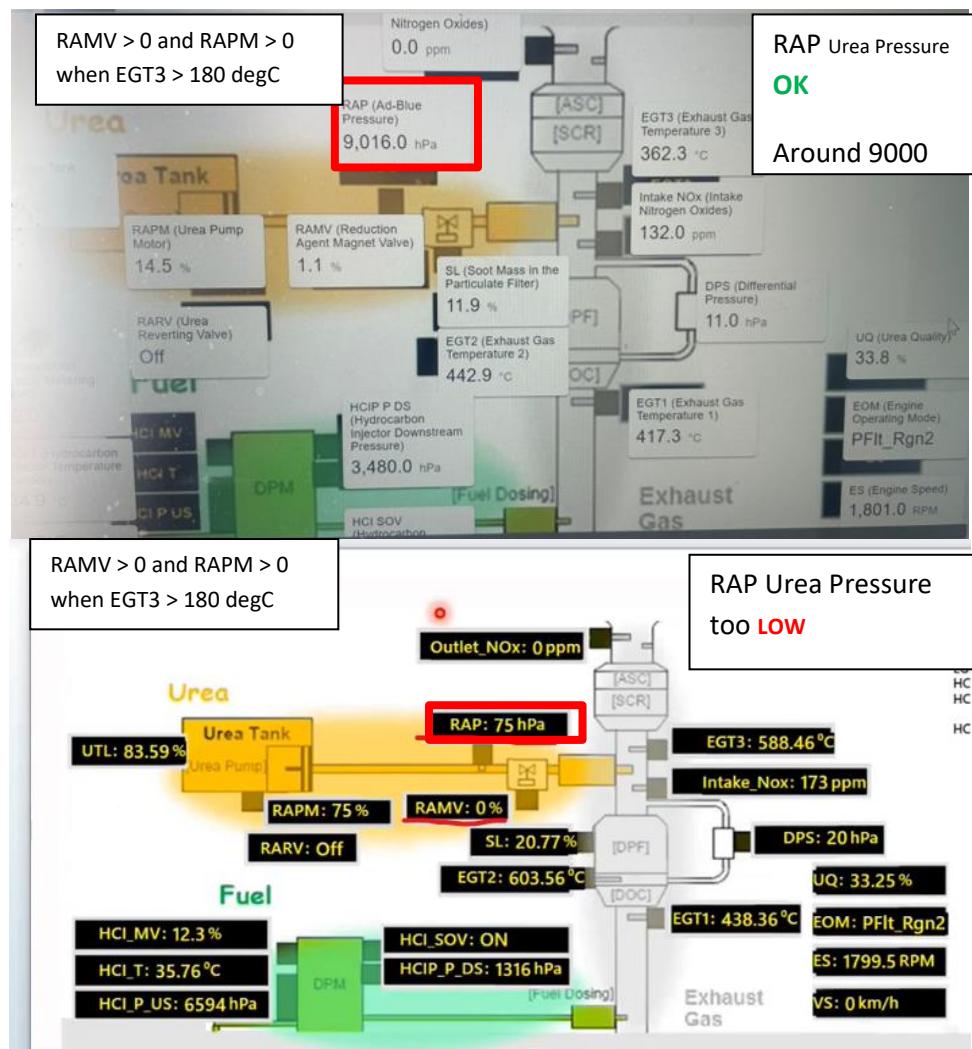
Picture 5 AFFT Screen

Note: The DPF Regen application on step 6 can be performed via Manuel Regen (25 min). Extended service regeneration is not required for the parameter check.
