## TSB-ENHCV-2225 Urea Pump Replacement Checklist

### Appendix 1

21.11.2025

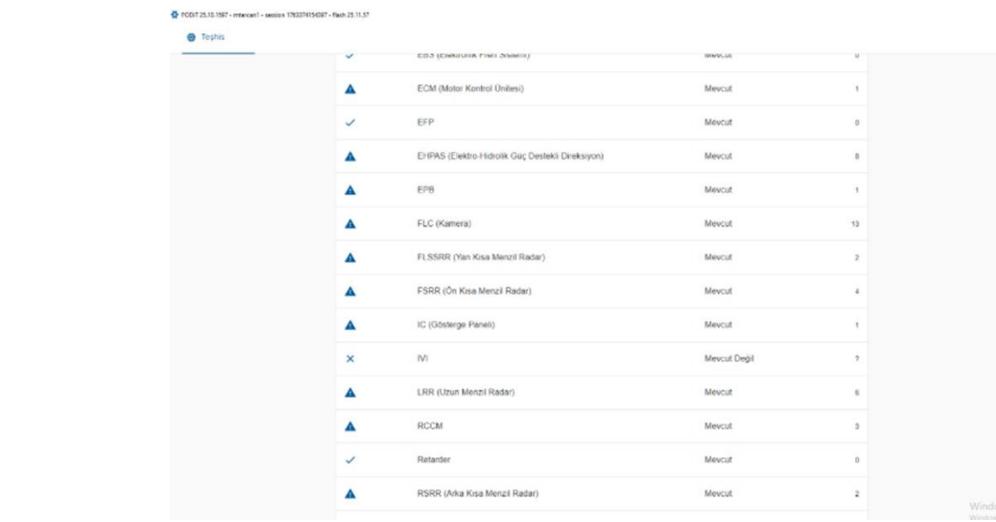
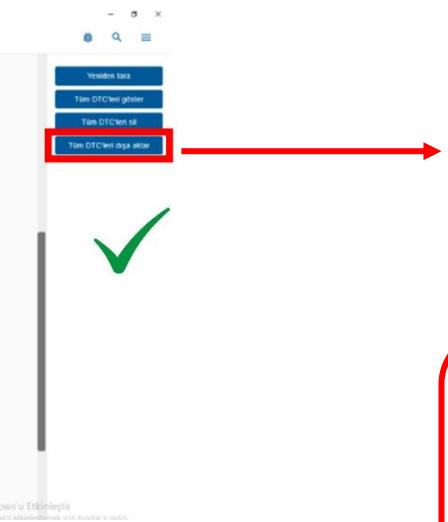
1	Initial Check and DTC Scan	<ul style="list-style-type: none"> <li>* Connect the FODIT tool and perform a full DTC scan. Save the report including all active and stored fault codes in the ECM.</li> <li>* [LOG 1] Save the complete DTC report as a PDF to be submitted with the warranty claim ticket.</li> <li>* If there is a fault related to the urea pump, proceed to the next step.</li> </ul>
---	----------------------------	---

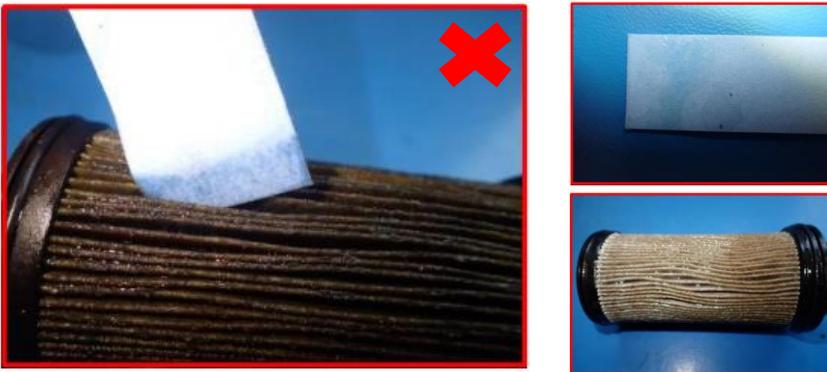
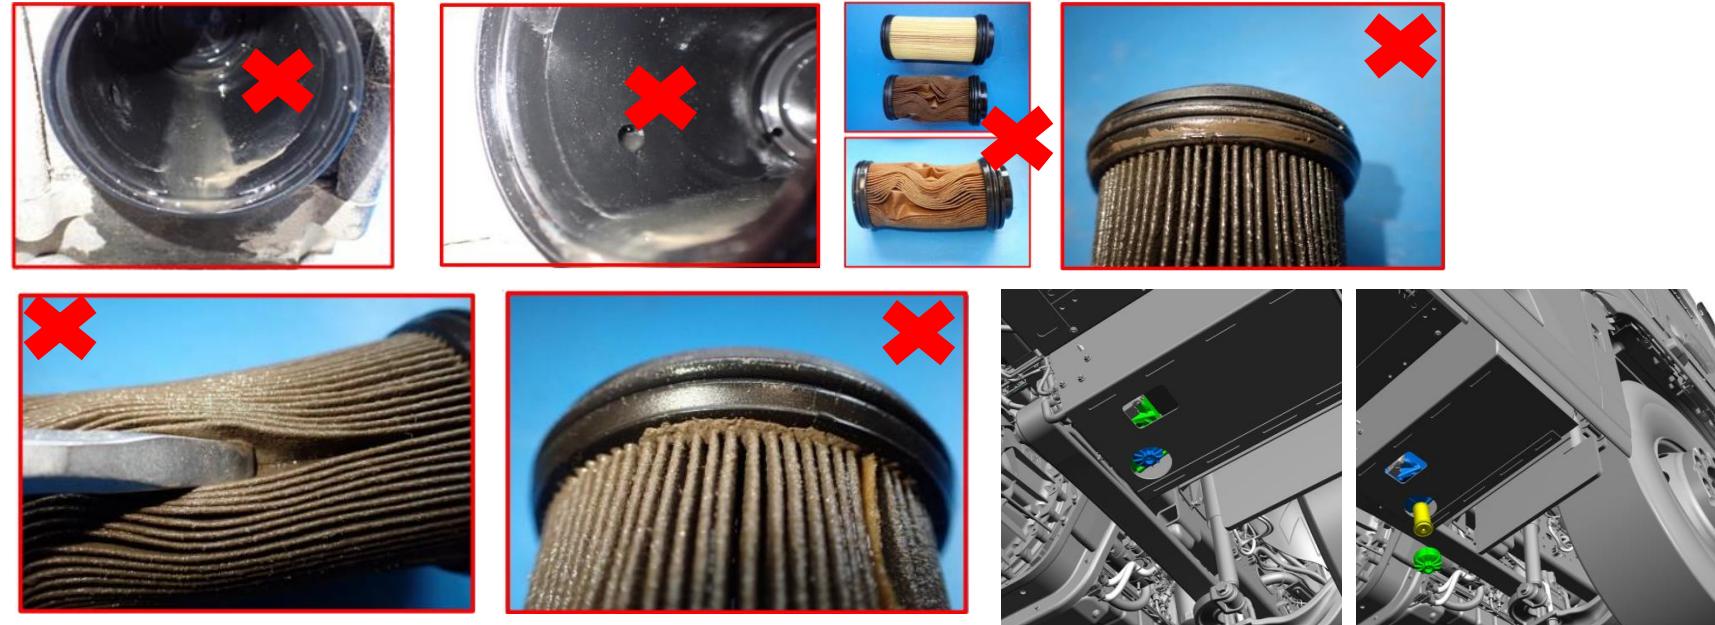
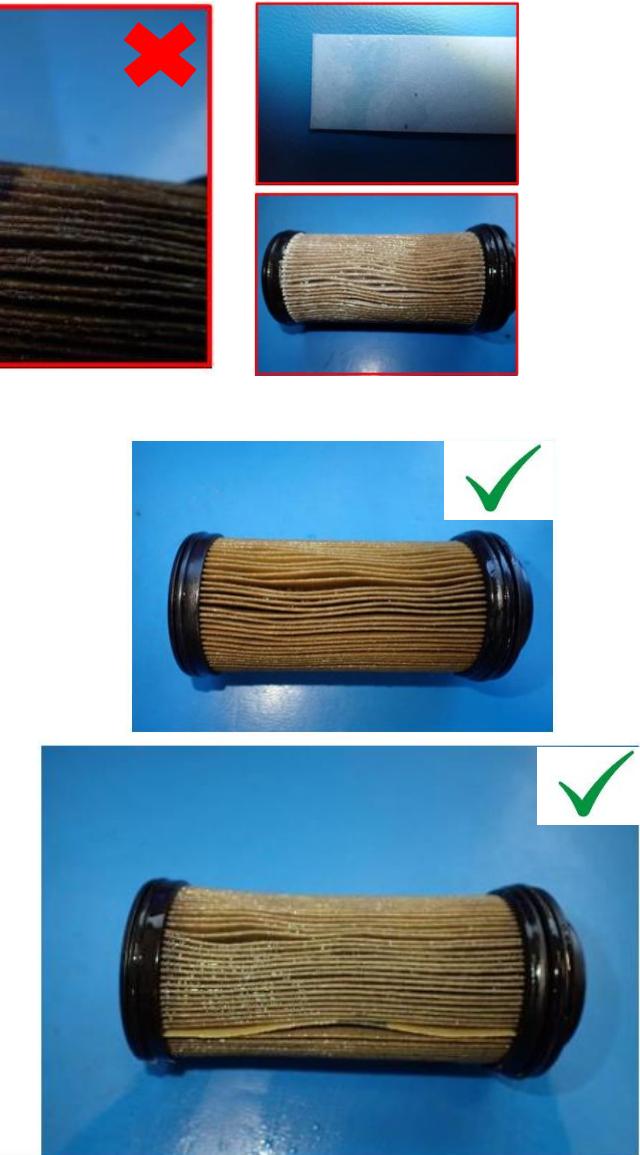
- \* Remove the urea filter (5L264) from the pump module. Inspect it for crystallization, contamination, oil/diesel ingress, or clogging (see “Contamination in Urea Filter” - Image 2).
- \* [LOG 3] Attach a photo of the removed filter to the warranty claim ticket.
- \* If contamination is observed in the filter, proceed to Step 6: DPF Regeneration Test and Functional Checks.
- \* If the filter appears clean, replace the filter and move on to the next step.

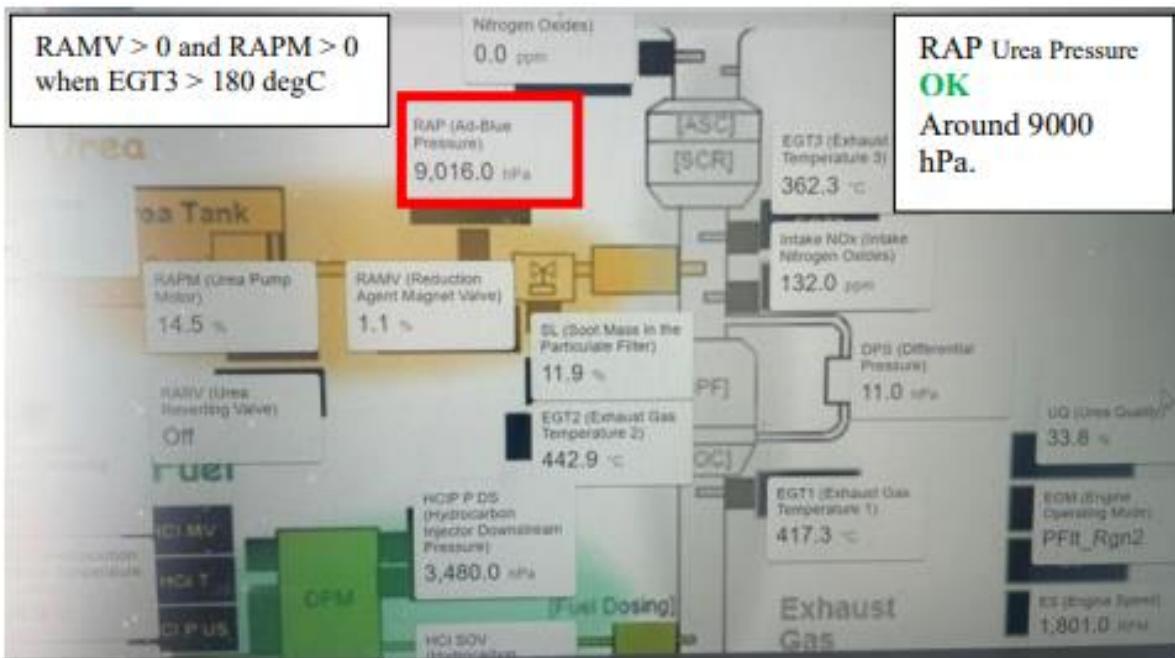
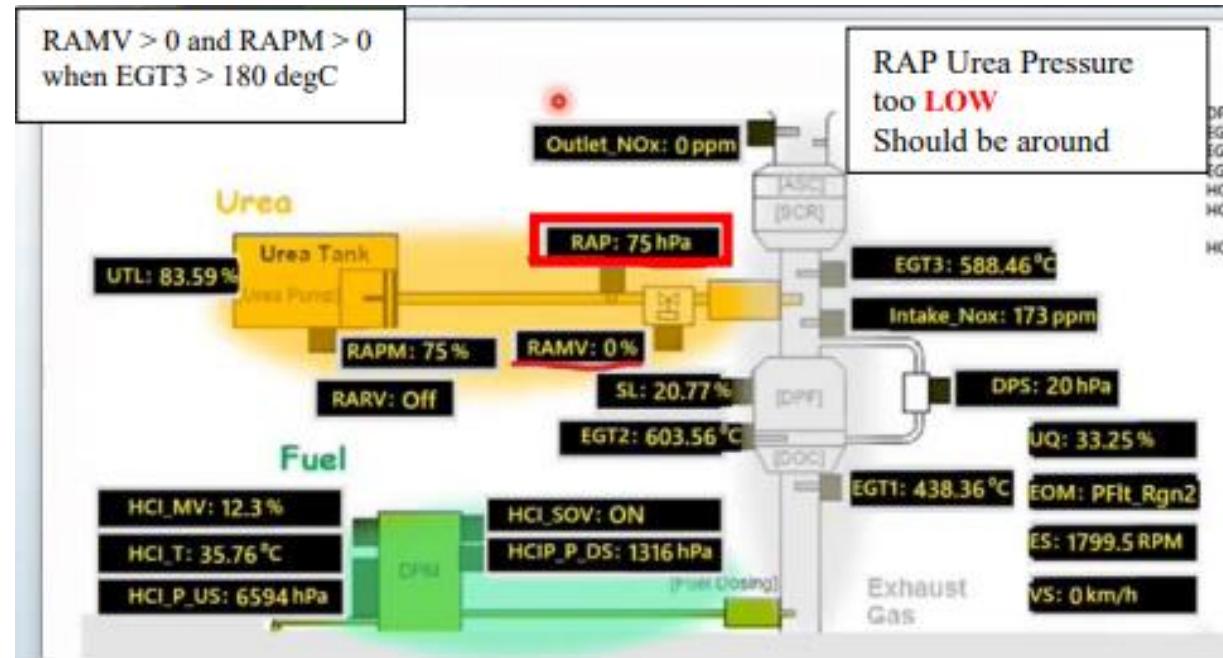
- \* Reconnect all components. Initiate the DPF regeneration.
- \* During the test, ensure there are no leaks or abnormal noise, and system pressure on the AFFT screen (RAP) approx. 9000 hPa (Image 5).
- \* [LOG 5] Take a screenshot of the AFFT screen and, after regeneration is complete, perform a new full DTC scan and attach it to the warranty claim ticket.
