*Heavy Commercial Vehicles*

| <b>Subject</b> | Front Area Oil Leak Check on Ecotorq 16S AMT Transmissions |
| <b>Model</b> | GEN 1.5 and GEN 2 Vehicles |
| <b>Summary</b> | Inspection and part replacements to be performed if oil leakage is detected in the front section of the transmission. |

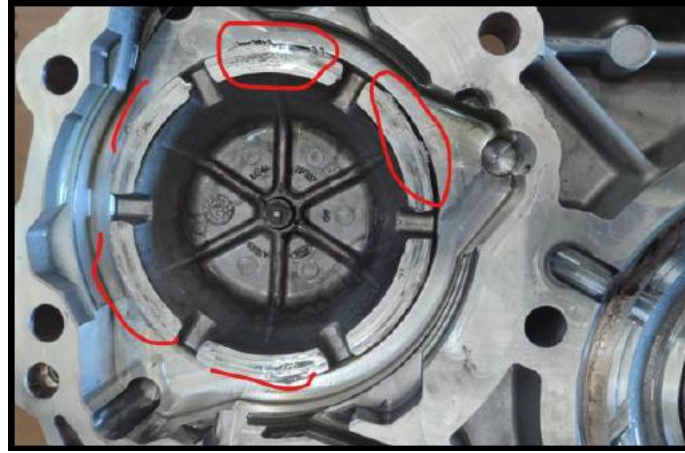
*\*According to observations, if the layshaft (auxiliary shaft) brake piston and seal are heavily lubricated, it is recommended to replace the following parts.*

- LC46-7P303-A – Replace the auxiliary shaft brake piston seal if it is lubricated and deformed as described above.
- PC46-7D289-A or SC46-7D289-A – Replace the entire front cover kit if there is wear.
