SERVICE PROCEDURE

REFERENCE:FSA 202315A/B

SUBJECT: ECM Update of Gen1.5 Vehicles due to Air Conditioning Pressure Switch Misinformation

FSA TYPE: Next Service Visit

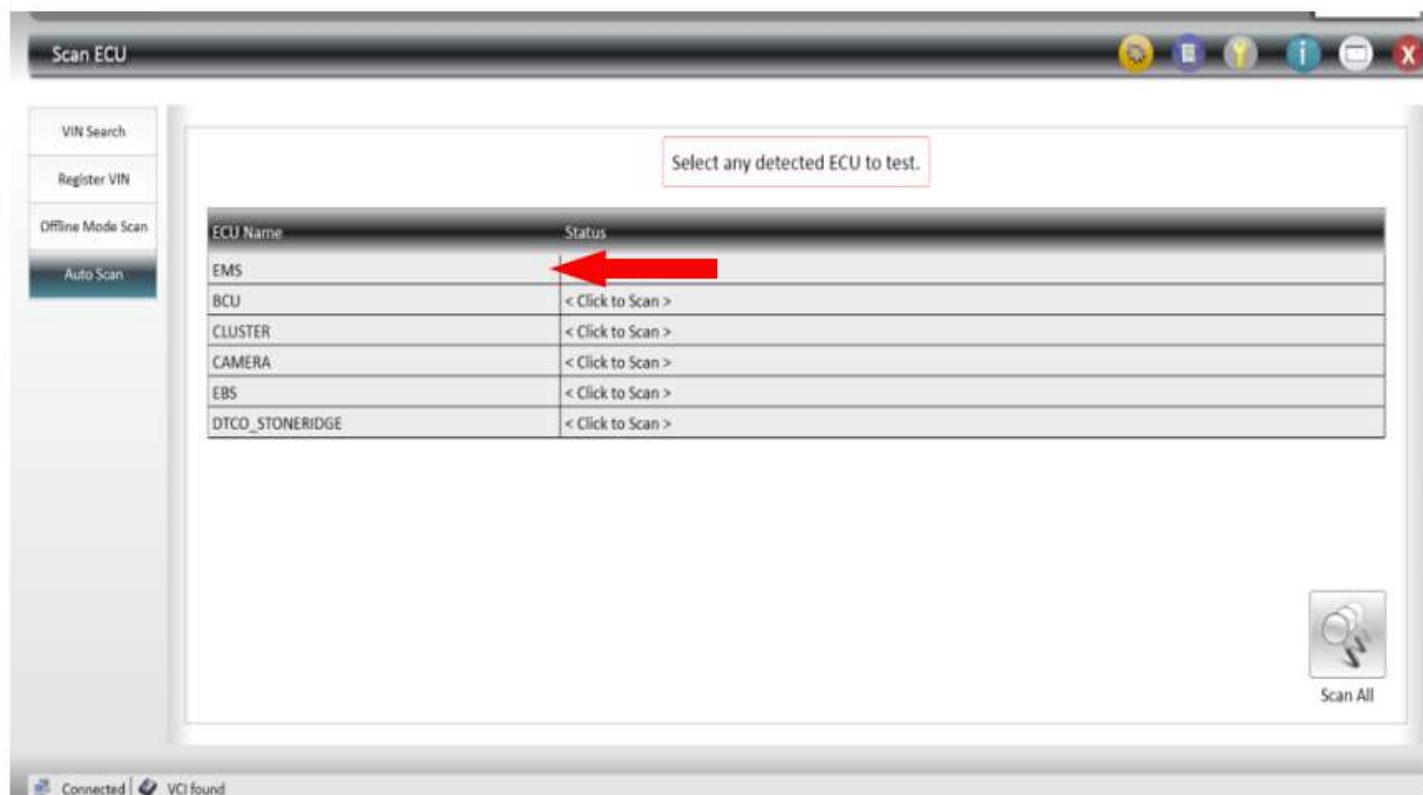
- After running the program click on the “Search Module” button and go to the page which defines vehicle modules “Module Choosing Menu”. On this screen, operation needs to be done on the EMS module. Below screenshots are belong to FODP2 Lite but this process **can be performed via FODP2 Lite or FODiT.**

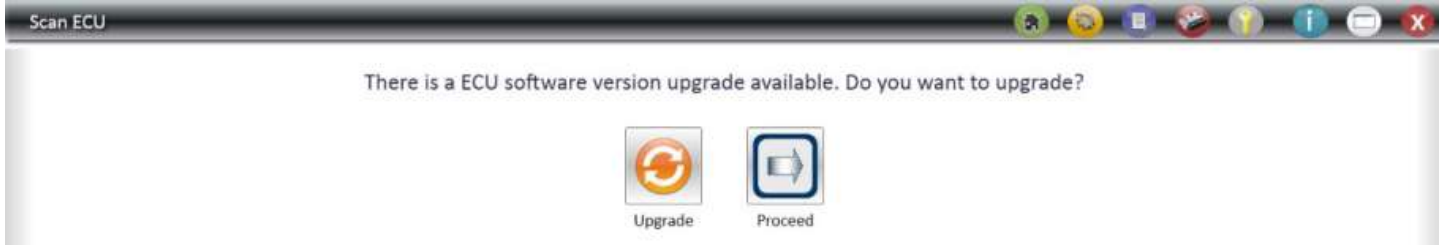
- After completing the required connection please go to the EMS module and if you see below screen, please click "Update" button. If there is an update for the program, this process could be take 1-10 minutes. Please do not touch to the computer during this process and be sure that internet connection and battery is in good condition.

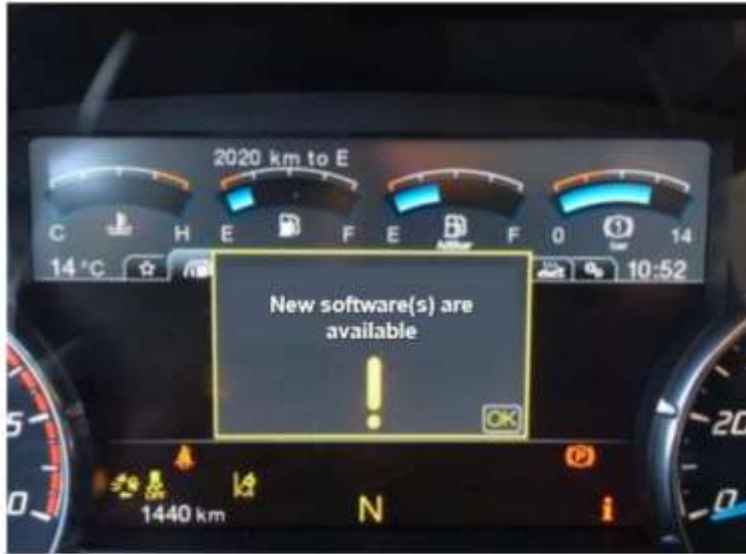
- In vehicles with ConneCTruck feature, remote software is sent to related vehicles automatically in the background.
- When the first ignition is switched on after the software is downloaded to the vehicle, the message "New software updates are available" is displayed on the instrument panel.

- This message will be displayed as a reminder each time the ignition is switched on if the software update process has not been started in the vehicle.

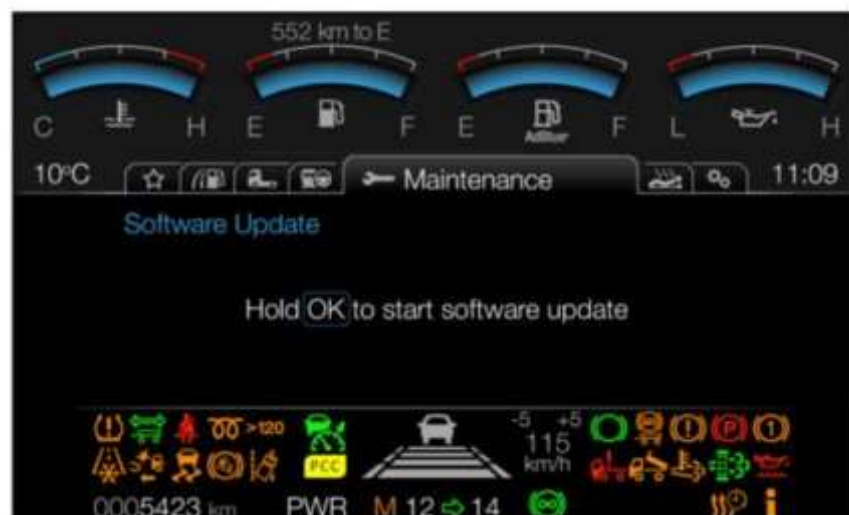
5. The related sub-menu shows the number of pending software updates

- In order to start the software update process, it is necessary to enter the "Software Update" submenu under the "Maintenance menu".

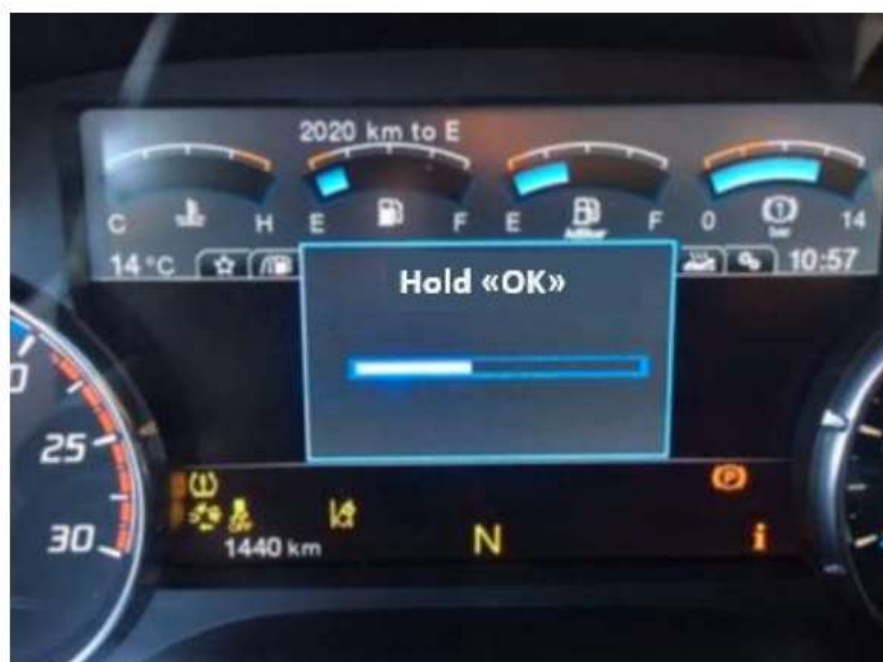
6. In order to start the software update, the vehicle is stationary, the parking brake is applied, the ignition is in the 2 position and the engine is not running, press the "OK" key for 5 seconds and release the OK button when the progress bar is full.

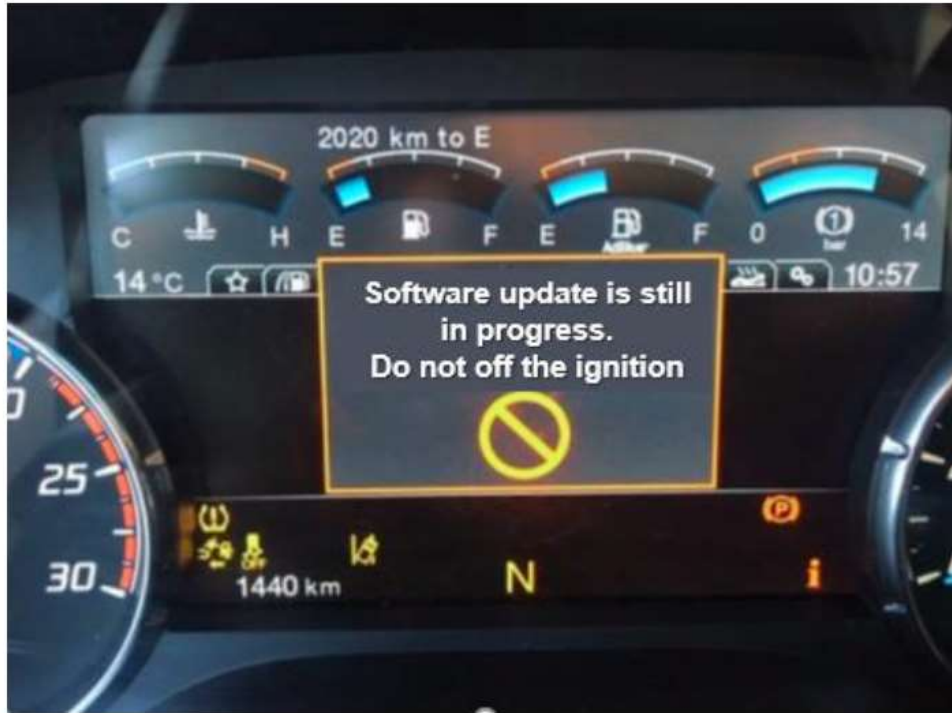
7. Within 1-2 seconds, an information message that the software update is continuing appears on the screen.

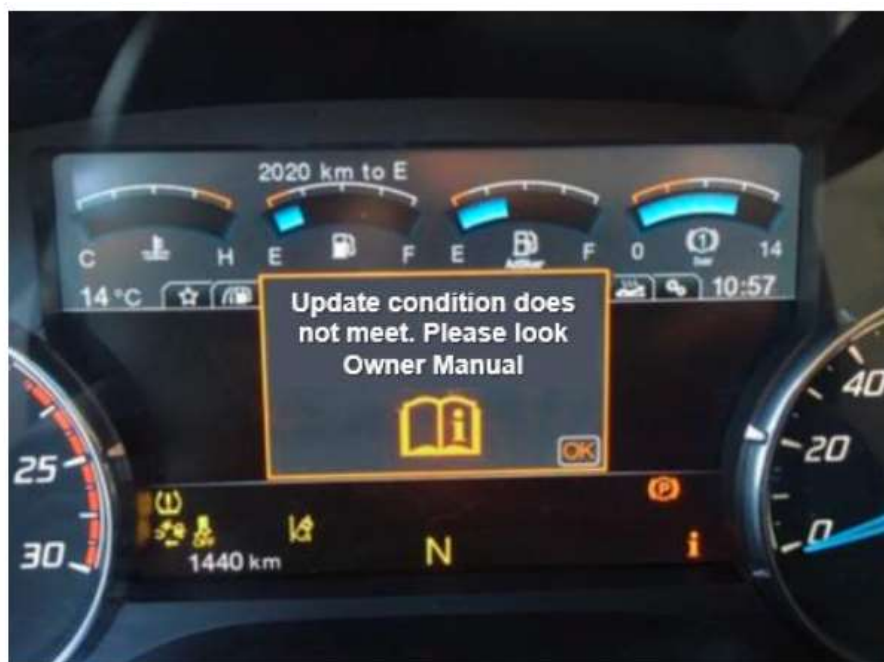
9. In the meantime, information messages on the instrument panel are monitored.

10. While the process is in progress, do not start the engine or turn off the ignition until you see the message "Update successful"

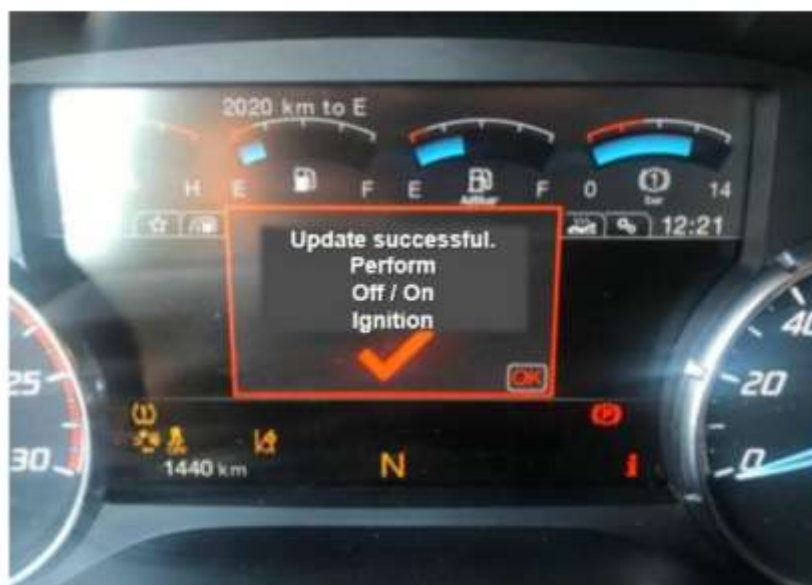
12. If the software update process is successful, the number of pending software updates will be updated after the relevant notification.

The above update successful message will appear on the display panel for 5-15 seconds and will disappear automatically. Do not turn off the ignition during this time and wait for the message to disappear. After a certain period of time after the message disappears, the contact can be turned off and on.
