**Heavy Commercial Vehicles**

<b>Subject</b>	Installing of Parking Cooler
<b>Model</b>	H625
<b>Abstract</b>	In case the installation of a Parking Cooler it should be assembled as specified in the Service Procedure section.

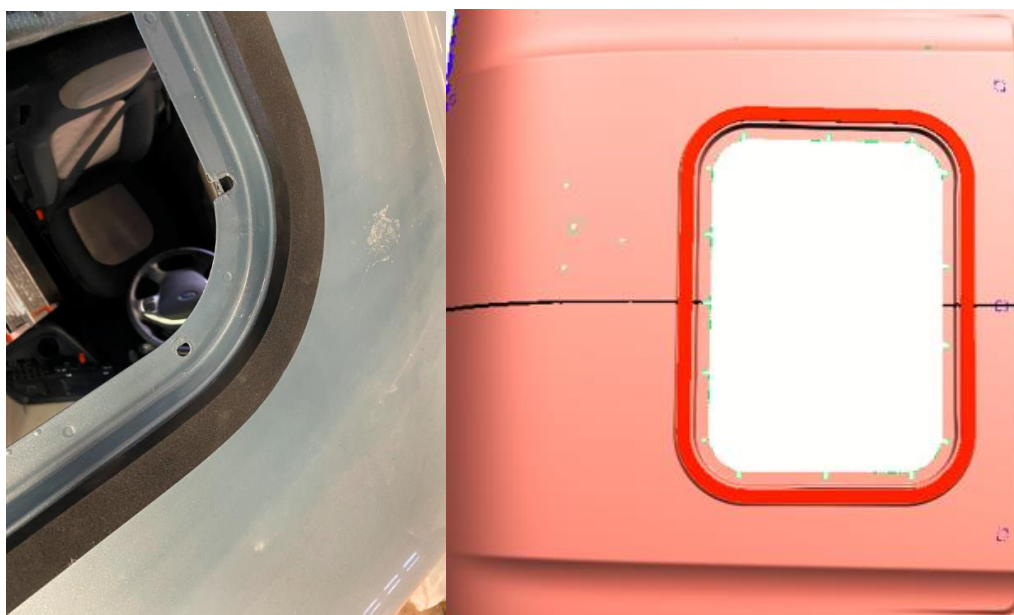
**Figure 2: Sealing gasket**

The sealing gasket will be attached to the area on the ceiling roof as shown in Figure 1 & 2 without leaving any gaps.

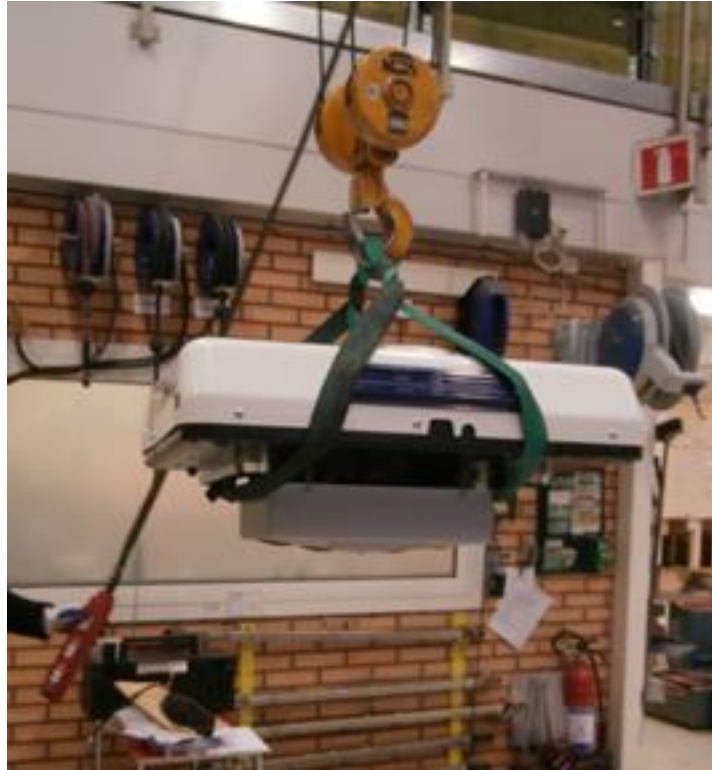
**Figure 3 : Carrying the parking cooler on the car top**

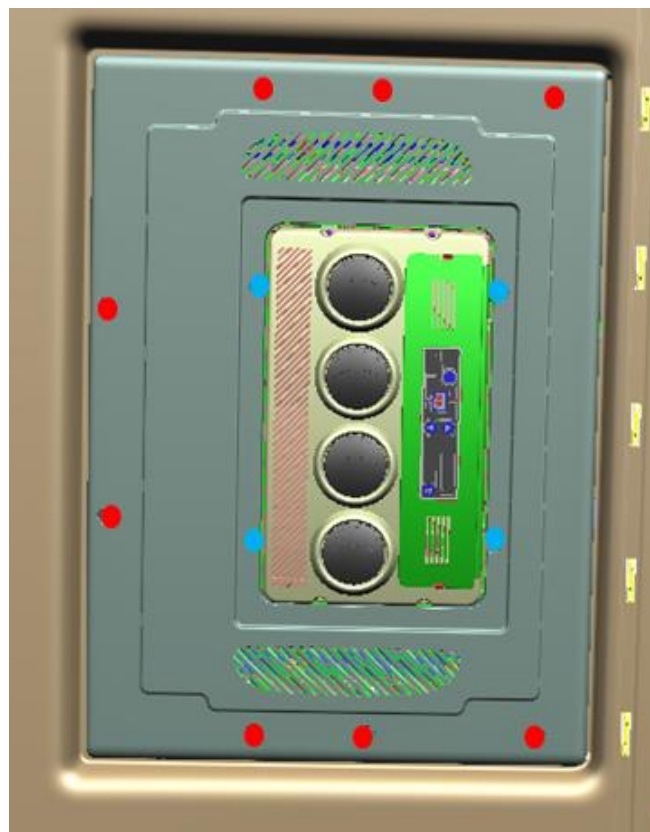
**Figure 12: Bezel**

The bezel shown in Figure 12 will be attached and the bolts will be tightened. The bolts shown with a red colour will be torqued to 1.5 Nm and the ones with blue colour will be torqued to 4.1 Nm.

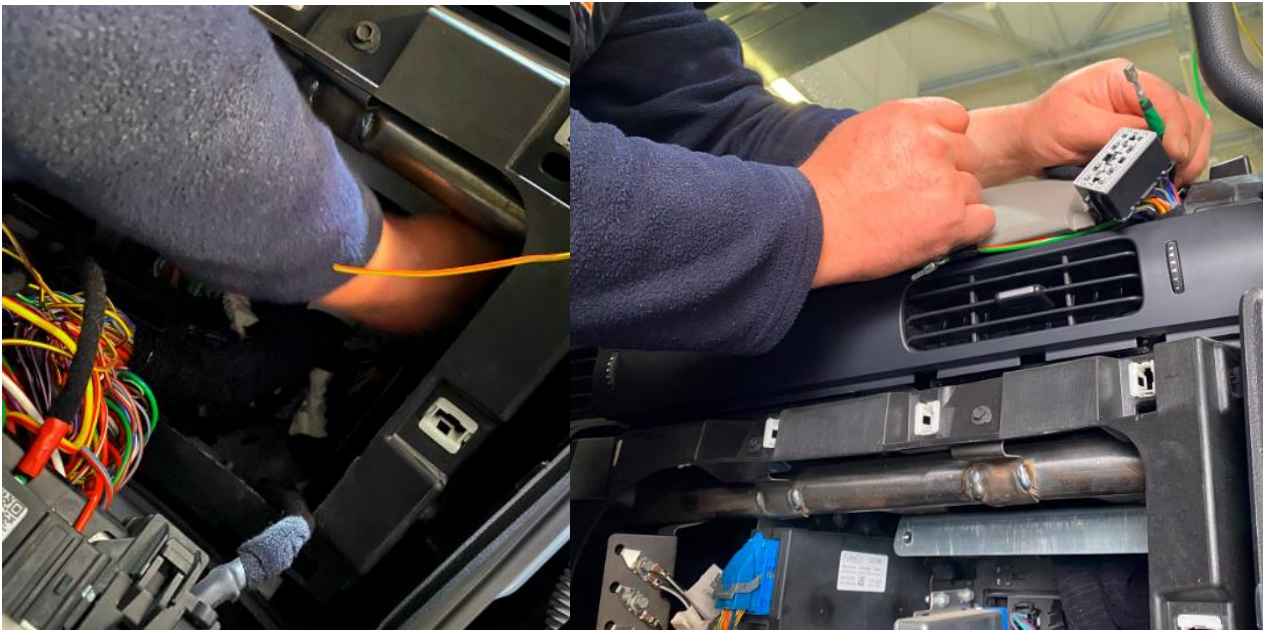
- 3) The other end of the kit should be led to the inline connector (C22-A2) of the roof installation over the console installation that is located in the area where the console and right A-pillar are combined. It should be attached

to the slot no 30. During this process, a strap should be attached every 15-20 centimetres. A 6 mm2 cable with the correct terminals printed on both sides and wrapped with fabric tape, will come out from the kit.

**Figure 16: Leading the other end of the kit to the inline connector**

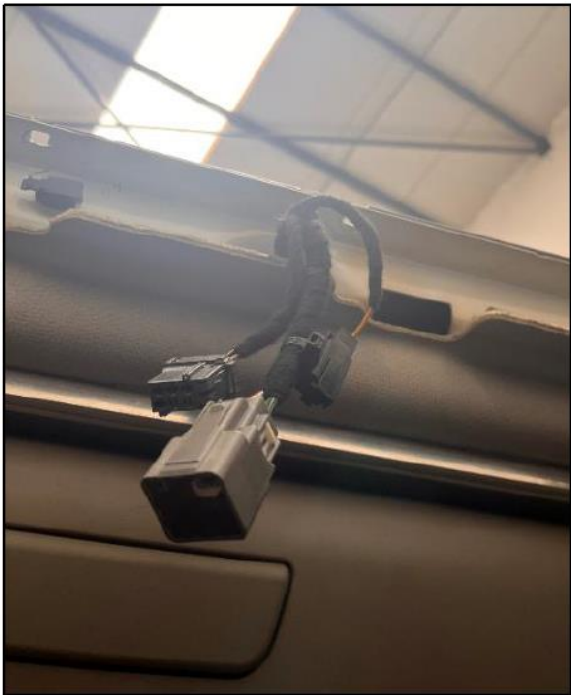
- 4) It should be checked whether there are two connectors as shown in Figure 17 where the parking cooler connections will be plugged in the roof area where the parking cooler is installed. If the connectors are located in the existing roof installation, the connectors of the parking cooler will be plugged into the existing matching connectors on the roof, and the electrical connection will be provided.

PIN	CIRCUIT	COLOR	WIRESPEC	TPM	TERM FPN	LEVEL
1	SBB66P	YE/RO	2TAD-0.75	(SN)	1L2T-14421-AA	(ALL)
2						
3

PIN	CIRCUIT	COLOR	WIRESPEC	TPM	TERM FPN	LEVEL
1	SBB04D	GN/RO	2TBD-6.0	(SN)	XW4T-14421-EA	(ALL)
2						
3						
4	GD351A	BK/GN	2TBD-6.0	(SN)	XW4T-14421-EA	(ALL)

**Figure 17: Roof connectors where the parking cooler connectors will be plugged**

\*\* Preparation of electrical installation for parking cooler is available in all F-MAXs manufactured after 2020 LP2 (01.07.2020). The locations and images for roof connection connectors of parking cooler on the vehicle are shown in Figure 17.

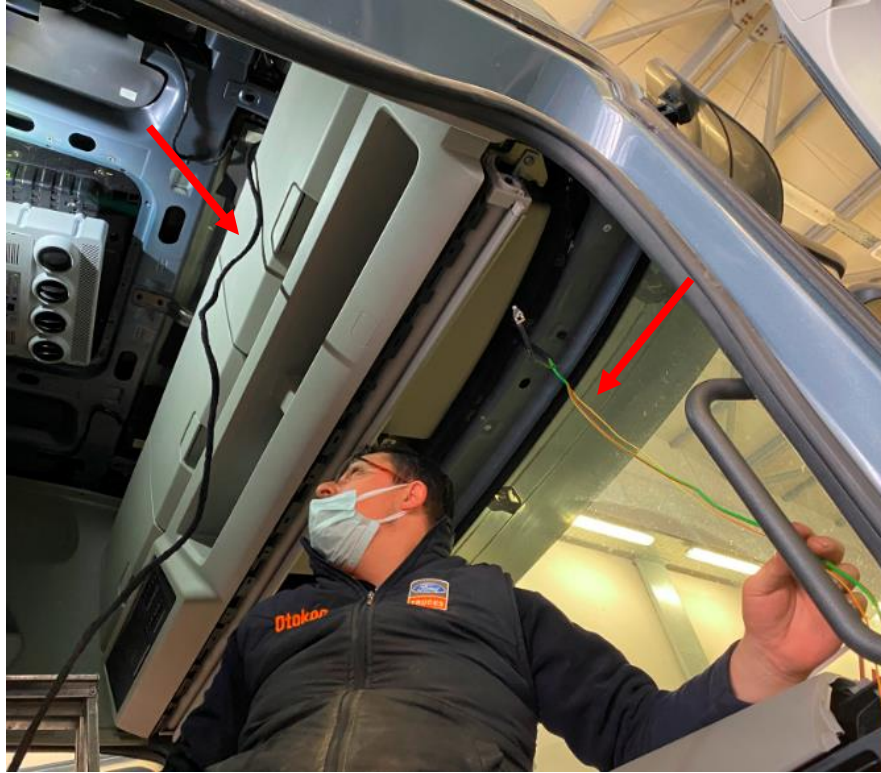
- 5) When parking cooler connectors are not available in the roof area of the vehicle, the kit with part number MC46-14293-EA should be ordered. Among the cables coming out from the kit no. MC46-14293-EA, the terminal end of the long cable should be attached to the pin no 30 of the console inline connector (C22-A1) of the roof installation. The 1.5 mm<sup>2</sup> cable in the same part and the cable without a terminal at the end should be entered in addition to the cable on the pin no. 39 of the roof installation - console inline connector (C22-A1).

**Figure 18: Bypass of the cable from the roof rack**

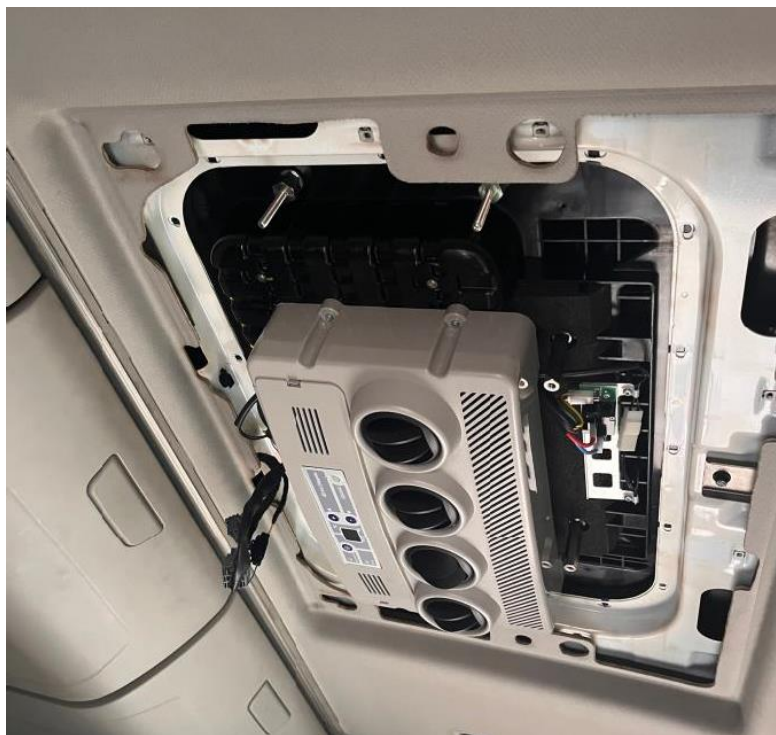
**Figure 23: Installation of parking cooler**
