**INTRODUCTION**

A decision has been made to implement an FSA for Gen2 and Gen2 MCA vehicles regarding the following issues:

**FSA 202521A:****Service Implementation:**

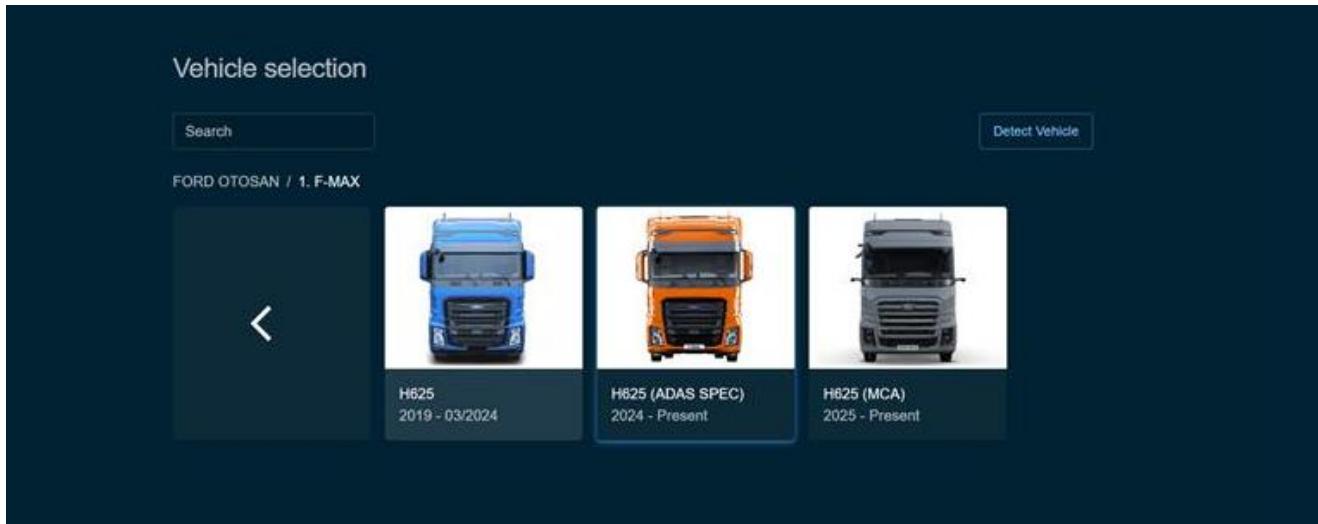
1. The vehicle should be connected using **FODIT**.
2. After launching the program, click the “**Search Module**” button to access the “**Module Selection Menu**” page, where the vehicle modules are listed. On this screen, the operation must be performed on the **ECM module**.

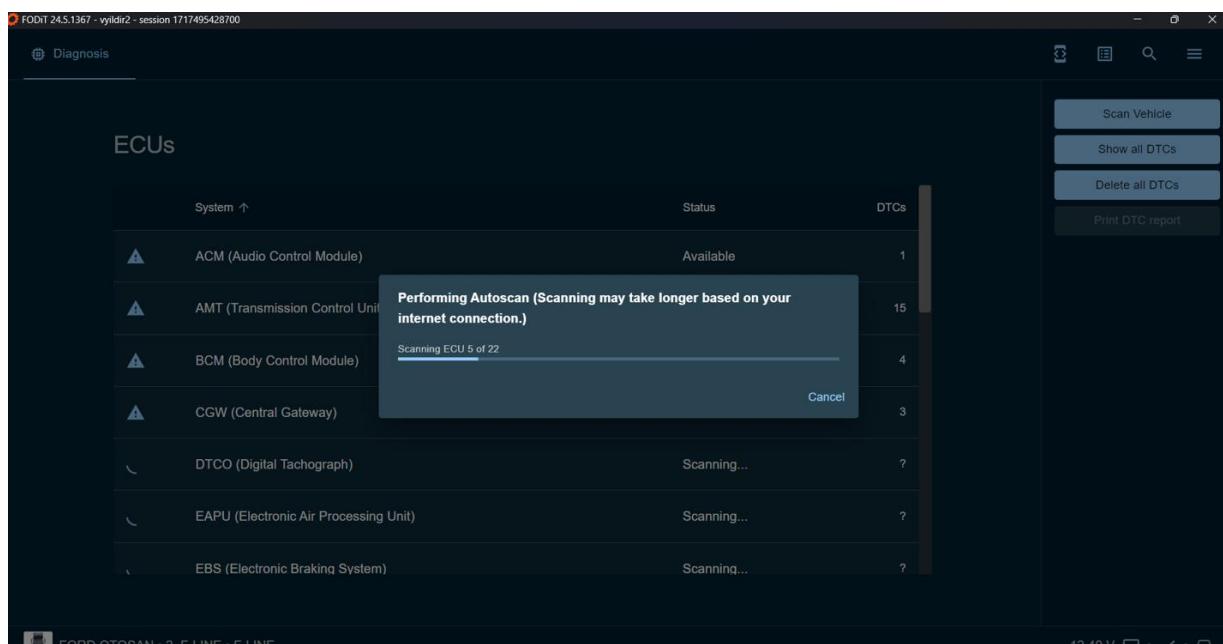
3. After completing the required connection please go to the ECU module and if you see below screen, please click “Scan Vehicle” button. If there is an update for the program, this process could be take 1-10 minutes. Please do not touch to the computer during this process and be sure that internet connection and battery is in good condition.

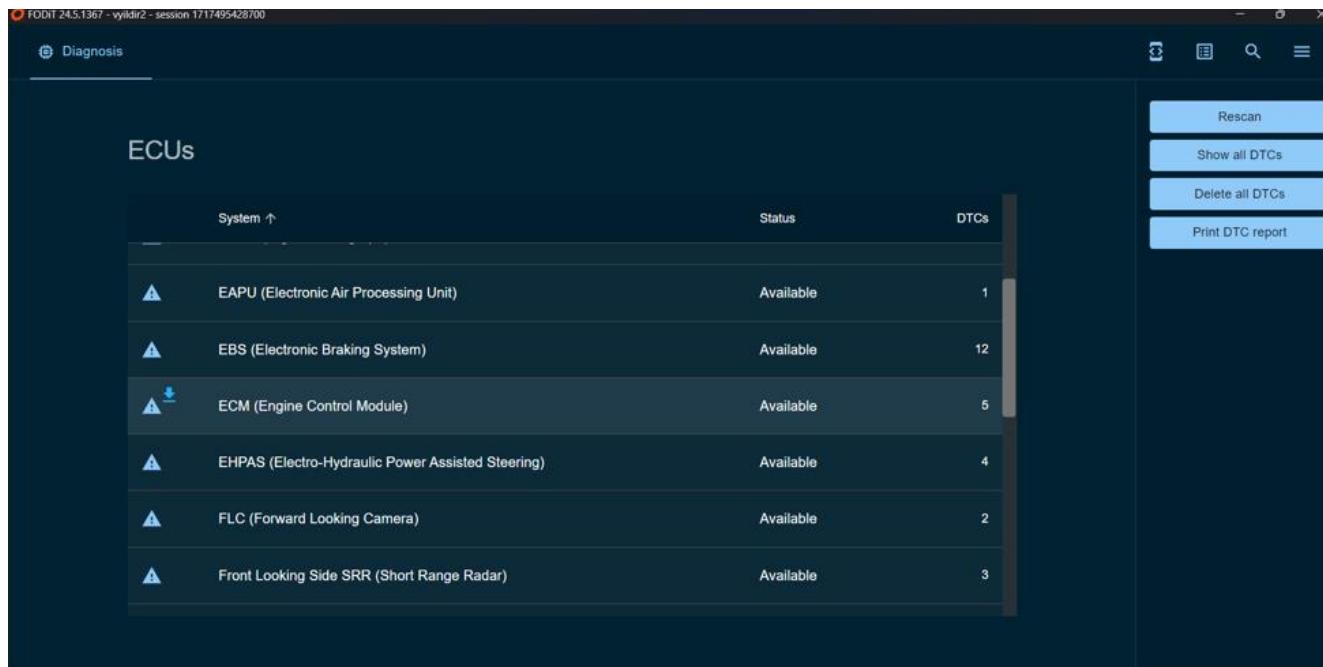
4. Please select “ECM (Engine Control Module)” button.

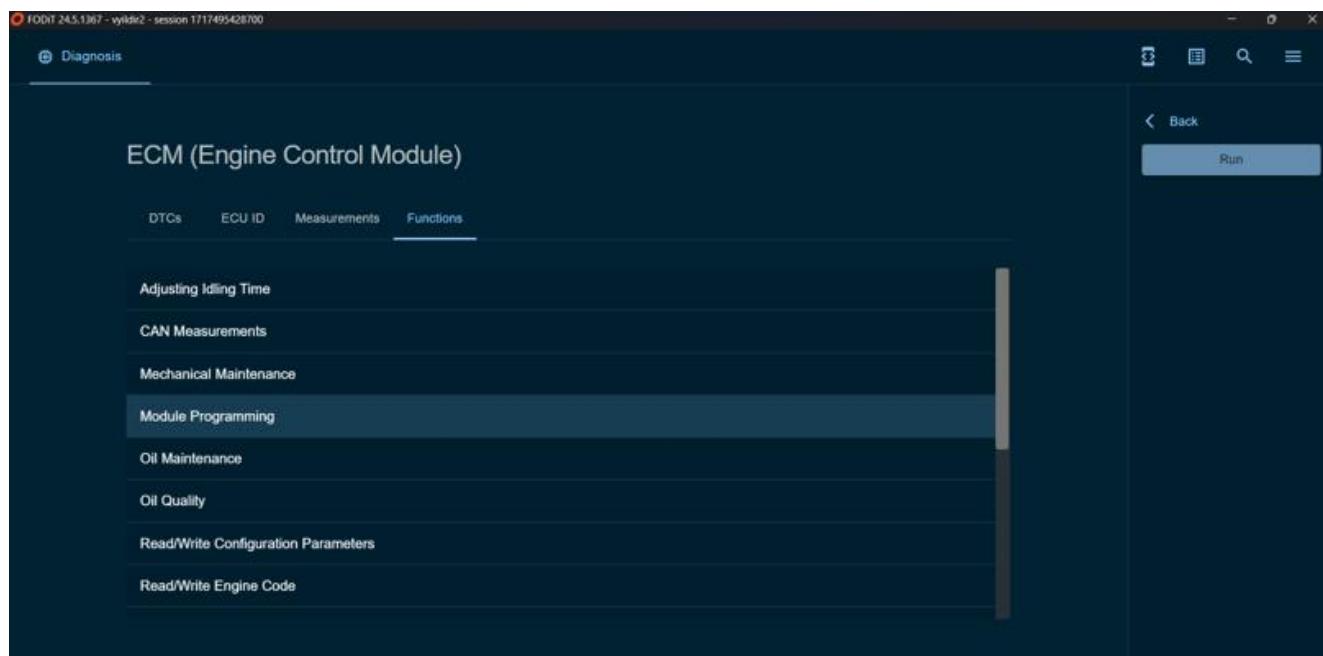
5. Select “Module Programming” button and then press “Run”.

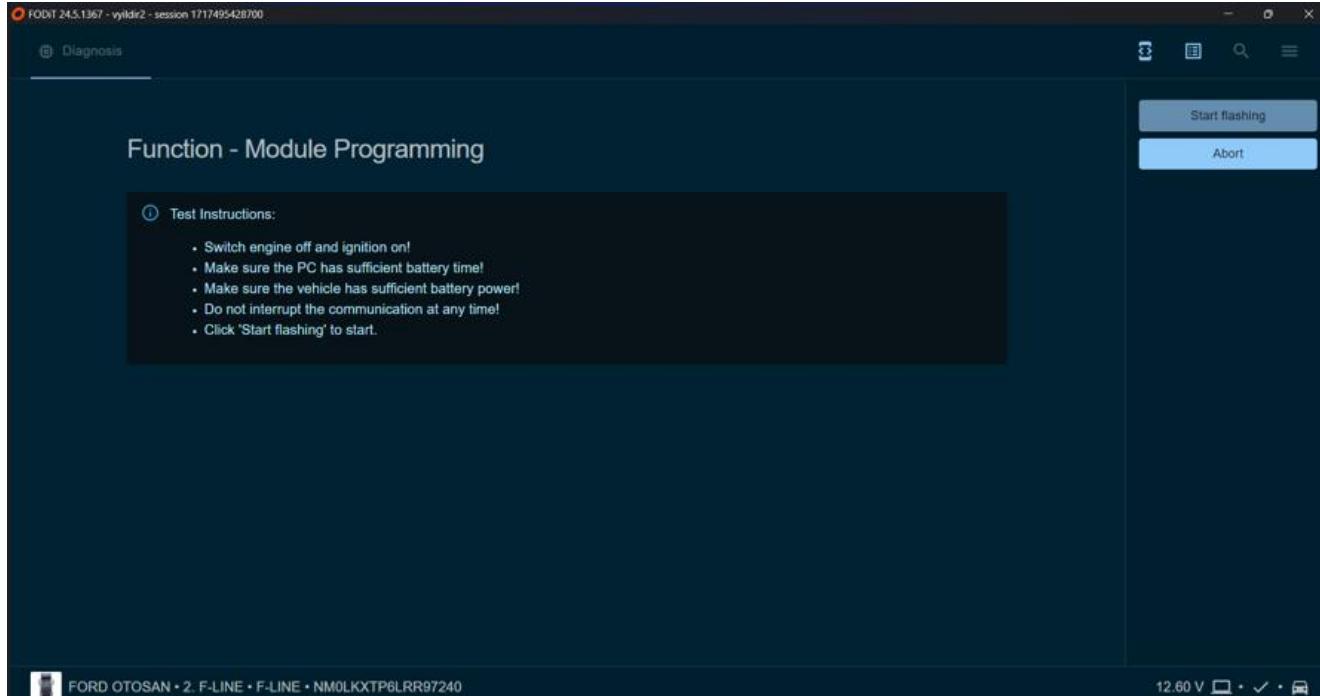
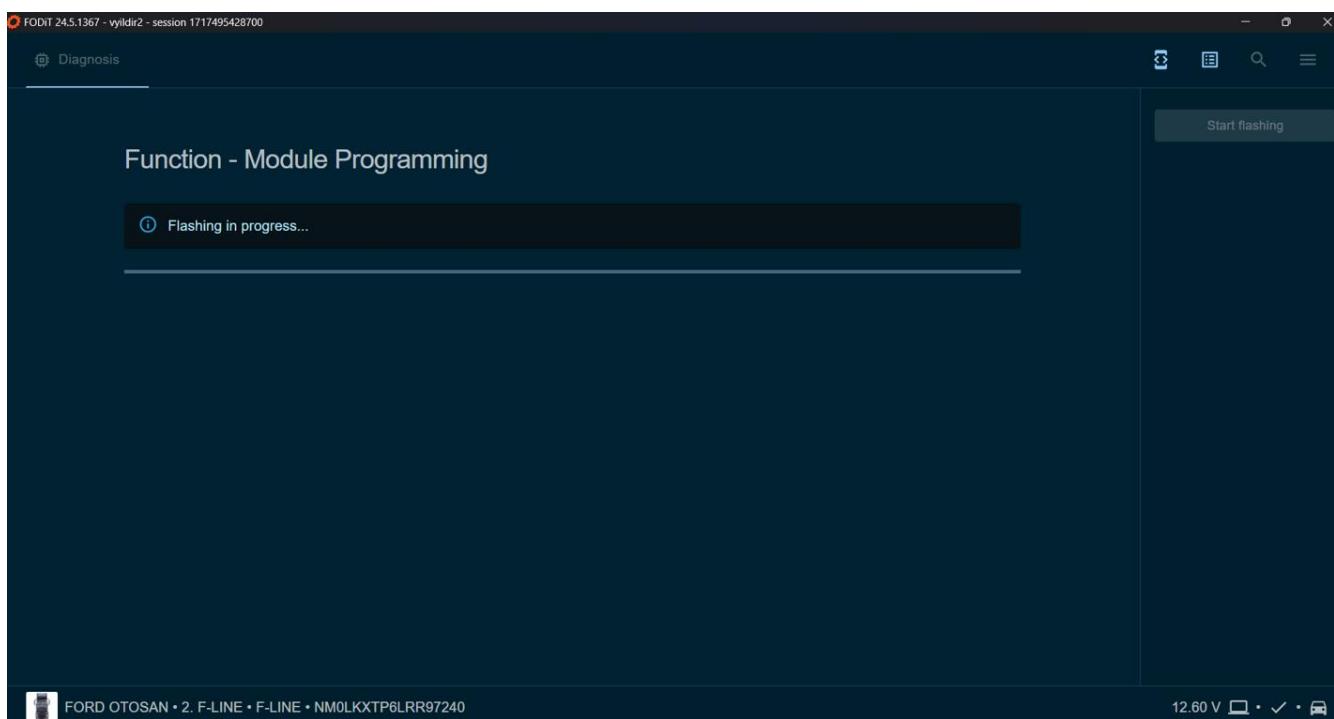
6. Select "Start Flashing" button.

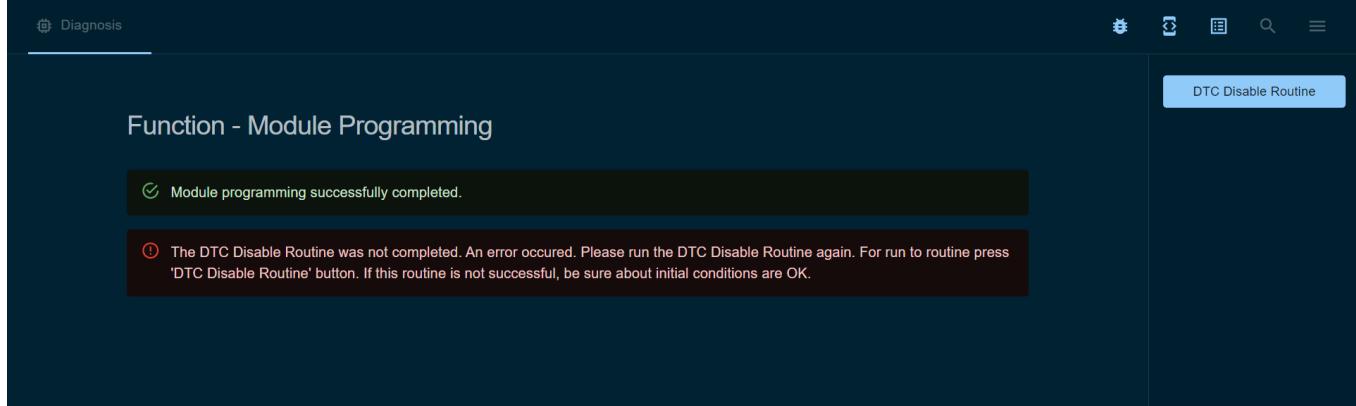
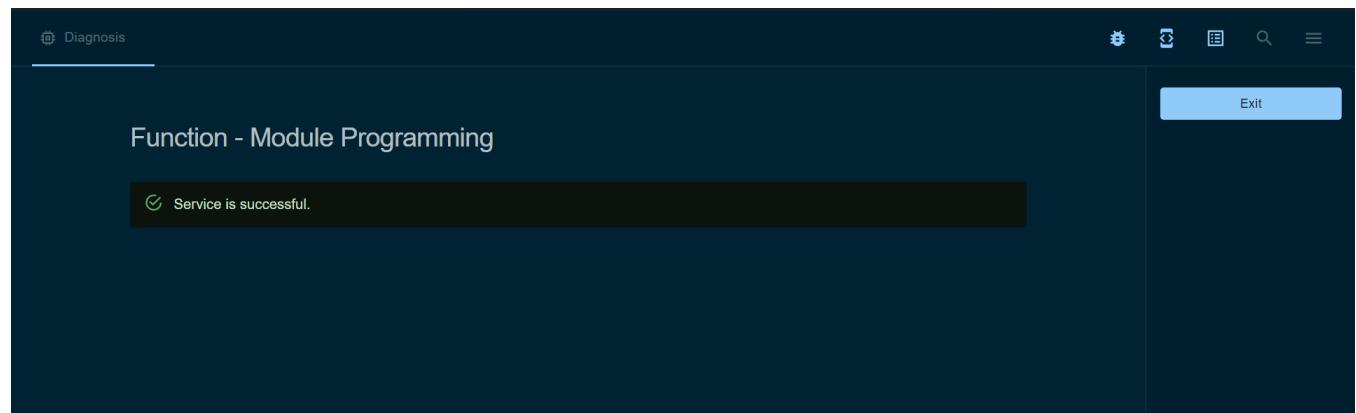
7. If the DTC Disable Routine was not completed, please retry DTC Disable Routine.

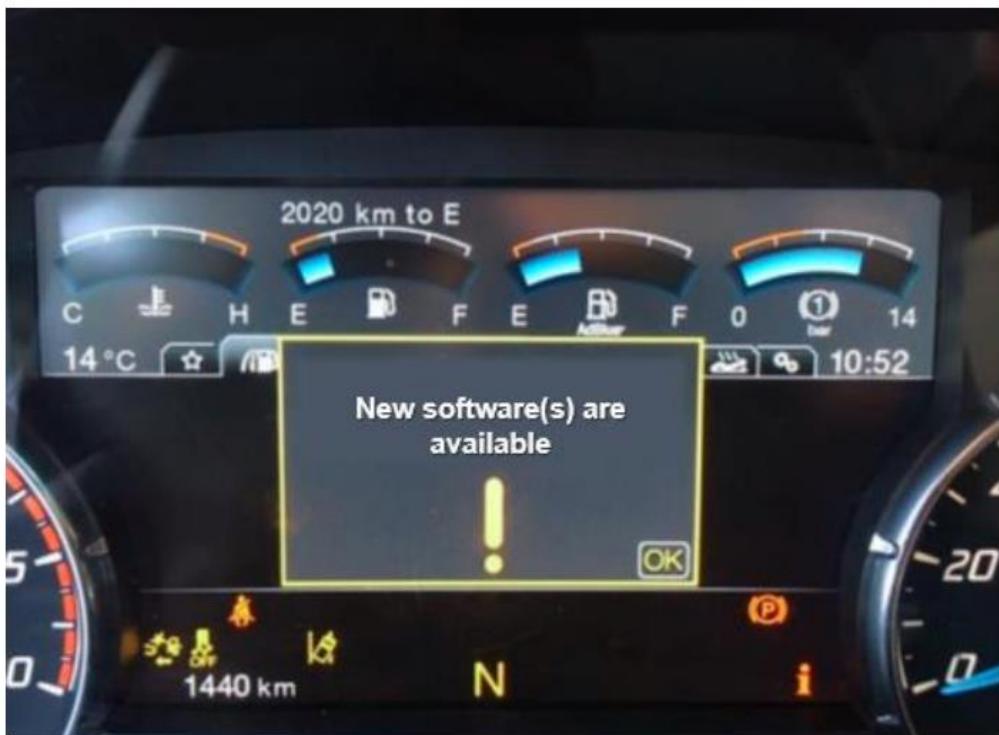
1. In vehicles with ConnecTruck feature, remote software is sent to related vehicles automatically in the background.
2. When the first ignition is switched on after the software is downloaded to the vehicle, the message "New software updates are available" is displayed on the instrument panel.

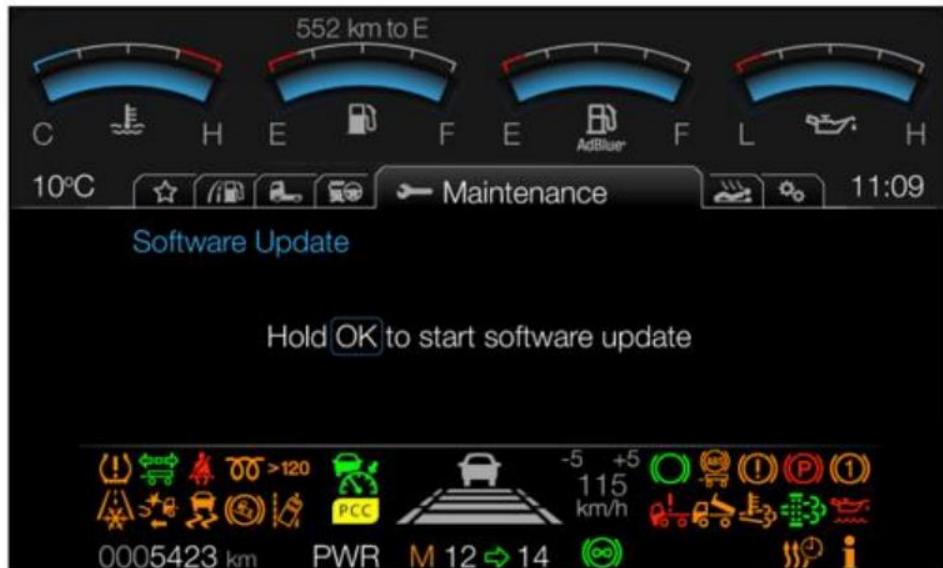
5. The related sub-menu shows the number of pending software updates

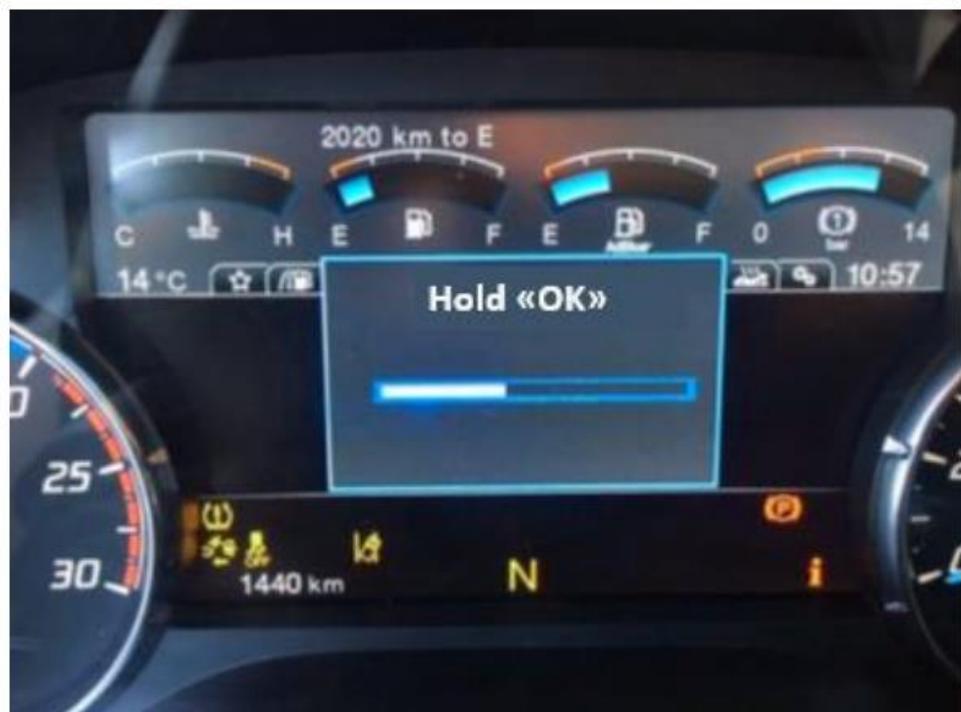
6. In order to start the software update, the vehicle is stationary, the parking brake is applied, the ignition is in the 2 position and the engine is not running, press the "OK" key for 5 seconds and release the OK button when the progress bar is full.

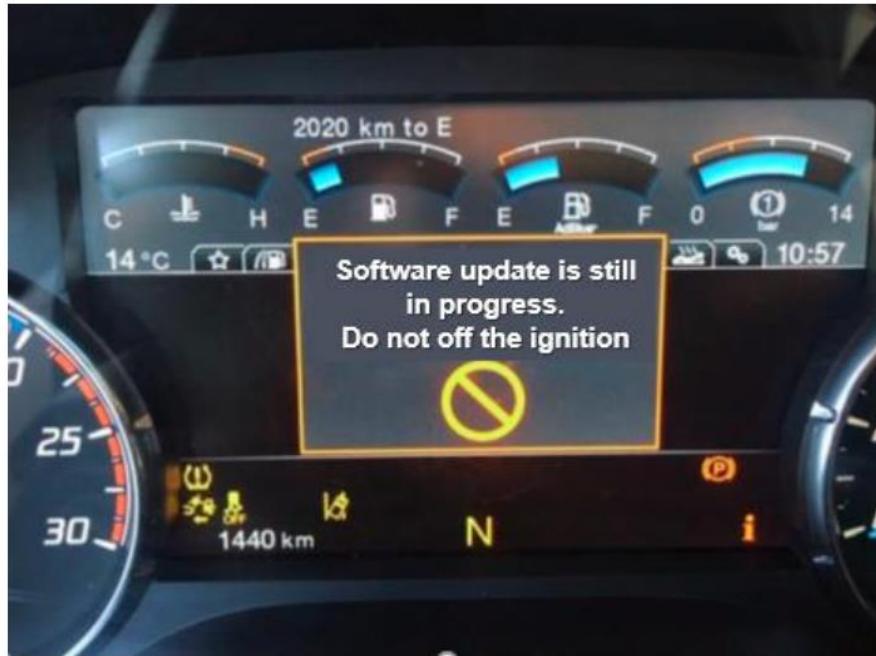
7. Within 1-2 seconds, an information message that the software update is continuing appears on the screen.

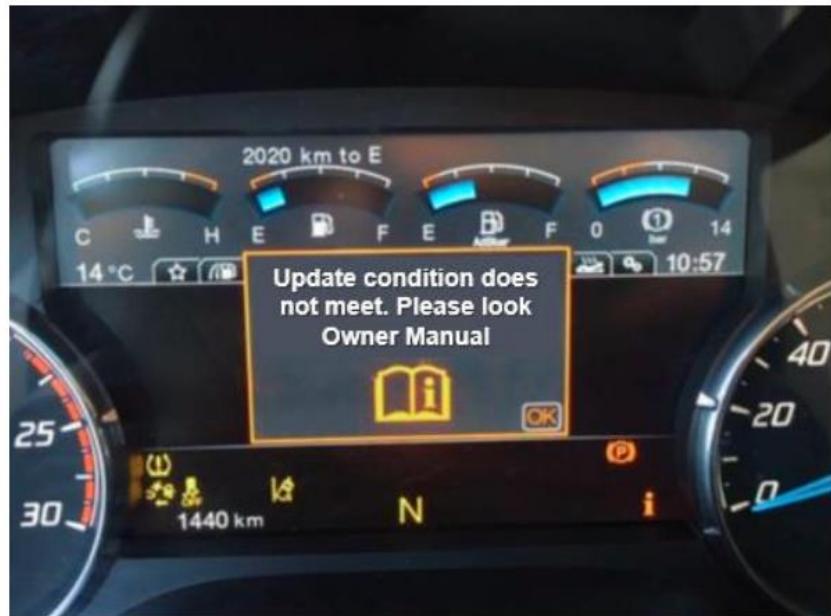
11. If the software update process fails for any reason, the process is terminated with the relevant notification message. In such cases, the software update process can be started from the beginning by following the same steps.

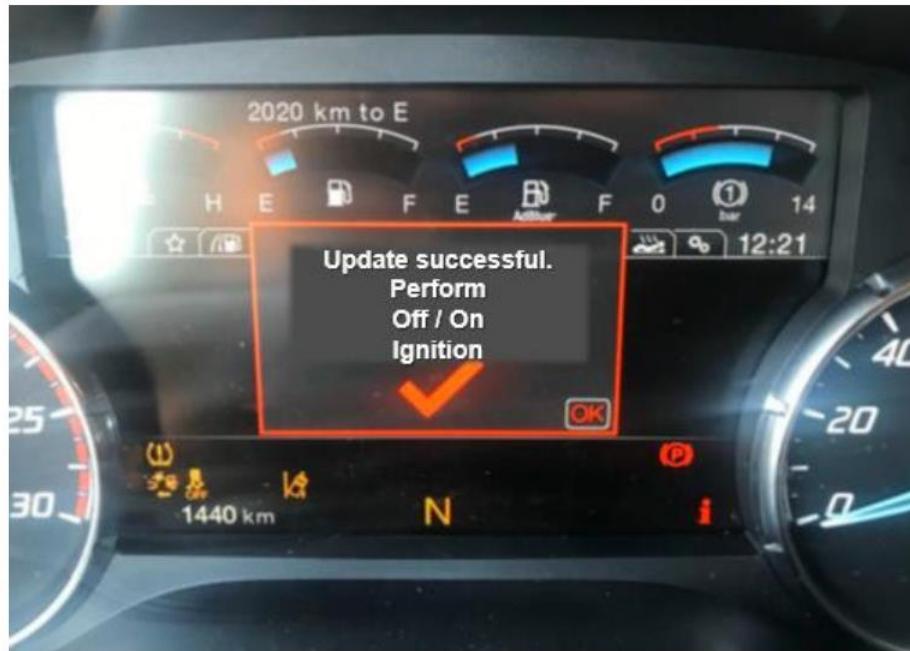
12. If the software update process is successful, the number of pending software updates will be updated after the relevant notification.

The above update successful message will appear on the display panel for 5-15 seconds and will disappear automatically.
