TECHNICAL SERVICE INFORMATION No. 01/2021

Heavy Commercial Vehicles

Subject	Installation of Float Filter Kit on Eu6 Vehicles with Short Urea Tank
Variant	On Eu6 Vehicles with Short Urea Tank
Abstract	On vehicles with float with a VIN number between LA93126 – LL97063 where urea quality is low error is received, the installation of the filter kit shall be performed as specified in the service application.

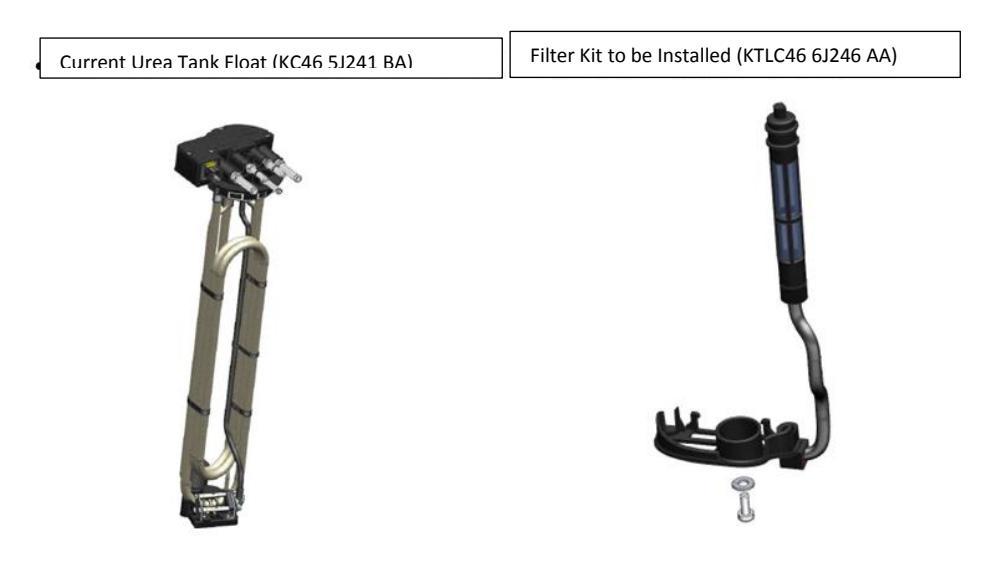
• KTLC46 5J249 AA kit includes 1 filter, 1 bolt and spring washer and a plastic clamp.

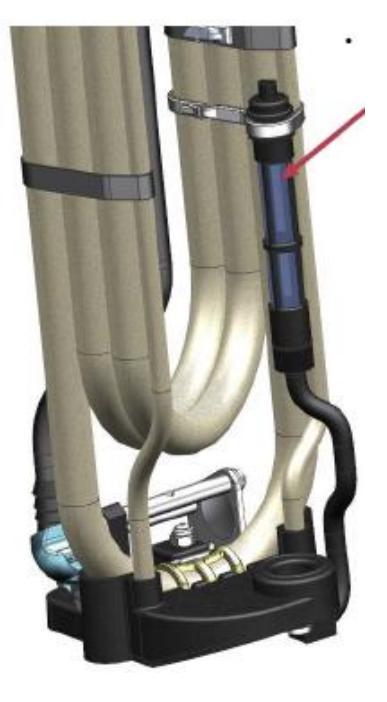
• Installation Condition of the New Filter Kit in the Urea Tank Float

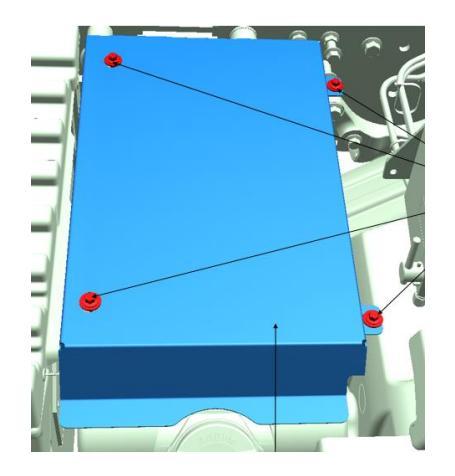
- 2- The urea tank surface shall be cleaned with water before removing the urea float. It shall not remain dirty. Otherwise dust may enter the tank and may cause other errors on the vehicle.
- **3-** Some models have a protective cover on the urea tank. This cover shall be removed together with 4 screws shown on the figure.

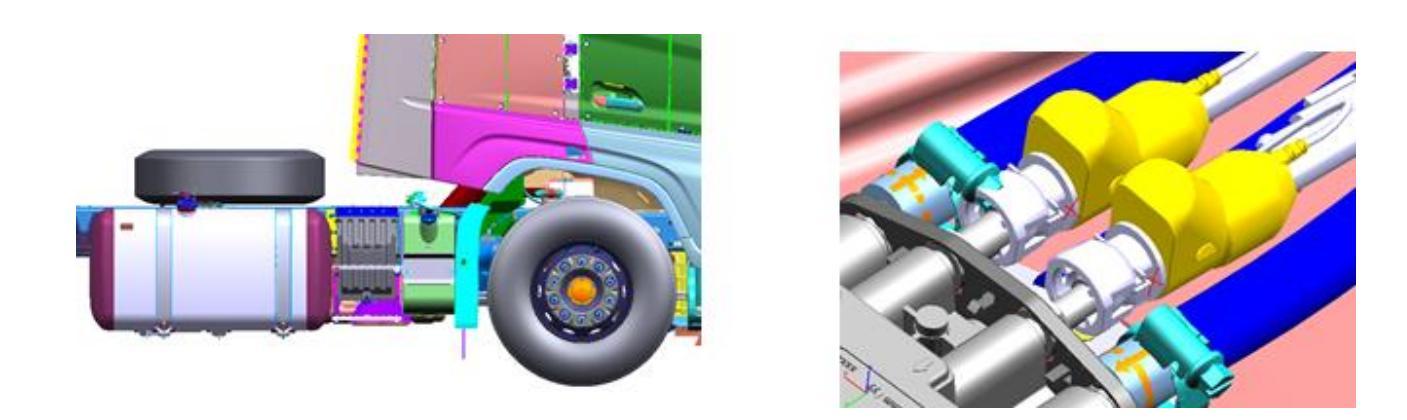
4- Tighten the urea line inlet and outlet connectors on the float from the tabs on two sides as marked on the figure and pull them to the reverse direction of the float. It is normal that some urea drips.

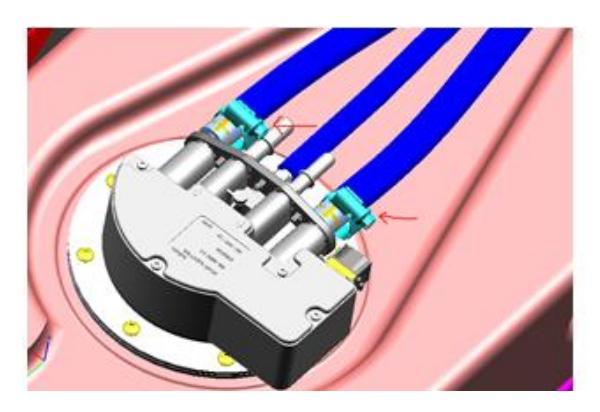
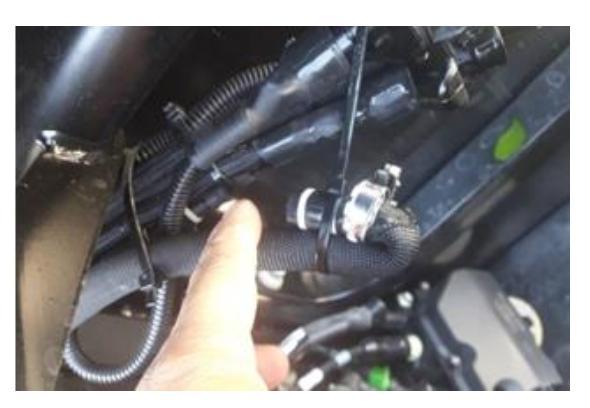
5- Loosen the clamps of the water line inlet and outlet hoses on the float and remove the water hoses. After performing this operation, bend the cooling line quickly to prevent draining of coolant completely; it shall be blanked by tightening with straps from the bending points.

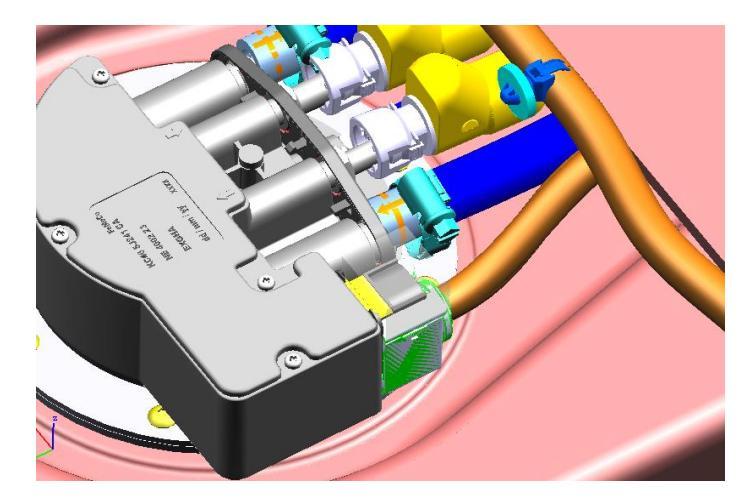
6- Pull the yellow clip on the urea float upwards in the direction of the arrow from its tabs and detach the electric connector from the float in the direction of the arrow.

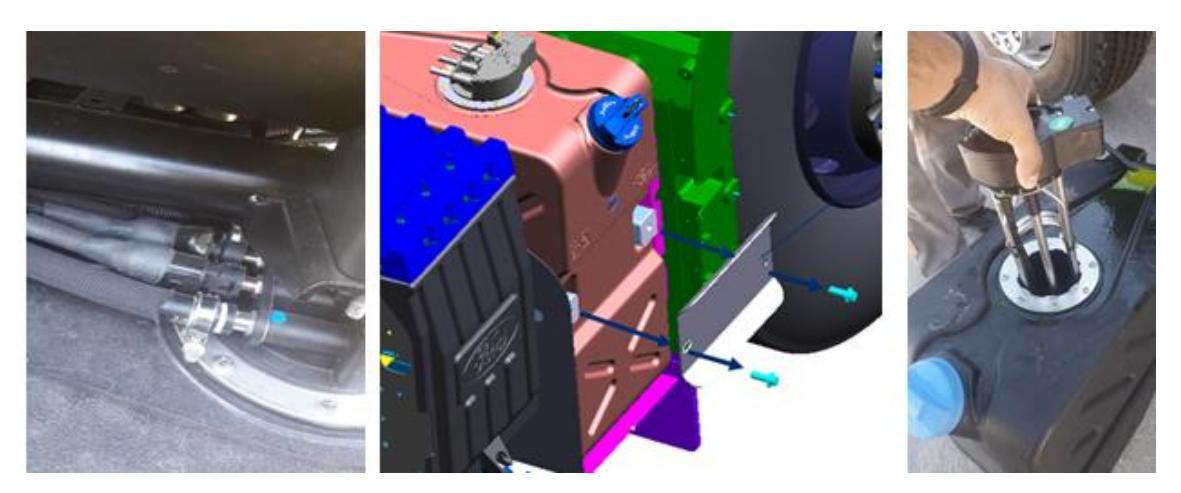
7- Remove the float from the tank. On some vehicles, the tank shall be removed completely as the air filter bracket is located on the float. The retaining cover bolts in front of the tank shall be removed with an M12 socket for this purpose. Bolts shall not be re-used. Then the tank shall be pulled out from the frame and the float shall be removed as described above.

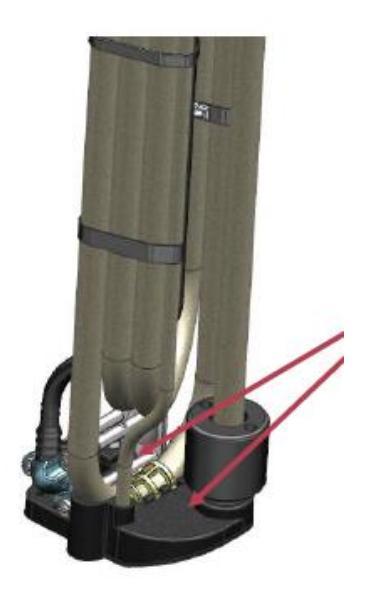
8- After removing the float, wash the areas shown with an ARROW with clean water. Ensure that there is no urea residue left.

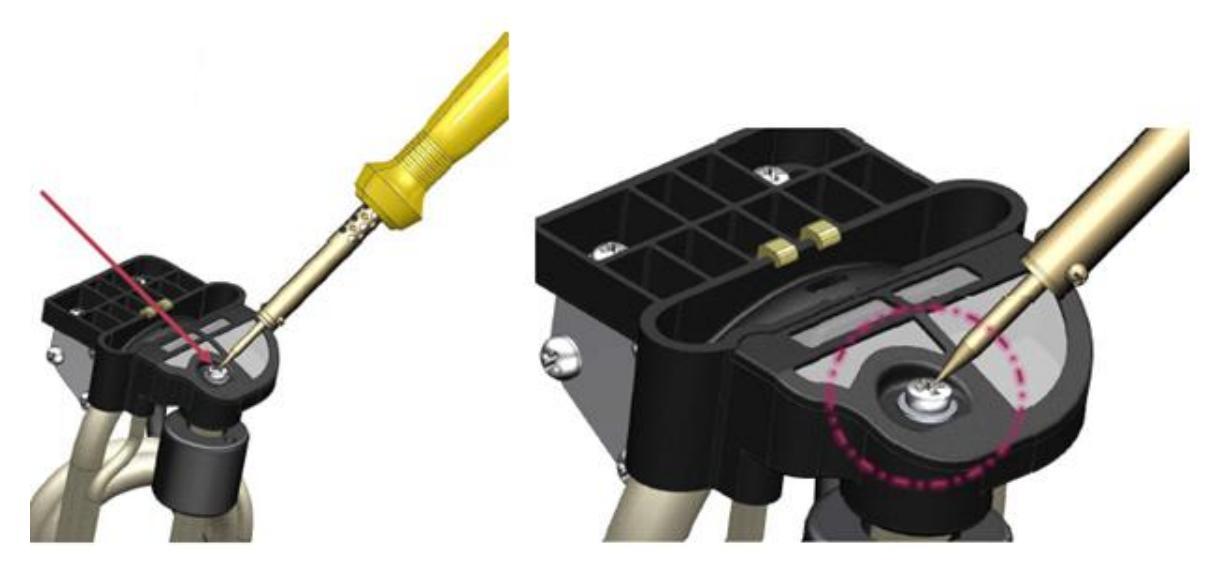
9- Turn the float upside down. First, try to remove the screw with a phillips screwdriver. If you have a trouble in removing, heat the screw shown with an arrow using a soldering iron to prevent damage to the teeth. While heating with a soldering iron, the tip of the soldering iron shall only contact the screw. It shall not contact any other area.

Note: The temperature of the soldering iron shall be 300 – 400 degrees and it shall be applied on the screw for about 2 minutes.

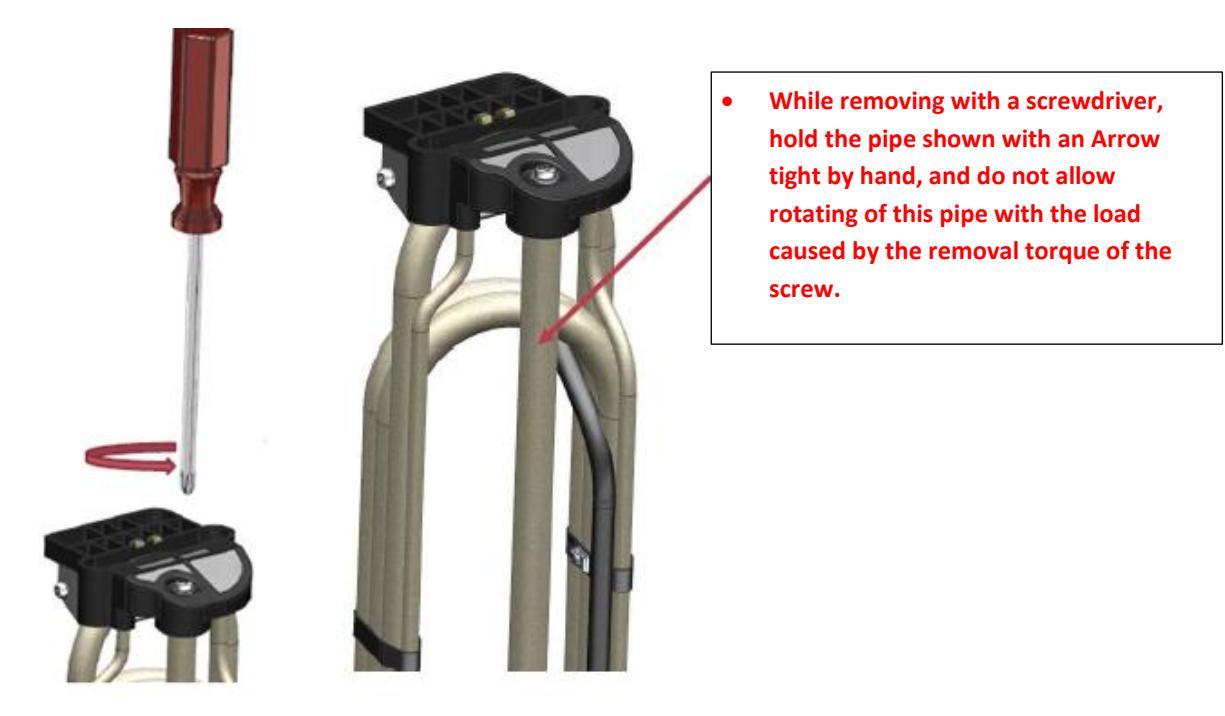
10-After heating the phillips head screw with the soldering iron, remove the screw with phillips screwdriver.

Note: While removing with a screwdriver, hold the pipe shown with an arrow tight by hand, and do not allow rotating of this pipe with the load caused by the removal torque of the screw.

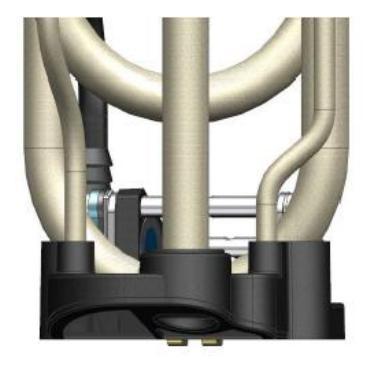
11-The screw and the spring washer under it shall be scrapped after removing them.

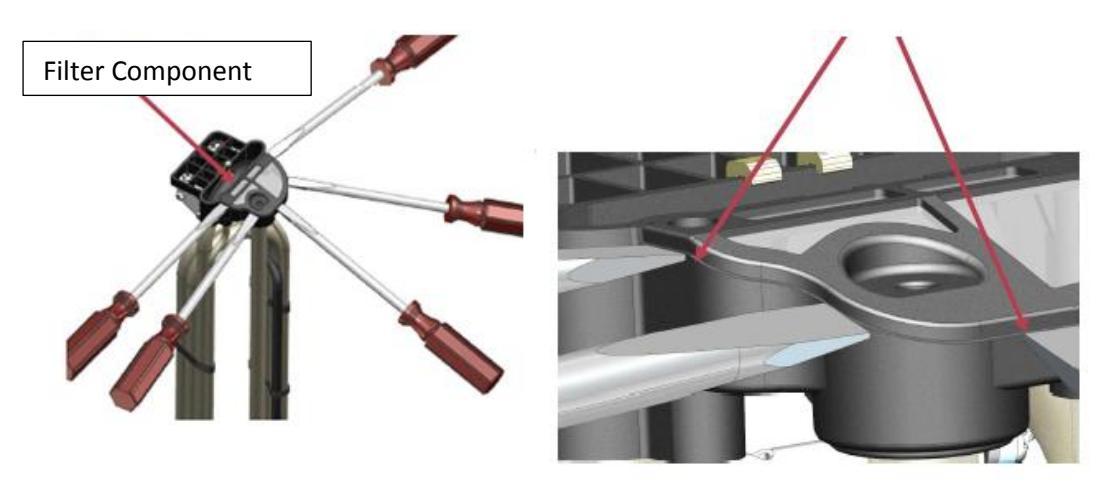
12-Try to remove the filter component on the float by pressing on the areas shown on the image with a flat tip screwdriver. Remove the filter component by inserting the flat tip screwdriver to the areas shown with an arrow.

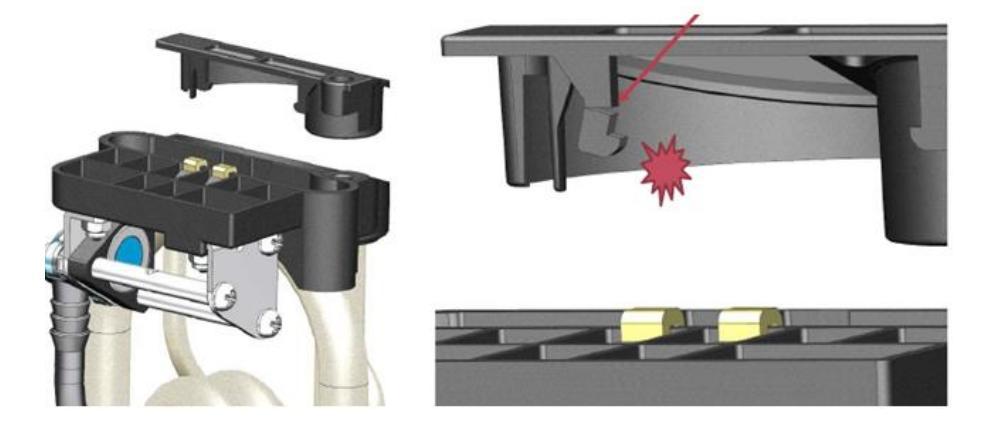
13-Remove the filter component as shown in the figure. The tabs specified with an arrow may break while removing the filter component. The removed filter component shall be scrapped and shall not be used again. There are 2 tabs on the filter component.

Note: The broken tabs shall be removed if they fall down inside the installation area, they shall not be left in the relevant area.

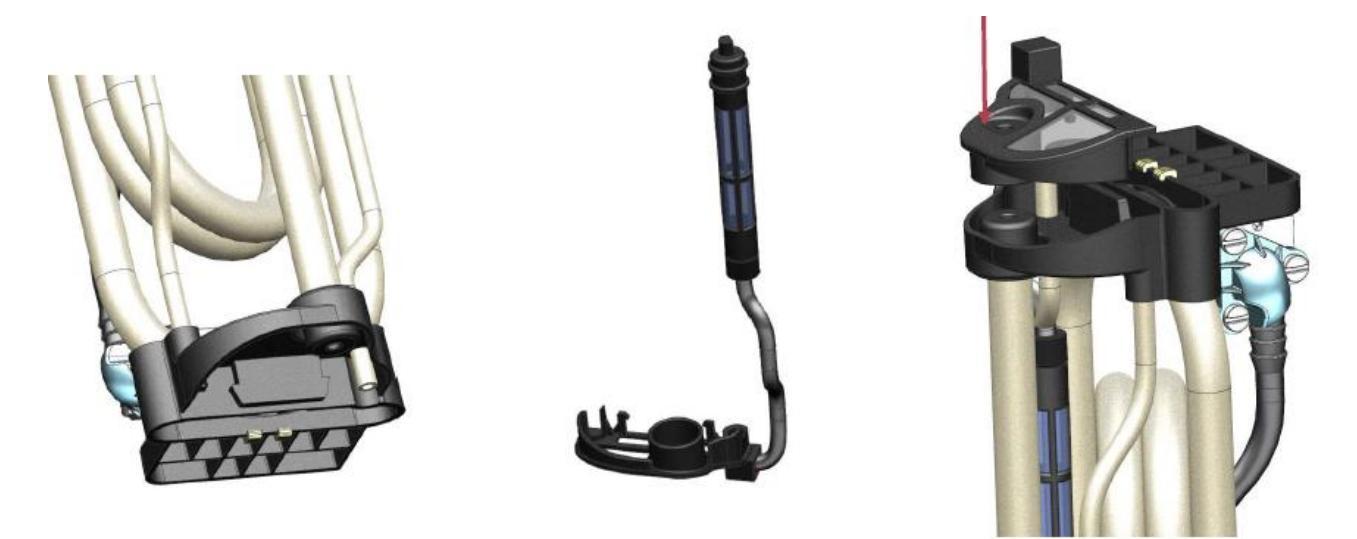
14-After removing the filter component, new filter kit shall be installed on the relevant area. Installation procedure shall be performed as shown in the figure.

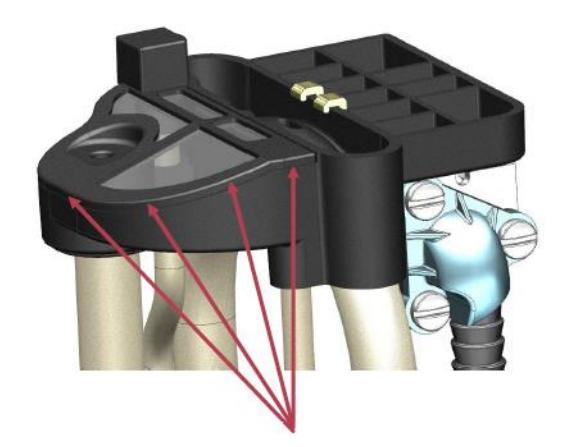
15-After installing the new filter kit, ensure that the surfaces shown with arrows are completely covered.

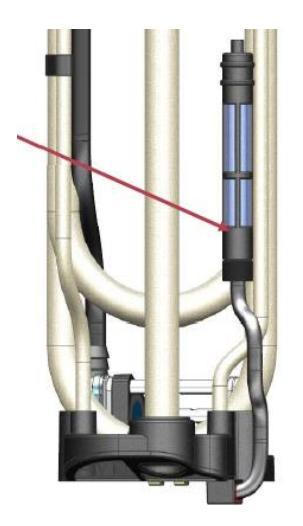
16-After installing the service component, the filter component shown with an arrow shall be inside the float pipes as shown in the figure.

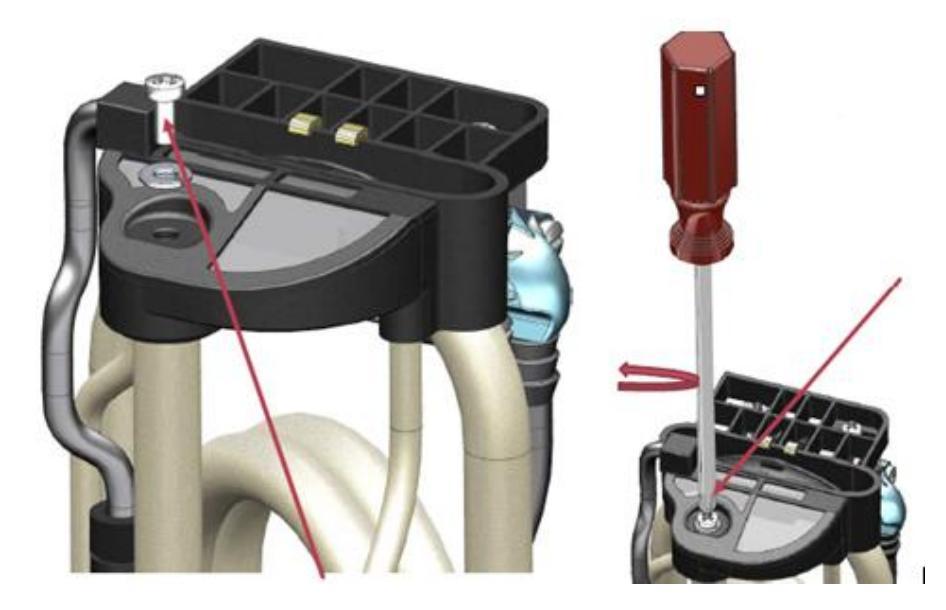
17-The spring washer and the screw provided with the kit shall be installed on the relevant area. The installation torque for the relevant screw is 2-2.5Nm. It shall be installed with an adjustable torque wrench, if applicable.

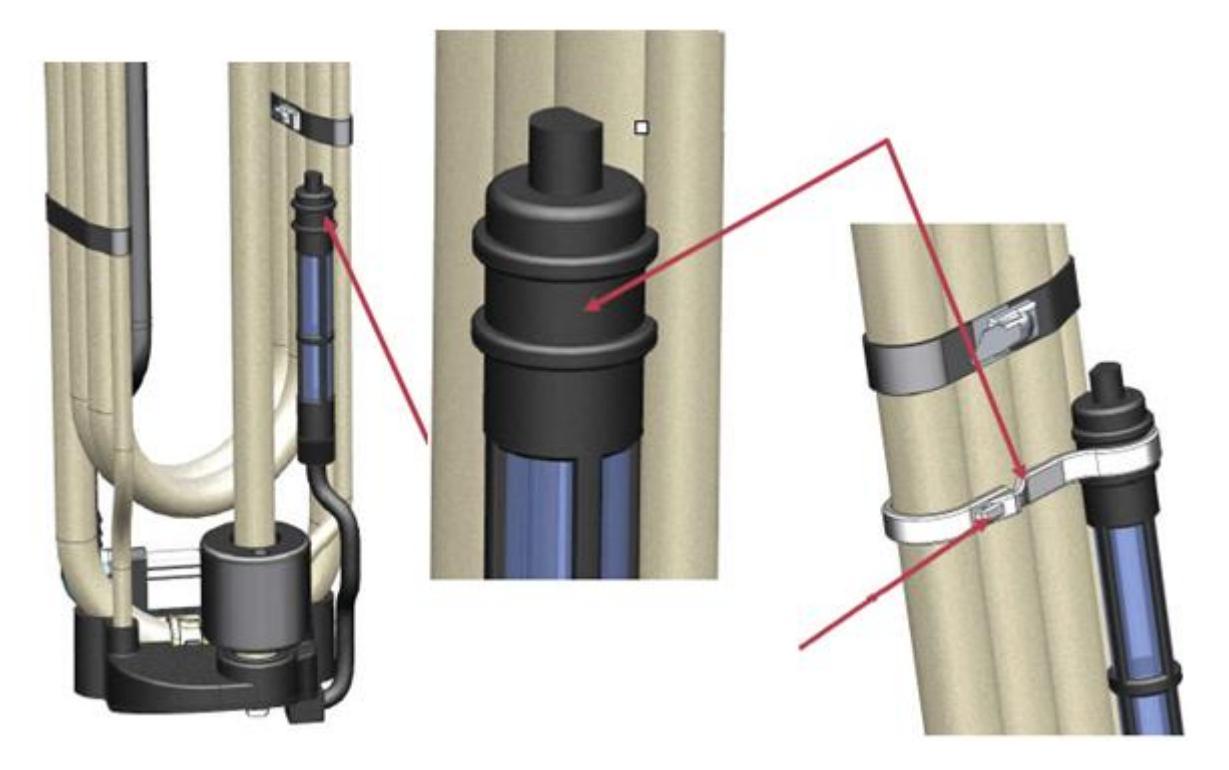
18-There is a groove on the filter for connection with the plastic clamp. The plastic clamp shall be installed from this groove to the float pipes as shown in the figure.

Note: The connection area of the plastic clamp shall remain inside the heater pipes as shown in the figure. If it is installed so that it will be outside of the pipes, it shall be hard to install the float to the adblue tank.

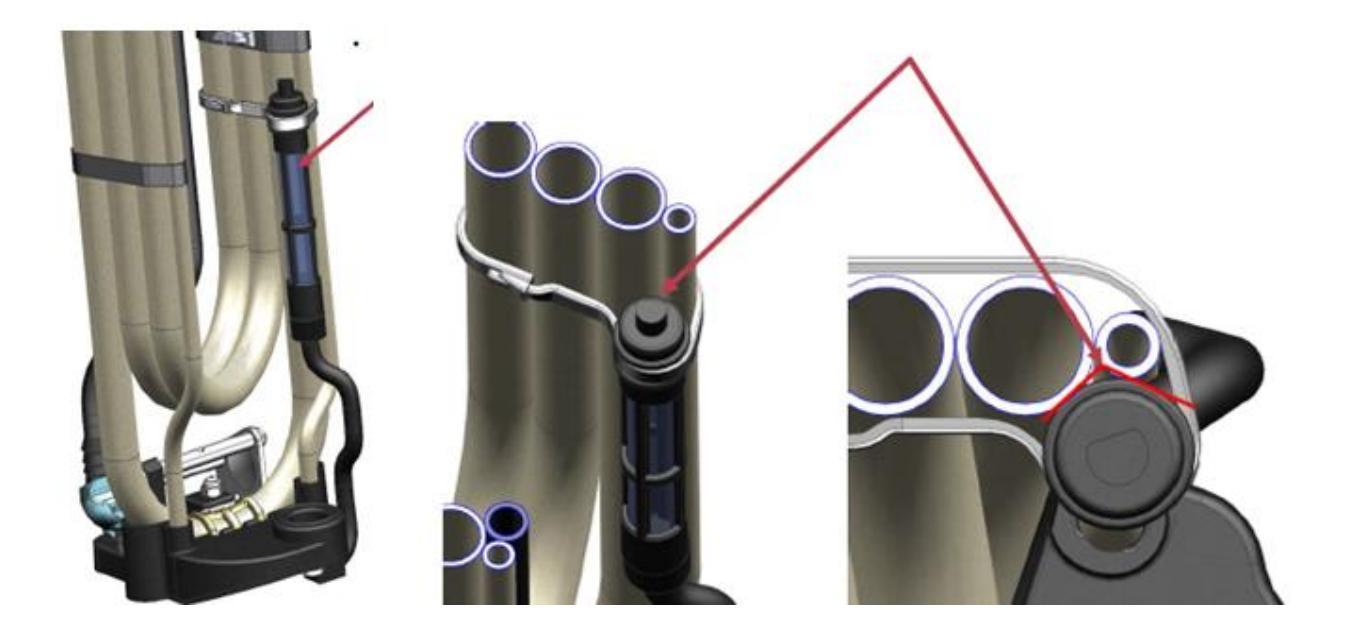
19-After completing the installation of the service component, it shall be in the upright position as shown in the figure. It shall be installed on the V seat that is created between the filter return pipe and the heater pipe.

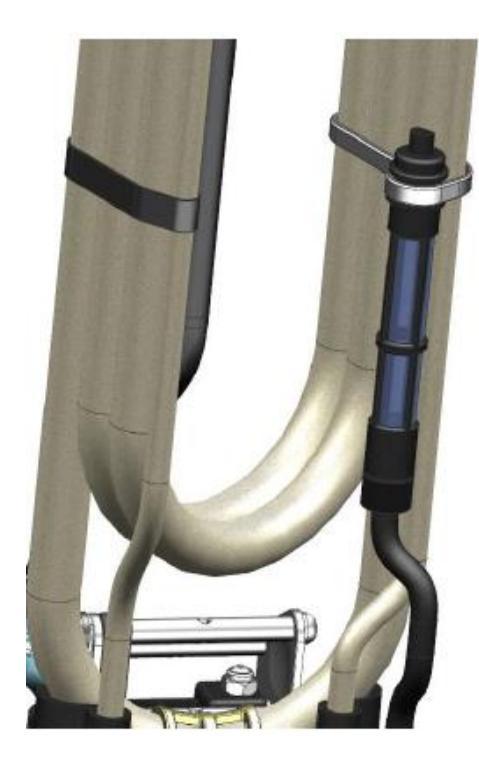
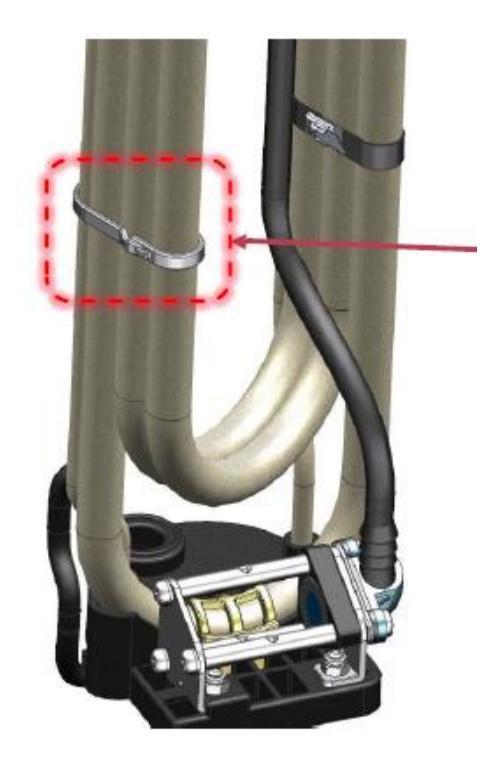
Examples of incorrect installation;

• The connection area of the plastic clamp shall not remain outside of the heater pipes.

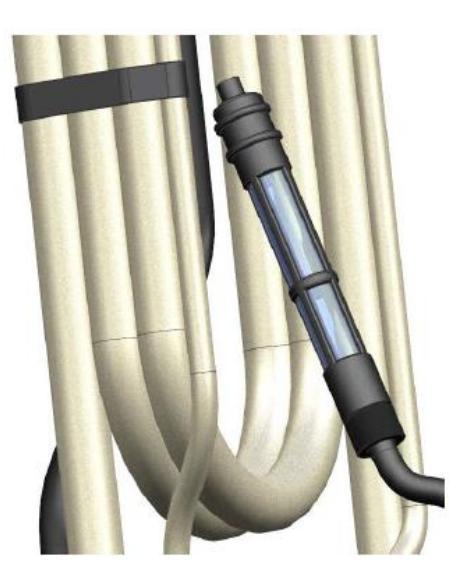
• Service component shall not be positioned at an angle as shown in the figure.

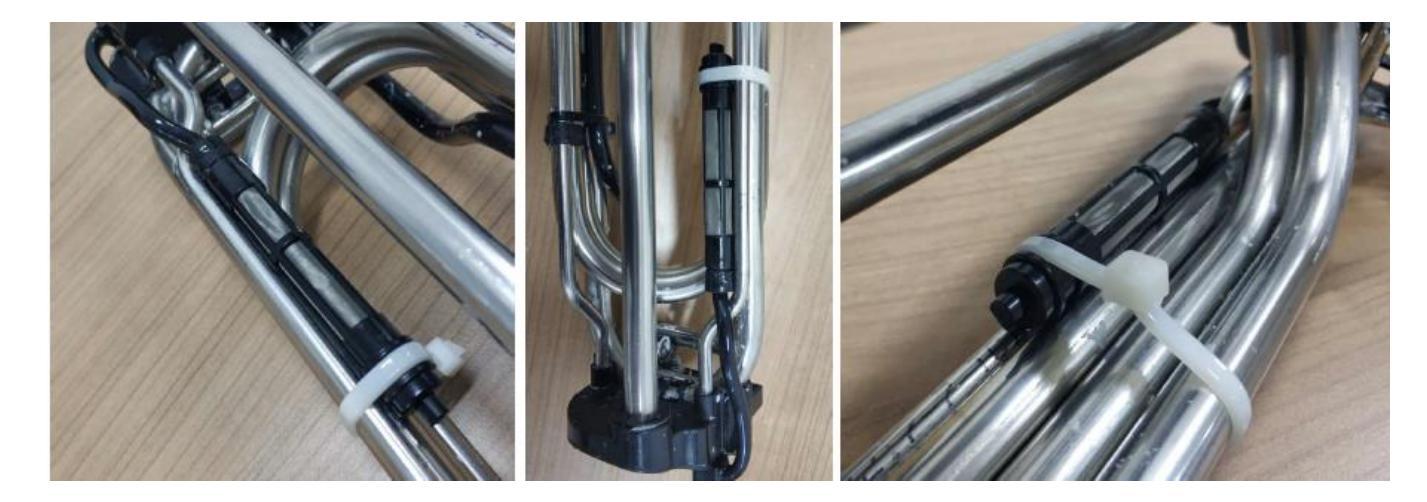
• Installation images below are examples of correct application.

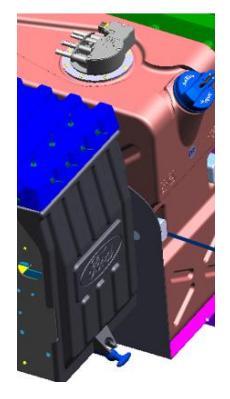
20-After completing all inspections and applications specified above, the float shall be installed to the tank. The float shall be installed without damaging metal pipes of the float and the filter while installing the new float to the tank. Ensure that the rubber O-rings on the float are not forgotten. After the installation, spigot ends of the float shall be upright and shall face the frame.

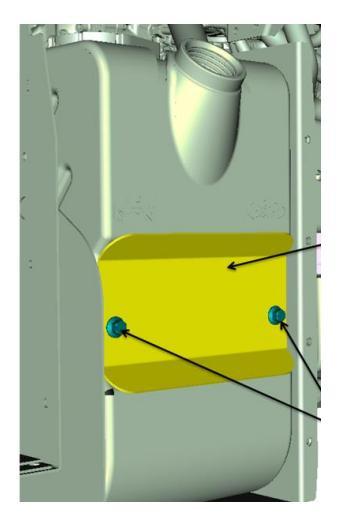
21-If the tank is removed, it shall be placed inside the metal casing as per its original position. The retaining cover shall be installed and new GC46-5J286-AB bolts (2 pcs.) shall be tightened with a torque of **80Nm**.

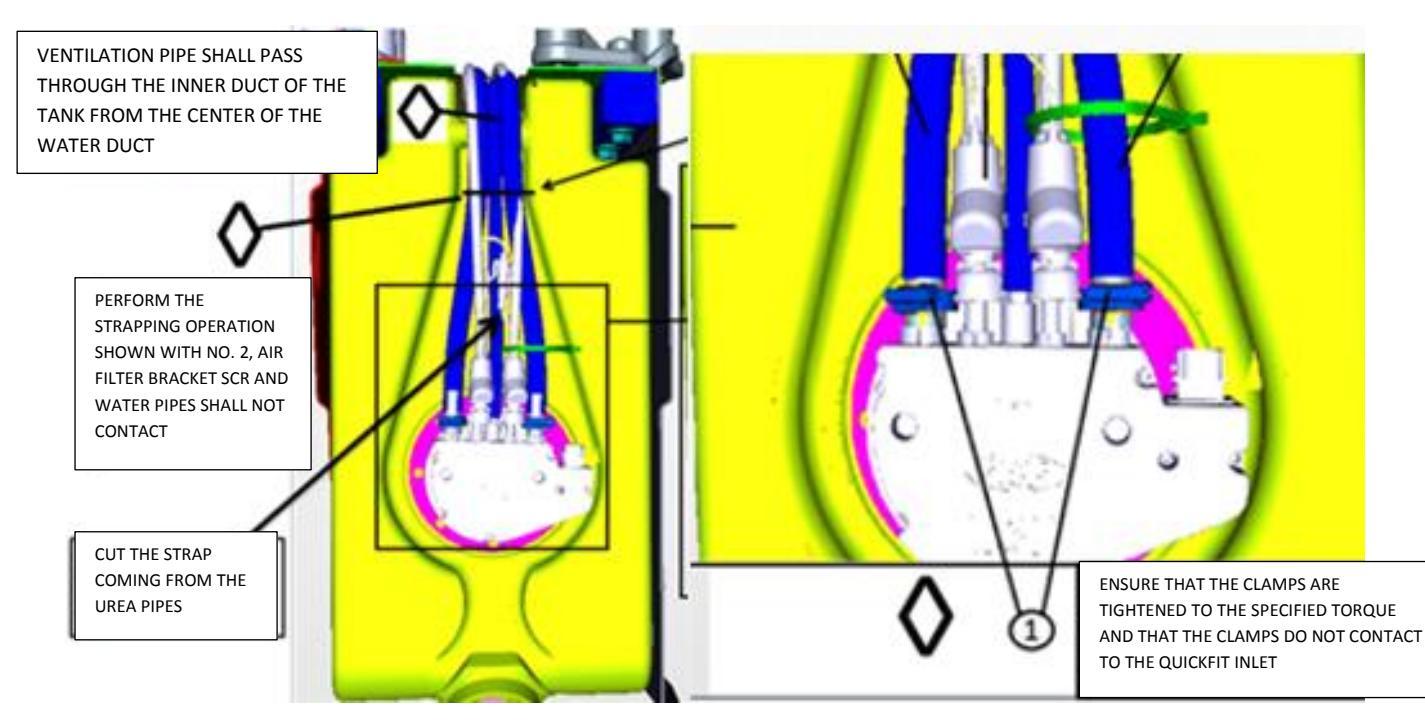
22-First, plug the electrical connector to the float. Then, visually inspect the insides of the urea hose connectors and ensure that the O-rings do not rotate inside. Urea inlet and outlet hoses shall be installed correctly in their original position and it shall be ensured that the quick-fit device is seated properly. Water inlet and outlet hoses shall be installed correctly to the float as in their original position and then tightened to 3.2 Nm. Ensure that the ventilation hose is not caught in between and that it passes right through the center as its original position. After completing the procedures, straps shall be applied correctly as in their original position.

Note: To prevent corrosion due to ingress of water to the electrical connector of the float, remove the water, then urea and then the electrical connection respectively. And during re-installation, perform the electrical connection first, and then the urea, and finally the water hose connection.

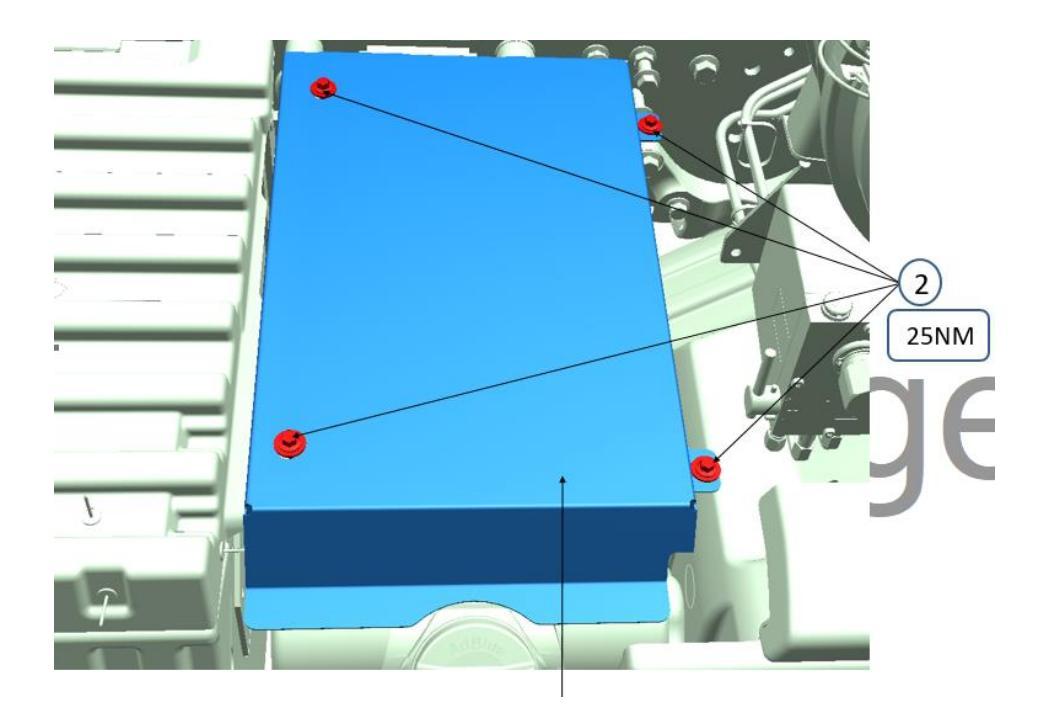
23-If the urea tank's protective cover is removed, it shall be installed together with 4 screws and tightened to 25 Nm.
