# REFERENCE: FSA202305

DATE: 17.07.2023

# SUBJECT: Air Filter Sensor Clogging Failure

FSA TYPE: Next Service Visit

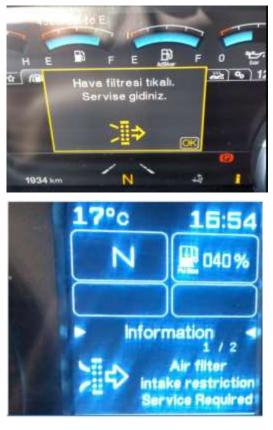
This TSB is prepared for the vehicles that come to the service with the warning "Air filter intake restriction, service required". When this error mode is encountered, first, the air filters of the vehicles should be checked visually.

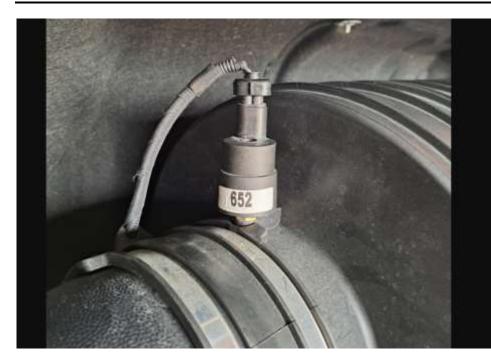
• The sensor attached to the air filter in the photo on the left is the "MC46 9N622 AA" sensor. It is **suitable** for part replacement.

\*After the air filter restriction sensors in the air filters of the vehicles are visually checked; suspicious MC46 9N622 AA parts specified in the photos above on the filters should be removed and the secured DC46 9N622 AA part must be mounted.

\*The parts to be replaced will be tightened clockwise by hand after threading.
