SERVICE INSTRUCTIONS

REFERENCE: GAR202103

SUBJECT: Turbocharger Oil Pipe Control

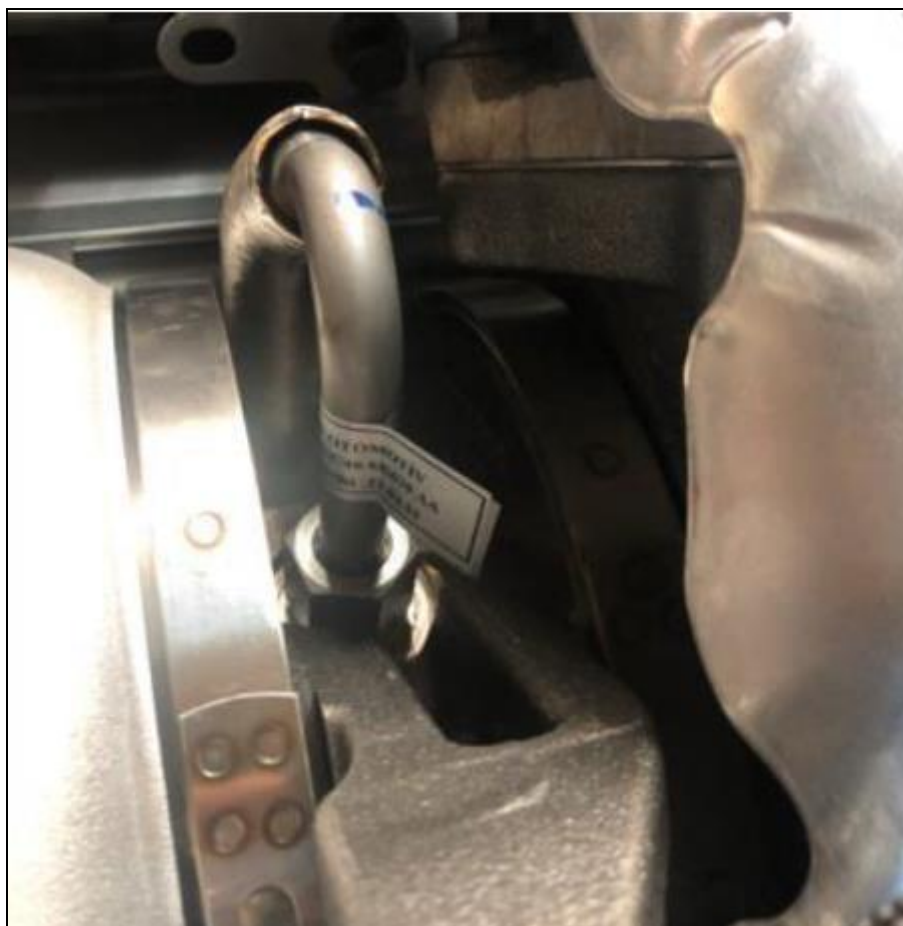
1- Oil leakage should be checked on the pipe seating surface.

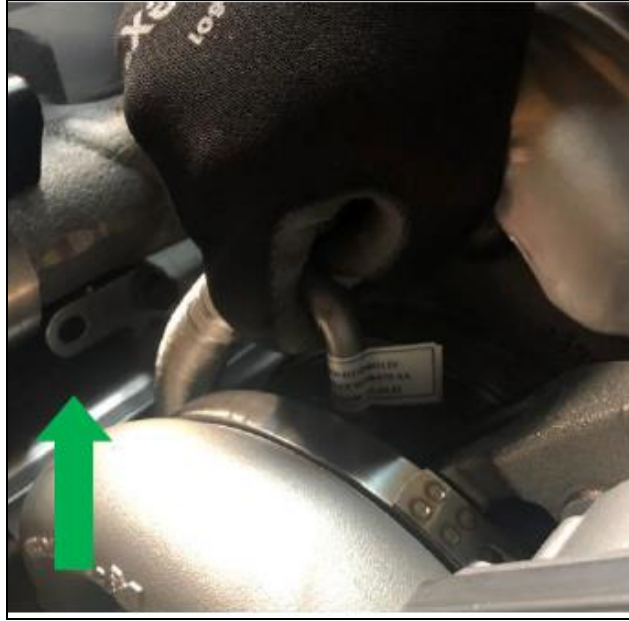
2- The pipe should be pulled up

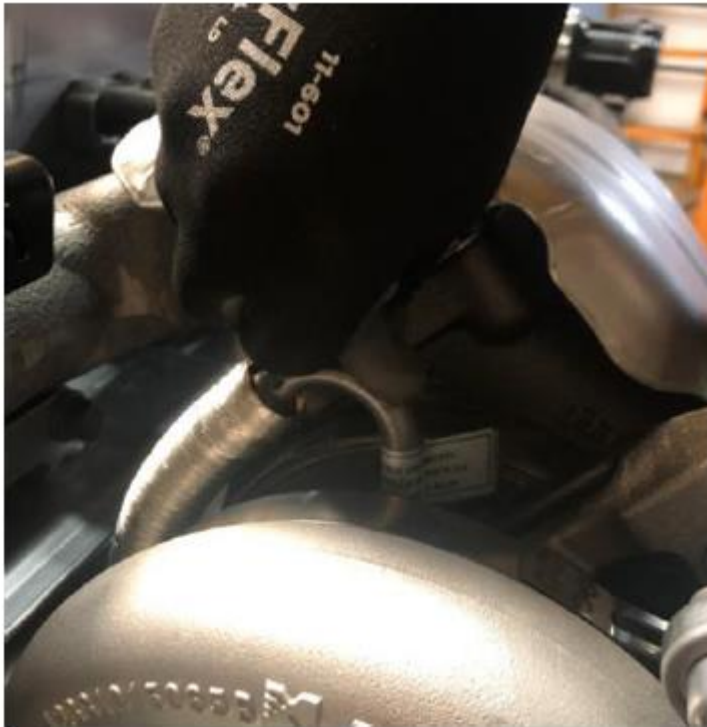
3- If you pull the pipe upwards, if there is no dislodgement, make sure that it is fit well by pushing it in the right direction.

If it displaces when pulled up, contact service engineering without any application.
